Guidelines

THE STAINED GLASS WINDOWS OF CAPITOL HILL

BY LYLE SCHAUER

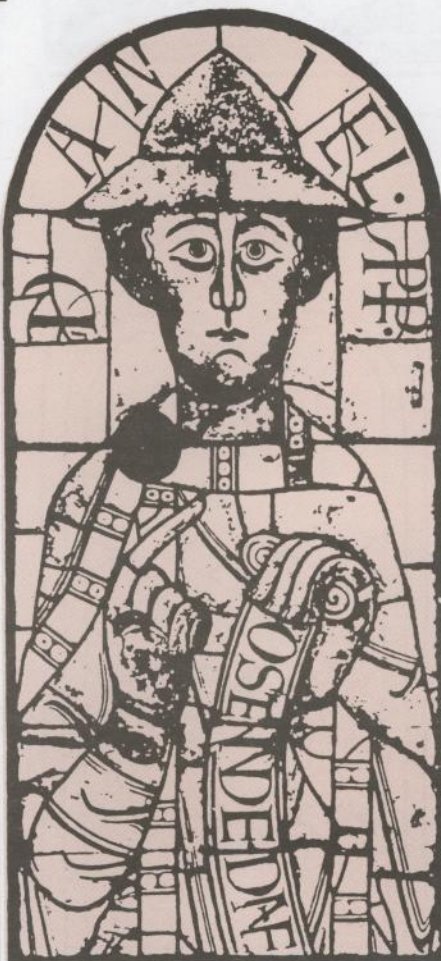
1. THE DANIEL WINDOW (UPPER PORTION ONLY SHOWN) IS ONE OF THE FIVE PROPHET WINDOWS IN AUGSBURG CATHEDRAL. THEY ARE THE OLDEST WINDOWS KNOWN (11TH CENTURY), BUT THEIR TECHNICAL AND ARTISTIC SOPHISTICATION SHOW THAT STAINED GLASS WAS ALREADY WELL DEVELOPED.

The stained glass art form apparently originated in the Christian churches of Europe. The oldest windows extant, dated to the 11th century, are those of the five prophets in Augsburg Cathedral in Germany (Fig. 1). Since the windows are technically sophisticated, they are evidence that the art form was already well established. Stained glass windows are referred to as early as the 7th century, but the windows have not survived and their design and construction are unknown.

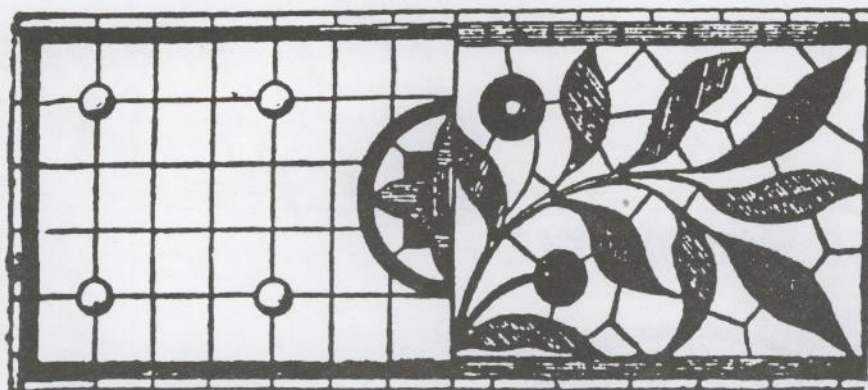
2. THIS DRAWING FROM AN ENGLISH 19TH CENTURY ADVERTISEMENT COMBINES BOTH MAJOR CLASSES OF STAINED GLASS DESIGNS: ON THE LEFT, GEOMETRIC; ON THE RIGHT, CURVILINEAR.

The Philadelphia Centennial Exhibition of 1876 strongly influenced the development of American glass. The exhibition was held when the North had nearly recovered from the Civil War and prosperity had returned. Americans were receptive to products, designs, and styles from Europe and the Orient displayed at the exhibition. Styles of home decoration became more elaborate and eclectic. Stained glass styles also became more elaborate. Curvilinear designs, frequently decorated with jewels (the term "jewel" describes small round or square, sometimes faceted bits of glass) and other ornamentation, became popular, although geometric patterns continued to be produced (Fig. 2).

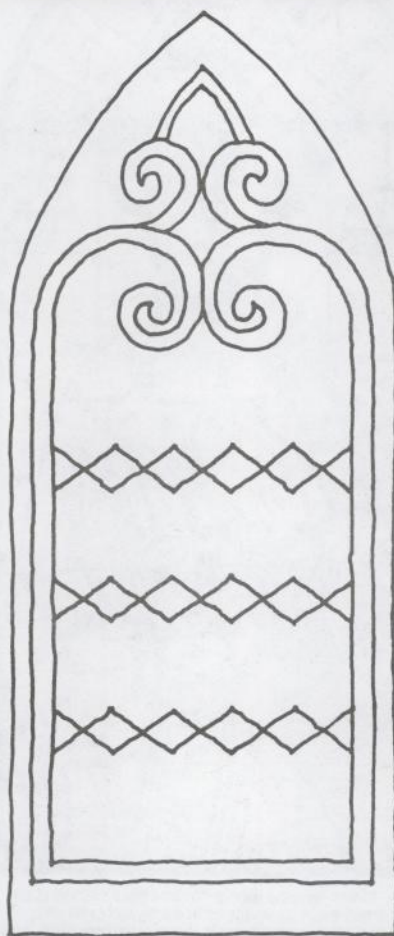
3. THIS DESIGN, WORKED IN OPALESCENT GLASS, STANDS OUT PROMINENTLY DURING THE DAY IN WINDOWS AT CAPITOL HILL PRESBYTERIAN CHURCH. OPALESCENT GLASS ADDS INTEREST TO WINDOWS WHEN SEEN FROM THE LIGHTED SIDE, WHETHER FOR PASSERSBY DURING THE DAY OR FOR RESIDENTS FROM THE INSIDE AT NIGHT.

Opalescent glass is a milky, semitranslucent glass that reflects some of the light falling on it. Both church and home windows sometimes have a part of the design worked in opalescent glass to add visual interest. Without that addition, windows that gleam with multicolored splendor inside as light streams through them, appear dark and uninteresting from the other side. The addition of opalescent glass adds interest to windows when viewed from the street during the day or when viewed from inside at night. An excellent example of the use of opalescent glass is found in the windows of the accessory building on the south side of Capitol Hill Presbyterian Church (Fig. 3).

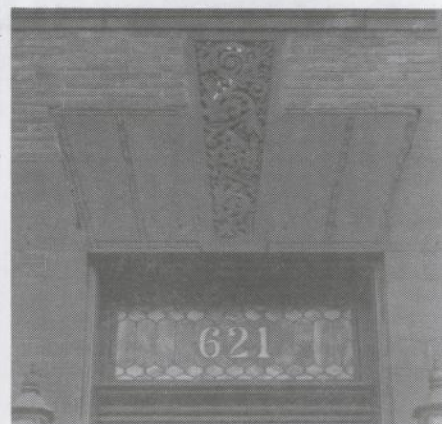
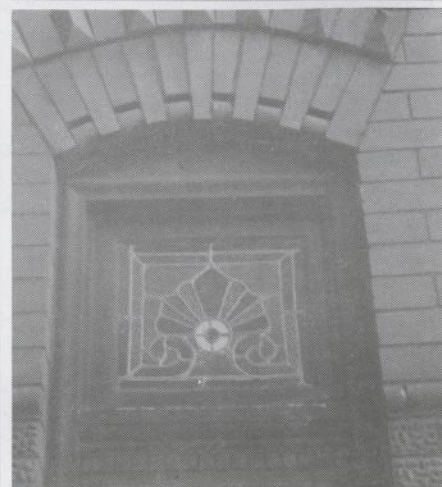
4. PRESSED BRICK BAY FRONTS USUALLY HAVE STAINED GLASS TRANSOMS OVER THE FRONT DOOR LIKE THIS ONE AT 621 EAST CAPITOL STREET AND OFTEN HAVE STAINED GLASS TRANSOMS OVER THE FRONT AND SIDE WINDOWS IN THE BAY AS THIS AT 1109 INDEPENDENCE AVENUE, SE.

Stained glass windows are associated largely with the square bay front houses of Capitol Hill, and are usually installed in transoms above the front and side windows in the bay and over the front door (Fig. 4). The stained glass in the side window transoms is a simplified version of the pattern used for the front transom. The pattern of the stained glass panel over the front door may repeat the patterns of the bay windows, but with the house number added. However, there are many exceptions: a common variation is door transoms made up of borders surrounding three or four squares of beveled glass with the house number added in gold leaf.

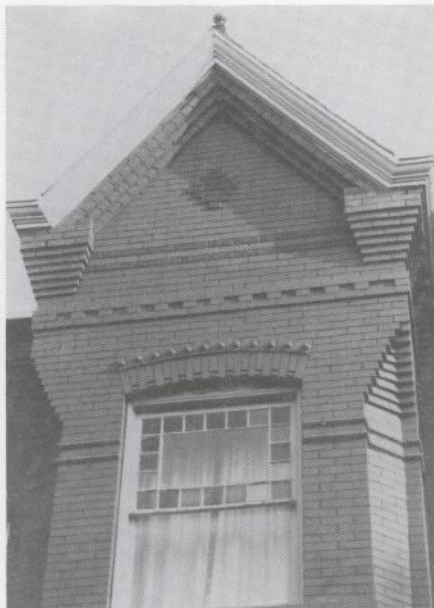
5. THE ROW OF COLORED GLASS SQUARED AROUND A PANEL OF CLEAR GLASS IN THE UPPER SASH OF THIS WINDOW AT 1107 INDEPENDENCE AVENUE, SE, IS A DECORATIVE ELEMENT PARTICULARLY ASSOCIATED WITH THE QUEEN ANNE STYLE.

som over the inner door of this vestibule, often with a stained glass panel similar to that over the front door but without the house number. Some more elaborate houses have stained glass transoms at the second and third floors. In less elaborate houses the upper sash of the second story windows often has a row of colored glass squares set around a panel of clear glass, a decorative element particularly associated with the Queen Anne style. (Fig. 5).

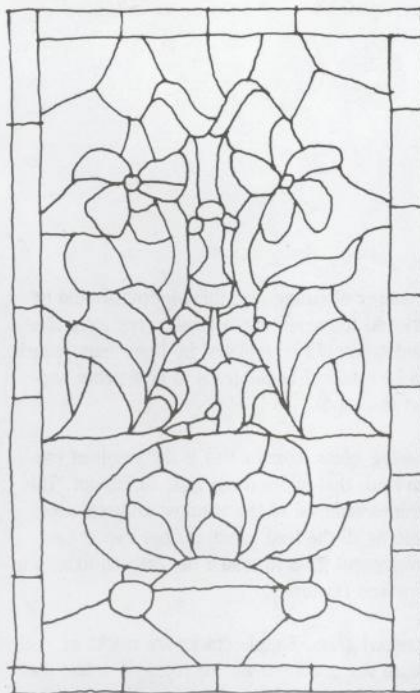
7. VASE WITH FLOWERS AT 329 EAST CAPITOL STREET, SE, IS AN EXAMPLE OF A FINE CURVILINEAR PATTERN. THIS PANEL OCCUPIES ITS OWN WINDOW, UNUSUAL ON CAPITOL HILL WHERE MOST STAINED GLASS IS IN TRANSOMS.

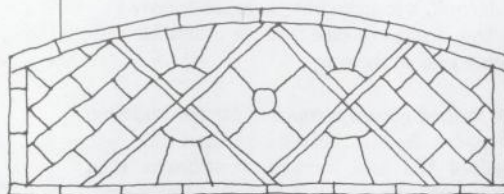
6. TRANSOM OF RECTILINEAR DESIGN AT 9 FOURTH STREET, SE, HAS SUNBURSTS, A COMMON DESIGN ELEMENT.

used throughout the period of stained glass popularity. The geometric sunburst pattern is very common on Capitol Hill and some windows were designed to incorporate as many sunbursts as possible (Fig. 6). Curvilinear patterns usually consist of a central design, such as a flower, fan, lozenge, or crown surrounded by twining foliage or ribbons (Fig. 7&8). No windows of geometric design decorated with stenciled patterns are known in Capitol Hill homes, but this is not surprising since nearly all of the Hill glass postdates the 1870s, when these designs were common. Examples of line drawing and enameling also are unknown in Capitol Hill homes, but since these are expensive techniques they are uncommon anywhere in homes. Several of the churches on Capitol Hill, however, have enameled glass. The windows of St. Peter's Church (Second and C Streets, SE) contain a great deal of enameled glass. Although the patterns used are typical of the 1870s, the church is dated 1889. The original windows were destroyed by fire and the present windows presumably are reproductions.

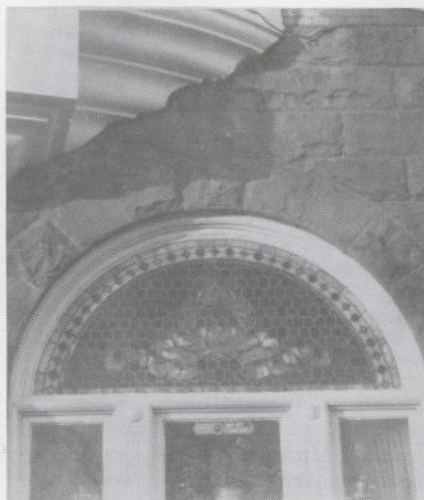
8. CURVILINEAR PATTERNS USUALLY CONSIST OF A CENTRAL DESIGN, SUCH AS A FLOWER, FAN, LOZENGE, OR CROWN SURROUNDED BY TWINING FOLIAGE RIBBONS, LIKE THIS ONE AT 512 EAST CAPITOL STREET.

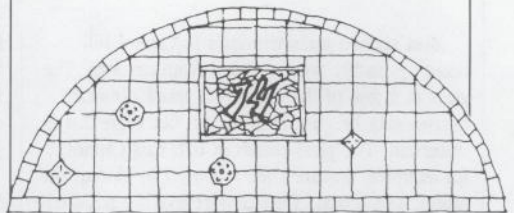
9. MOSAIC GLASS TRANSOM AT 14 FOURTH STREET, SE. THE USE OF RECTANGULAR PIECES OF GLASS IS UNUSUAL. MOST MOSAIC GLASS PANELS ARE MADE OF SMALL PIECES OF GLASS TO RESEMBLE A MOSAIC BUT IN THIS PANEL THE TYPICAL CONSTRUCTION IS CONFINED TO THE SMALL INSERT FOR THE HOUSE NUMBER.

Capitol Hill has examples of mosaic glass, an American oddity, at 12-14 Fourth Street, SE (Fig. 9). Mosaic glass panels were fabricated without lead channels to hold the glass. Instead, what appears to be a lead amalgam (a mixture of lead and mercury, similar to the amalgam used in dentistry, but compounded with lead rather than silver) holds the glass. The amalgam presumably was mixed and quickly packed between the pieces of glass before it hardened. Mosaic windows were produced by the Belcher Mosaic Glass Company for a brief period in the late 1880s. (The Belcher Company allegedly went out of business because the materials used poisoned the workmen.) Capitol Hill's examples are simple geometric patterns of squares interspersed with glass "jewels" rather than patterns built from tiny fragments of glass.
