# Guidelines

## CAST IRON:

### FIRMNESS, COMMODITY, AND DELIGHT

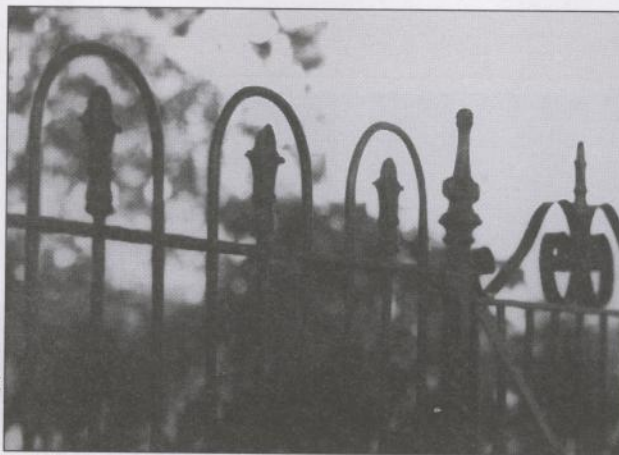
HAIRPIN FENCE

as "wrought" iron is actually "merchant" iron, a form of mild steel, hot rolled and soft enough to be bent into forms like our hair-pin fences. Stock merchant iron bars and castings are welded together to form fairly routine economical aggregations for railings, window guards and the like. The "iron", commonly used for the rods and bars in our fences and security gates is also "merchant" iron, although cast points and other decorative shapes are frequently applied. The term "merchant iron" may have its origins in 19th-century classifications of iron. Modern merchant iron, open hearth or Bessemer steel is iron with .2 to .6% carbon content, typically rolled into shapes like angles, "I's," "H's" rods, and bars.

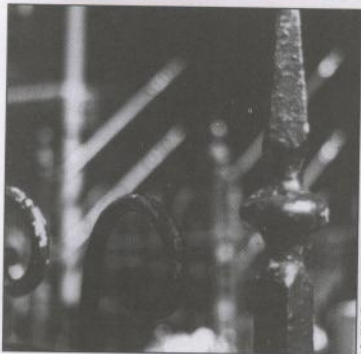
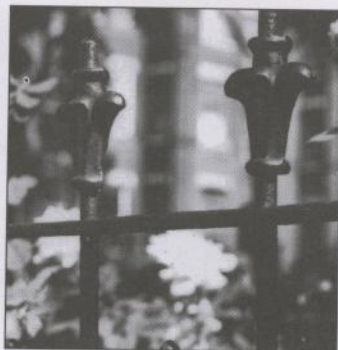
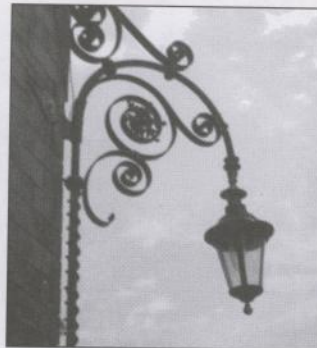
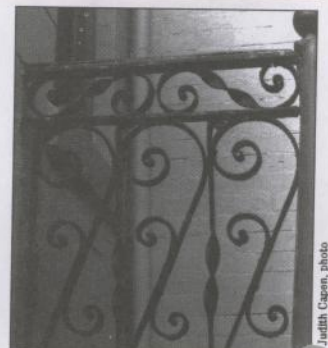
THE RICHNESS CONTRIBUTED TO OUR NEIGHBORHOOD BY THE AMAZING VARIETY OF IRON FENCES IS A PRODUCT OF 19TH-CENTURY IRON TECHNOLOGY. ALSO, THE FINIALS AND DECORATIVE PIECES ARE CAST IRON, THE HORIZONTAL AND ROUND VERTICALS ARE "MERCHANT IRON," OR A FORM OF MILD STEEL, SOFT ENOUGH TO BEND AND SHAPE. WROUGHT IRON, LESS BRITTLE THAN CAST IRON, IS SHAPED BY HAND - NOT MANUFACTURED.

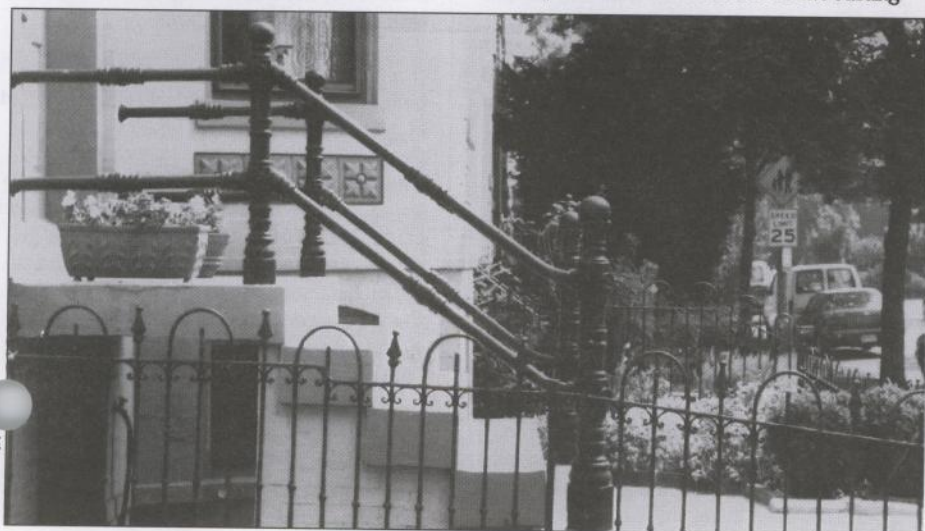
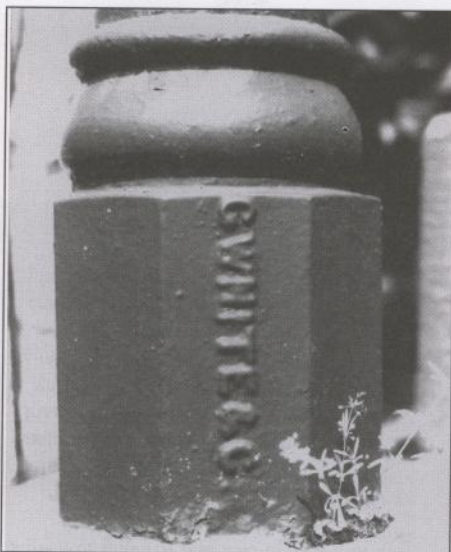
THE RAILINGS ON THE GEORGE WHITE STOOP (BELOW TO THE LEFT) FROM THE 1892-3 BUILDERS' CATALOGUE ARE SIMILAR TO THOSE OF THE FOUNDRY IN THE UNIT BLOCK OF FOURTH STREET, SE (BELOW)

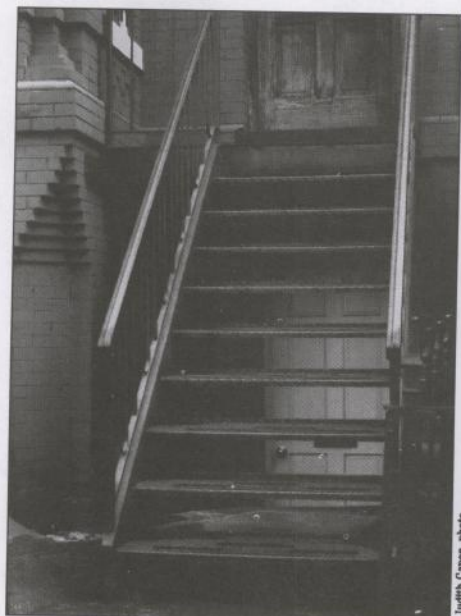
FOUR ADJACENT HOUSES AND ORIGINALLY IDENTICAL SETS OF STAIRS: THE ORIGINAL HISTORIC IRON STAIRS AT THIS HOUSE WERE REPLACED WITH INAPPROPRIATE STEEL STAIRS.

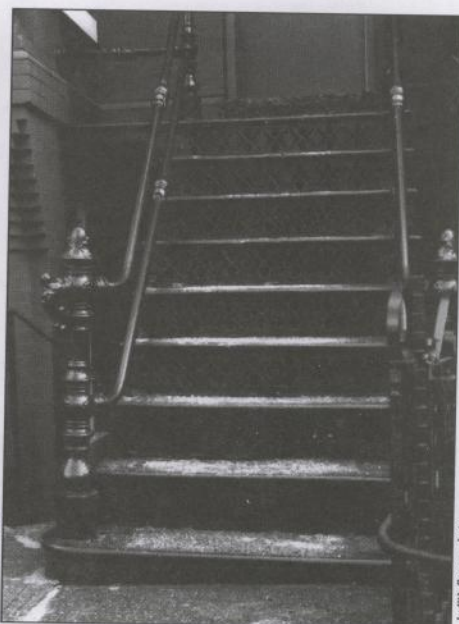
THIS RUN OF STAIRS IS IN GOOD SHAPE EXCEPT FOR SOME SETTLEMENT.

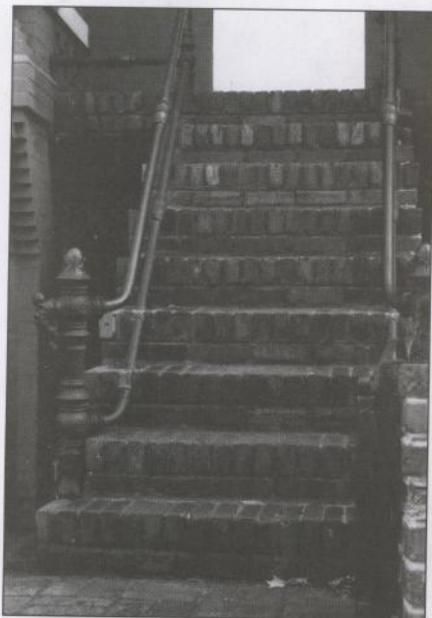
THE MOST DISTRESSING OF ALL IS THIS SET OF STAIRS WHERE BRICK HAS BEEN INSTALLED ON TOP OF HISTORIC IRON STAIRS. IT IS A VERY POOR IDEA, DENYING THE NATURE OF THE IRON IN FAVOR OF ANOTHER MATERIAL. THE BRICK WILL HOLD WATER AGAINST THE IRON, GUARANTEEING CORROSION AND THE ULTIMATE DESTRUCTION OF THE HISTORIC IRON.

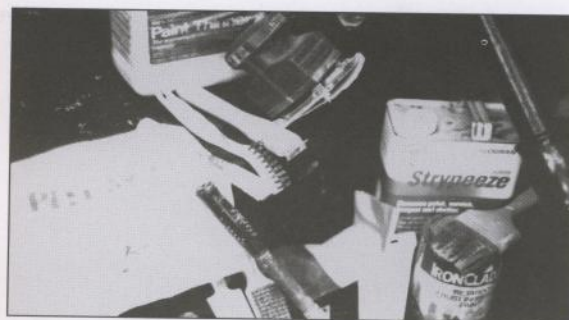
REPAIR AND MAINTENANCE PRODUCTS: PAINT THINNER, SCRAPERS, BRUSHES, PAINT REMOVAL PRODUCTS, CAULK, SANDPAPER, PAINT, AND PRIMER.

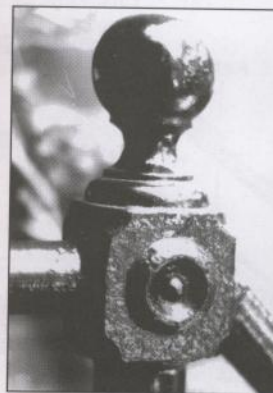
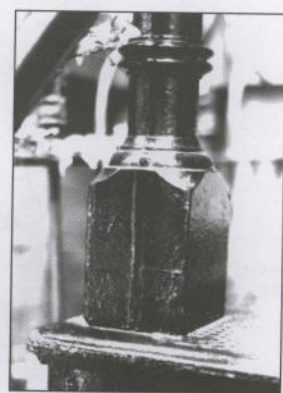
INTERMEDIARY NEWELS WITH OLD PAINT REMOVED AND WITH NEW PRIMER, AND TWO COATS OF GLOSS BLACK ALKYD EXTERIOR PAINT APPLIED. NOTE FIRMLY ATTACHED RAILS - THE NEWEL CONNECTION CAULKED TO ENSURE A WATERTIGHT SEAL. ALSO NOTE BASE FIRMLY ANCHORED TO LANDING PLATE WITH RODS AND BOLTS AND RISER SECURELY SCREWED TO STRINGER.

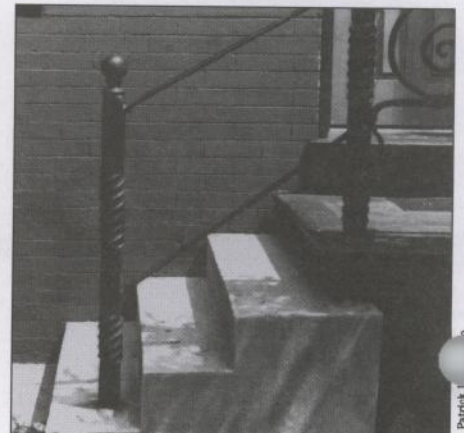
EMBEDDING THE NEWEL OF THIS STAIR IN CONCRETE IS INAPPROPRIATE. CONCRETE'S TENDENCY TO HOLD MOISTURE IN CONSTANT CONTACT WITH THE IRON WILL ACCELERATE THE CORROSION PROCESS ON THE EMBEDDED PART WHERE IT IS IMPOSSIBLE TO PROTECT IT WITH PAINT. NEITHER CAST NOR WROUGHT IRON SHOULD EVER BE EMBEDDED IN CONCRETE OR OTHER HYGROSCOPIC MATERIALS, SUCH AS BRICK AND MORTAR.

Sometimes, people ill advisedly pour concrete inside these newels, in an attempt to re-secure them. The concrete hastens corrosion of the newel from the inside. Pouring concrete, a hygroscopic material that absorbs moisture from the air and through which moisture can travel, inside a newel ensures moisture will be kept in constant contact with the iron, on a probably unpainted surface. For the same reason, it is not good to embed any iron elements, stairs, stoops, fences or the like, in concrete, brick, or mortar, all hygroscopic

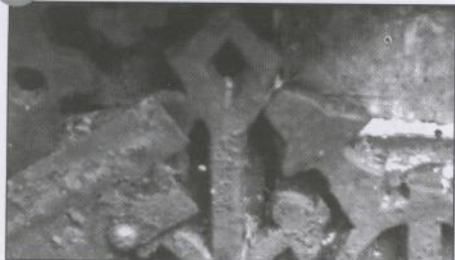
LEFT: THIS PHOTO AND DETAIL SHOW SEVERAL UNFORTUNATE REPAIR ATTEMPTS. POORLY MAINTAINED AND BADLY REPAIRED CAST COMPONENTS WILL ULTIMATELY FAIL AND LEAD TO THE DETERIORATION OF ADJACENT PARTS. AS ANY PART OF THE CONSTRUCTION FAILS, IT PUTS STRESS ON ADJACENT PARTS CAUSING OR ACCELERATING THEIR FAILURE IN TURN. APPLICATION OF "CHECKER" PLATE SUCH AS ON THE BOTTOM TWO STEPS IN THE LEFT PICTURE AND BELOW, HAS BEEN A COMMON REPAIR ON MANY CAPITOL HILL CAST IRON STAIRS. IT IS NOT A SOLUTION TO STRUCTURAL PROBLEMS THAT MAY HAVE CAUSED CRACKING OF TREADS IN THE FIRST PLACE. IT IS BETTER TO PROVIDE NEW STRUCTURAL SUPPORT UNDER A CRACKED TREAD, KEEPING IT IN PLACE, AND FILLING THE CRACK TO PRESERVE VISIBLE HISTORIC FABRIC.

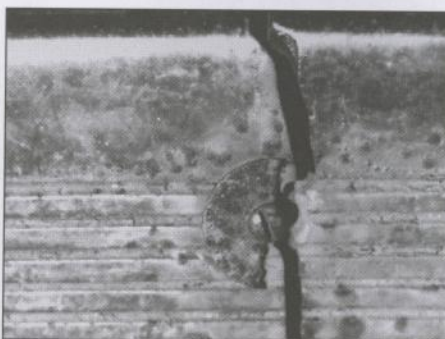
THESE PICTURES SHOW SEVERAL INEFFECTIVE ATTEMPTS AT REPAIRS. TOP: THIS WELD JOINT IS AS INEFFECTIVE AS IT IS UNSIGHTLY. ALTHOUGH WELDING CAST IRON IS SOMETIMES SUCCESSFUL IN LIMITED APPLICATIONS, IT IS RARELY A LONG TERM SOLUTION FOR STRUCTURAL COMPONENTS LIKE THIS TREAD BECAUSE IT DOES NOT ELIMINATE THE WEAKNESS ALONG THE CRACK LINE. BOTTOM: TEMPORARY REPAIRS SHOULD BE TEMPORARY. SOMETIMES TEMPORARY REPAIR MEASURES ARE IN ORDER WHILE PERMANENT SOLUTIONS ARE RESEARCHED, BUT IF LEFT TOO LONG, THEY THEMSELVES FAIL, SUCH AS THIS ONCE BOLT-SECURED CRACKED TREAD. THEN, SURROUNDING UNDAMAGED COMPONENTS OF HISTORIC IRON ARE IN JEOPARDY. GET TO THE ROOT OF THE PROBLEM - IN THIS CASE FAILED SUPPORTS - AND DON'T CONSIDER TEMPORARY REPAIRS PERMANENT SOLUTIONS.

Welding cannot return a structural member, such as a stair stringer or tread to its original single member integrity. Thus, a weld is inherently less strong than the original iron piece, and subject to the deterioration enumerated above. Furthermore, if whatever caused the tread to crack in the first place is not corrected, a welded repair cannot be anything but temporary. The preferred repair to a broken or failed cast iron member is to use a mechanical repair, bolting a new structural piece to the failed member as inconspicuously as possible, using welding only cosmetically if at all.

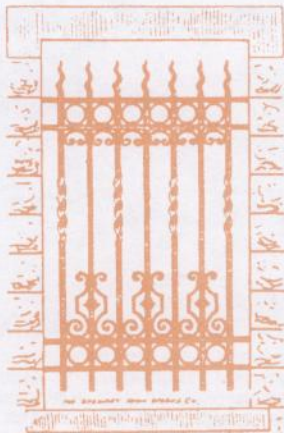
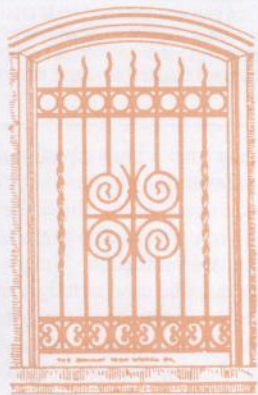
LEFT: THESE IRON GRILLES ARE MANUFACTURED AND AVAILABLE TODAY, DEMONSTRATING THAT A THOROUGH SEARCH WILL OFTEN TURN UP SUPPLIERS MAKING REPRODUCTION 19TH CENTURY PRODUCTS OR WHO MAY HAVE BEEN MAKING THESE PRODUCTS CONTINUOUSLY SINCE THE LATE 1800'S.

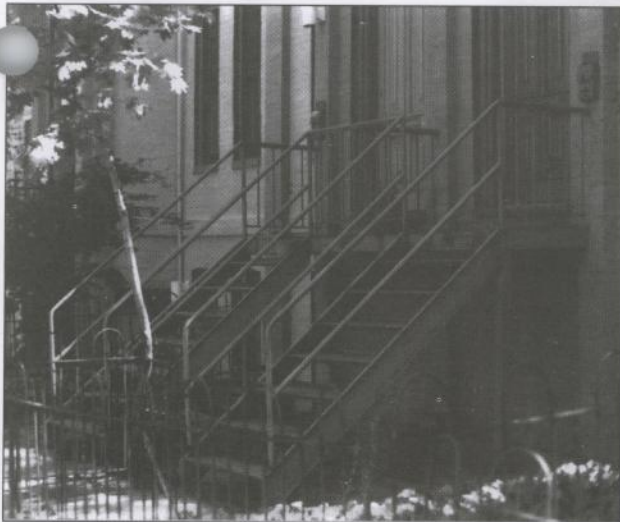
PRESSURE-TREATED WOOD TREADS, RISERS, NEWELS, SPINDLES, AND RAILS ARE INAPPROPRIATE SUBSTITUTES FOR HISTORIC CAST IRON. IN THIS EXAMPLE, REPLACEMENT MATERIALS DAMAGE THE OVERALL HISTORIC APPEARANCE OF THE HOUSE AND DETRACT FROM THE HISTORIC INTEGRITY OF THE ADJACENT PROPERTIES.

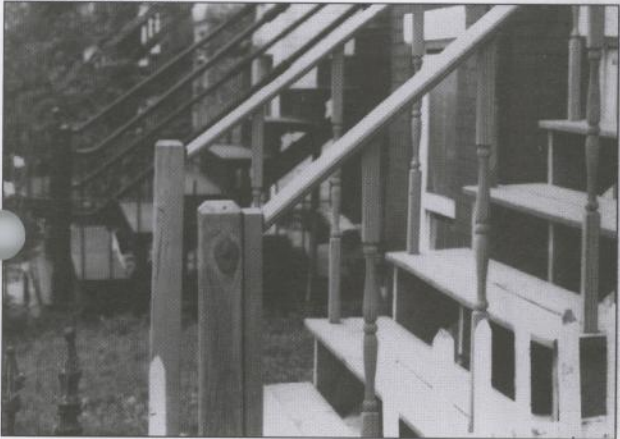
THESE STEEL REPLACEMENT STAIRS ARE POOR SUBSTITUTES FOR THEIR CAST-IRON PREDECESSORS. THESE STAIRS, WITH THEIR ATYPICAL PROFILES AND CONFIGURATIONS, LACK OF HEFT, AND ABSENCE OF PERIOD ORNAMENT, BEAR NO RESEMBLANCE TO HISTORIC CAST-IRON STAIRS. WHILE THESE MIGHT BE SUITABLE REPLACEMENTS FOR THE REAR OF A HOUSE, THEY SHOULDN'T BE CONSIDERED FOR THE FRONT.

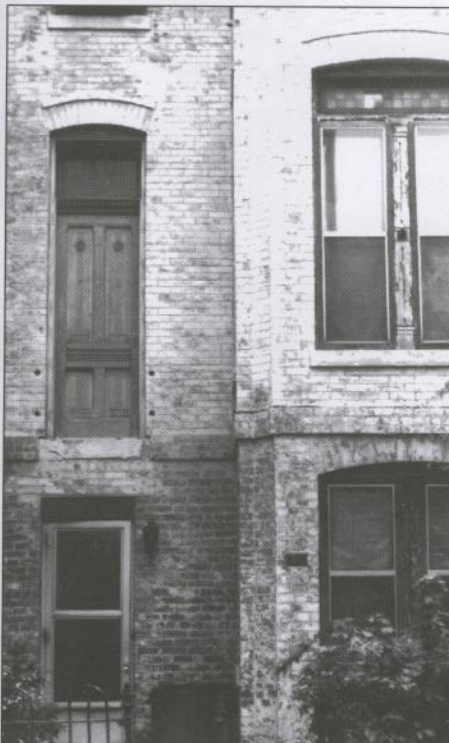
REMOVAL OF THE CAST-IRON STAIR (UNLIKELY TO BE ALLOWED TODAY IN THE HISTORIC DISTRICT) IS ALL TOO OBVIOUS ON THIS BUILDING. THE ABSENCE OF THE STAIRS COMPLETELY ALTERS THE RELATIONSHIP OF THE BUILDING TO THE STREET.

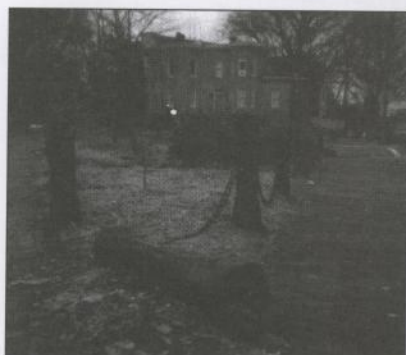
THE SAME BOLLARD PICTURED AT THE RIGHT WAS A CASUALTY OF 1996 WINTER SNOW REMOVAL, DRAMATICALLY ILLUSTRATING THE CONTINUING ASSAULTS ON OUR HISTORIC FABRIC WHETHER FROM SNOW PLOWS OR NEGLECT.

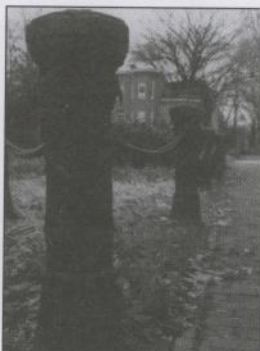
HISTORIC BOLLARDS AND CHAINS DEFINE A VESTIGIAL TRIANGULAR BIT OF PUBLIC SPACE AT NINTH AND A STREETS, SE.

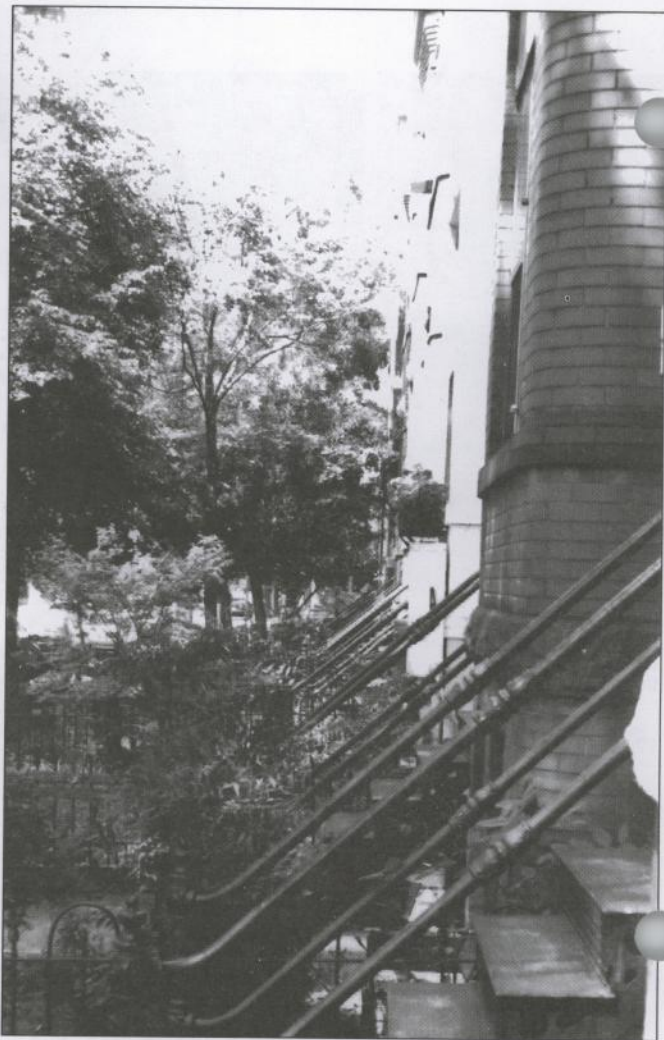
THIS INTACT ROW OF TWELVE ENTRANCE STAIRS DEMONSTRATES THE PRECISE RHYTHM, AESTHETIC UNIFORMITY, AND SUPERIOR MAINTENANCE THAT SETS THE STANDARD IN THE HISTORIC DISTRICT.
