Resource All Data Report

ID Number: 0983-0868

Name(s)	Type of Name
Apartment Building, 604 12th Street, N.E.	Common

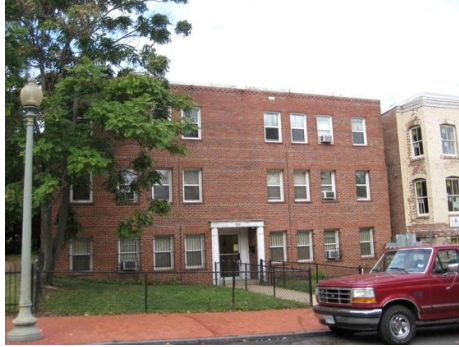
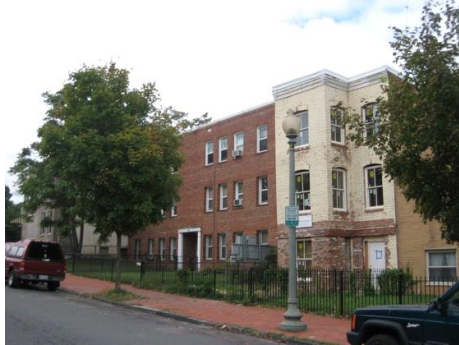
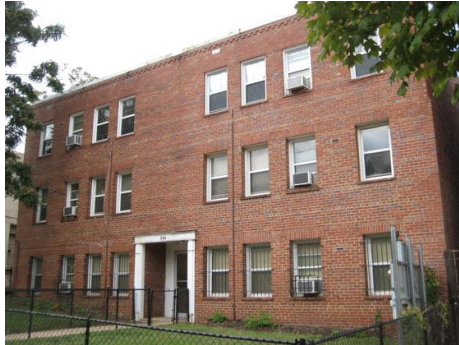
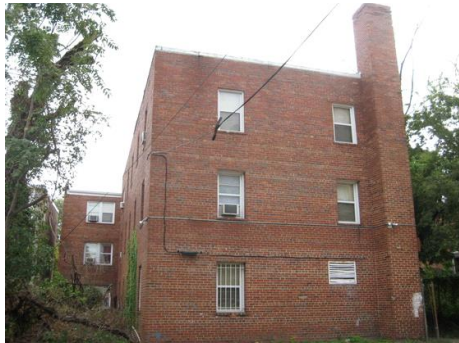
October 2010: This three-story apartment building is three structural bays wide and was constructed by Winfield Preston for owner George F. Warner in 1945. Designed by S. Winfield Preston, Jr., the building reflects a restrained interpretation of the Colonial Revival style and has a T-shaped form. Set on a solid concrete-block foundation faced with brick, the concrete-block building is faced with six-course, American-bond brick. The flat roof is edged with metal coping and has a denticulated brick cornice. Fenestration consists of 1/1, double-hung, vinyl-sash windows with header-brick sills and soldier-brick lintels. The main entry, a single-leaf metal-frame glass door, is recessed in the center bay of the façade (east elevation). It is framed by a Colonial Revival-style surround of pilasters and a molded lintel cap with dentil molding. A large exterior brick chimney with a plain cap is located on the rear (west) elevation.

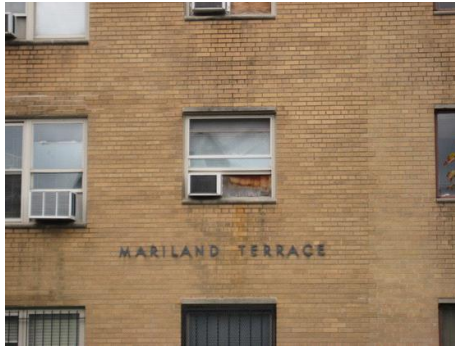
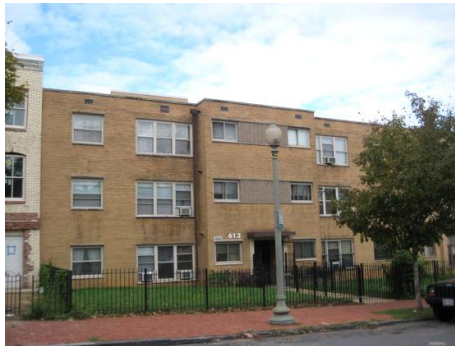
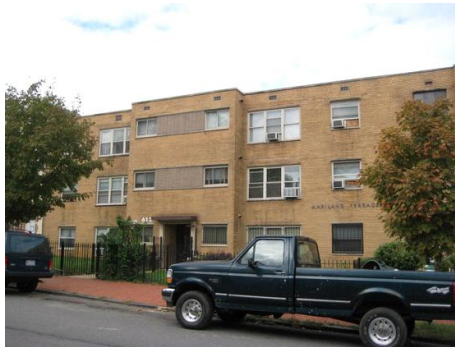
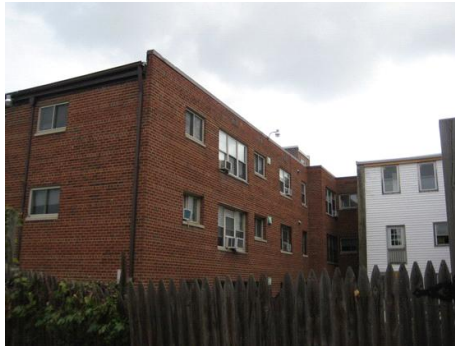
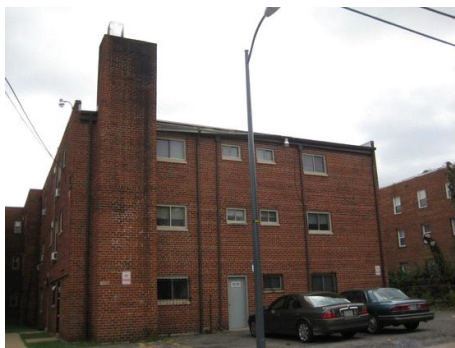
October 2010: This three-story, three-bay, 12-unit apartment building was constructed ca. 1950. The concrete-block building is an illustration of the Modern Movement. It sits on a solid concrete-block foundation and is faced with six-course, American-bond brick. The building has a T-shape and is capped by a flat roof with concrete coping. A large exterior brick chimney with a plain cap is located on the rear (west) elevation. Fenestration consists of single and tripled 1/1, double-hung, vinyl-sash windows and paired one-light vinyl sliding windows. Window openings have molded concrete sills and openings on the center bay are highlighted by a panel of stacked bricks. The main entry, a single-leaf metal-frame glass door, is recessed within the center bay and is highlighted by a concrete surround. The entry is sheltered by a metal hood. Secondary entries, single-leaf flush metal doors, are located on the rear and side elevations.

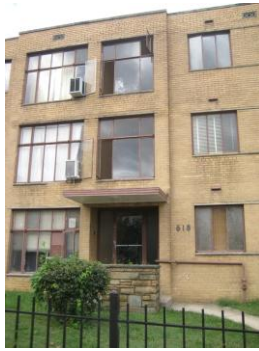
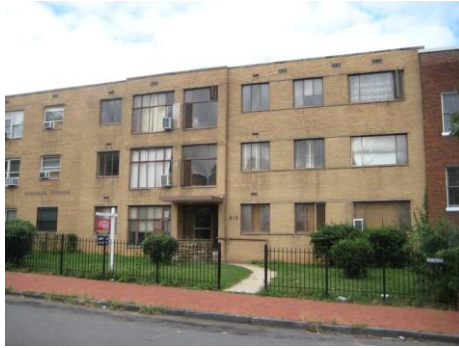
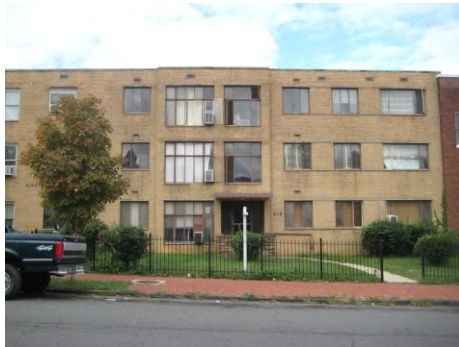
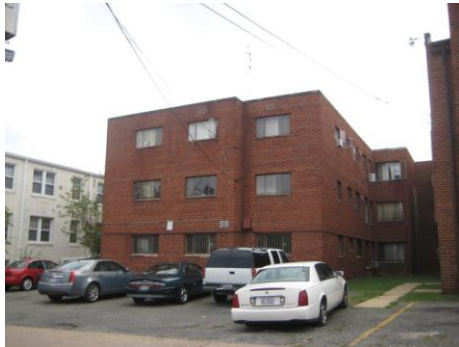
October 2010: This three-story apartment building was constructed ca. 1950 and has a T-shaped form. The concrete-block building is an illustration of the Modern Movement. It sits on a solid concrete-block foundation and is faced with six-course, American-bond brick. The flat roof is edged with concrete coping. Fenestration consists of one-light metal fixed and casement windows. Window openings have molded concrete sills and narrow concrete lintels. The main entry, a single-leaf metal-frame glass door, is recessed within the center bay. It is flanked by one-light sidelights and is sheltered by a metal hood.

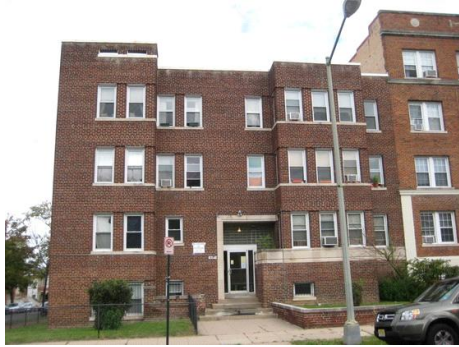
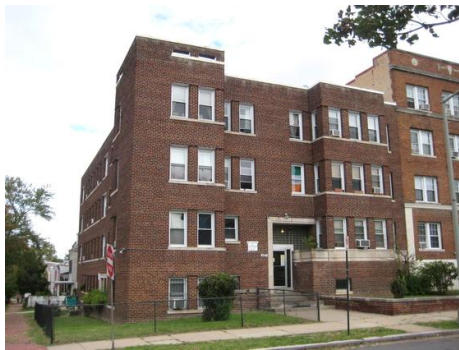
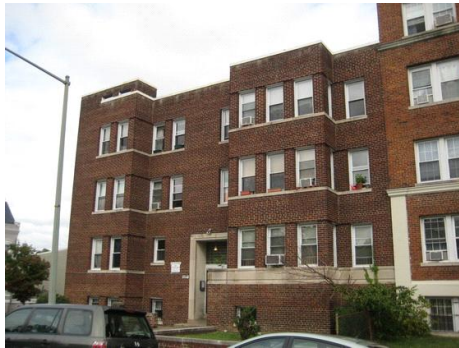
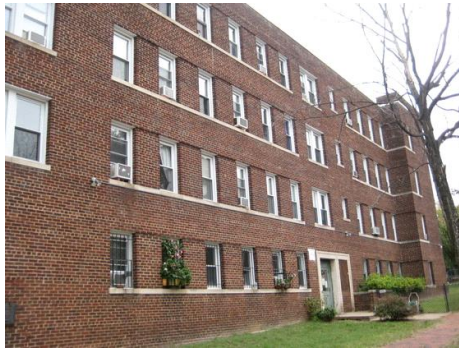
October 2010: This three-story apartment building was constructed in 1937 by the Eastern Construction Company, Inc. for owner Mrs. Howard Bader (permit #201057). The 23-unit apartment building was designed by Dillon & Abel and reflects a restrained interpretation of the Colonial Revival style blended with the Modern Movement. Set on a raised brick foundation, the four-bay-wide building is constructed of six-course, American-bond brick and has three-story rectangular projecting bays on the outermost bays of the façade (south elevation). The bay on the southwest corner is edged with a parapet with pierced openings that appear as clerestory windows. Fenestration consists of 1/1, double-hung, vinyl-sash windows with continuous concrete lug sills. The main entry, a single-leaf metal-frame glass door, is located off-center in the central bay of the façade. Edged by sidelights, the entry is recessed and has a large glass-block transom and a molded concrete surround. A secondary entry, a single-leaf paneled wood door with one light, is located on the west (side) elevation. The door has a wide surround and the entry opening is framed by a molded concrete surround. An interior-end brick chimney with a plain cap is located on the northeast corner of the building and an interior brick chimney pierces the flat roof of the building.

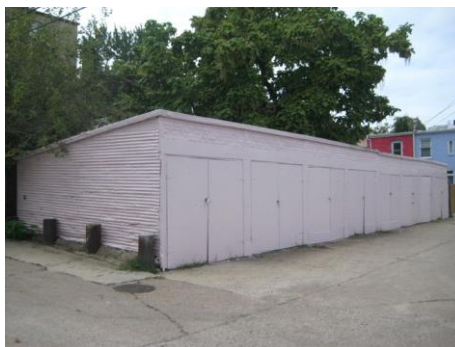
October 2010: This one-story, eight-bay garage was constructed ca. 1925. The garage sits on a solid concrete foundation and is constructed of wood-frame clad with corrugated metal and pressed metal sheeting that simulates rock-faced concrete. The garage has a shed roof with overhanging boxed eaves that appears to be covered with metal. Each bay holds a double-leaf flush wood door.

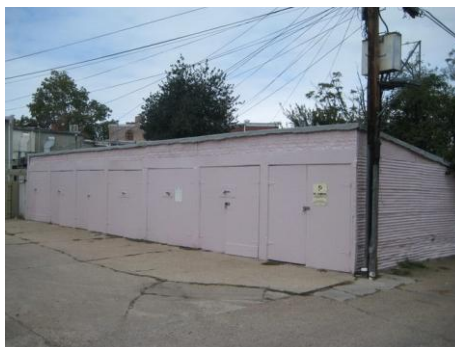
October 2010: This one-story, seven-bay garage was constructed ca. 1925. The garage sits on a solid concrete foundation and is constructed of wood-frame clad with corrugated metal and pressed metal sheeting that simulates rock-faced concrete. The garage has a shed roof with overhanging boxed eaves that appears to be covered with metal. Each bay holds a double-leaf flush wood door.
