Resource All Data Report

ID Number: 0810-0051

Rowhouse, 646 5th Street, N.E. **Common**

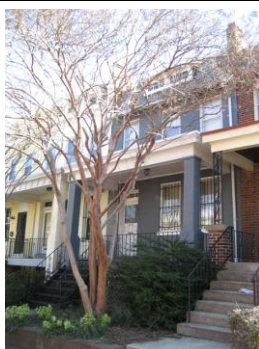
Path: **C:\Users\CHRS\Documents\CHRS
Databases\F&G Street - 2 to 11th
St\Database\Pictures\Square 0810\
File: 609_4th_Street_NE_facade_looking_NE.JPG**
Date:: Photog:
Code:: R: Fr:

March 2010: Constructed in 1936 by Raymond J. Grace, this two-story, three-bay Colonial Revival-style single-family dwelling has a rectangular form. Set on a solid concrete foundation, this masonry structure has six-course, American-bond brick coursing. Set between brick firewalls, the sloped roof is fronted by a false mansard of slate shingles. A shed roofed false dormer pierces the mansard. The dormer has overhanging eaves, rafter tails, and paired, six-light wood-sash windows. The façade (west elevation) features a one-story, full-width porch set on a brick foundation. A flat roof with a boxed cornice and overhanging eaves caps the porch and is supported by metal filigree posts set on brick piers. Metal balusters complete the porch. Fenestration of the façade consists of 1/1, double-hung, vinyl-sash windows. The northern bay of the first story holds a single-leaf, paneled wood door with light and a three-light transom. All of the openings have concrete sills and soldier brick flat arches. The second story of the east (rear) elevation is fenestrated with 1/1, double-hung, vinyl-sash windows flanking a single-leaf door with four lights. The elevation is dominated by a two-story, full-width porch with brick supports, square balusters, and a shed roof.

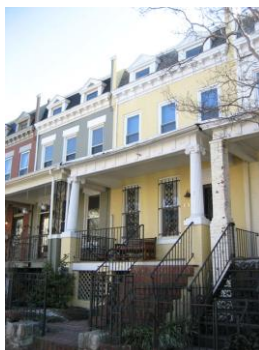
Path: **C:\Users\CHRS\Documents\CHRS
Databases\F&G Street - 2 to 11th
St\Database\Pictures\Square 0810**
File: **613_4th_Street_NE_facade_looking_NE.JPG**
Date:: Photog:
Code:: R: Fr:

March 2010: Constructed in 1913 by T.A. Jameson, this two-story, three-bay Classical Revival-style rowhouse is one of four rowhouses constructed from the same permit (#0627). The dwelling is constructed of brick and is set on a solid raised foundation. The façade (west elevation) is faced with pressed stretcher-bond brick. A sloping roof caps the dwelling and features a false mansard roof of slate shingles. A molded cornice with scrolled modillions extends between corbeled brick firewalls. Twin, front-gabled dormers punctuate the mansard. The dormers have a front-gabled pediment with molded cornice, raking boards, and ornamental plant motif molding supported architecturally by paneled pilasters. Single-light, vinyl-sash windows pierce the dormers. The façade features a one-story, full-width porch set on a brick pier foundation. Capped by a flat roof, the porch has a molded cornice and wide frieze adorned with triglyphs. Corinthian columns set on brick piers with metal balusters support the roof. Window openings on the façade hold 1/1, double-hung, vinyl-sash windows. The main entry, located in the southern bay of the first story, has a single-leaf, paneled wood door and wood-covered transom set in a narrow, square-edge wood surround. A single-leaf, paneled wood door flanked by 1/1, double-hung, vinyl-sash windows pierces the raised basement. All of the openings have concrete sills and lug lintels. The east (rear) elevation of the main block has 1/1, double-hung, vinyl-sash windows with concrete sills and two-course, rowlock brick segmental arches.

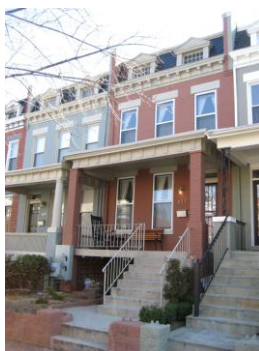
Path: **C:\Users\CHRS\Documents\CHRS
Databases\F&G Street - 2 to 11th
St\Database\Pictures\Square 0810**
File: **617_4th_Street_NE_facade_looking_NE.JPG**
Date:: Photog:
Code:: R: Fr:

March 2010: Constructed in 1913 by T.A. Jameson, this two-story, three-bay Classical Revival-style rowhouse is one of four rowhouses constructed from the same permit (#0627). The dwelling is constructed of brick and is set on a solid raised foundation. The façade (west elevation) is faced with pressed stretcher-bond brick. A sloping roof caps the dwelling and features a false mansard roof of slate shingles. A molded cornice with scrolled modillions extends between corbeled brick firewalls. Twin, front-gabled dormers punctuate the mansard. The dormers have a front-gabled pediment with molded cornice, raking boards, and ornamental plant motif molding supported architecturally by paneled pilasters. Eight-light, wood-sash windows pierce the dormers. The façade features a one-story, full-width porch set on a brick pier foundation. Capped by a flat roof, the porch has a molded cornice and wide frieze adorned with triglyphs. Brick columns with metal balusters support the roof. Window openings on the façade hold 1/1, double-hung, vinyl-sash windows. The main entry, located in the southern bay of the first story, has a single-leaf, wood-frame glass door and single-light transom set in a narrow, square-edge wood surround. Located below the porch is a single-leaf, paneled wood door with lights flanked by 1/1, double-hung, wood-sash windows. All of the façade openings have concrete sills and lug lintels. The east (rear) elevation of the main block has 1/1, double-hung, vinyl-sash windows with concrete sills and two-course, rowlock brick segmental arches.

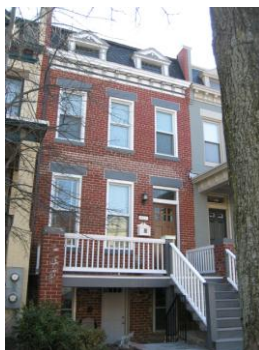
Path: C:\Users\CHRS\Documents\CHRS
Databases\F&G Street - 2 to 11th
St\Database\Pictures\Square 0810\
File: 621_4th_Street_NE_facade_looking_SE.JPG
Date:: Photog:
Code:: R: Fr:

March 2010: Constructed in 1913 by T.A. Jameson, this two-story, three-bay Classical Revival-style rowhouse is one of four rowhouses constructed from the same permit (#2513). The dwelling is constructed of brick and set on a solid raised foundation. The façade (west elevation) is faced with pressed stretcher-bond brick. A sloping roof caps the dwelling and features a false mansard roof of hexagonal slate shingles. A molded cornice with scrolled modillions extends between corbeled brick firewalls. Twin, front-gabled dormers punctuate the mansard. The dormers have a front-gabled pediment with molded cornice, raking boards, and ornamental plant motif molding supported architecturally by paneled pilasters. Eight-light, wood-sash windows pierce the dormers. The façade has a first-story porch set on a brick pier foundation. Brick piers and square balusters complete the roofless porch. Window openings on the façade hold 1/1, double-hung, vinyl-sash windows. The main entry, located in the southern bay of the first story, has a single-leaf, paneled wood door with six lights and single-light transom set in a narrow, square-edge wood surround. Located below the porch is a single-leaf, paneled metal door with lights flanked by 1/1, double-hung, wood-sash windows. All of the façade openings have concrete sills and lug lintels. The east (rear) elevation of the main block has 1/1, double-hung, vinyl-sash windows with concrete sills and two-course, rowlock brick segmental arches.

The two-story, two-bay addition, based on its form and materials, was constructed c. 2000. This addition replaced an original two-story porch or projection. Clad in Hardieplank siding and capped by a shed roof, the addition is fenestrated with 1/1, double-hung, vinyl-sash windows and a single-leaf door opening with single-light transom (first story not visible from the public right-of-way).

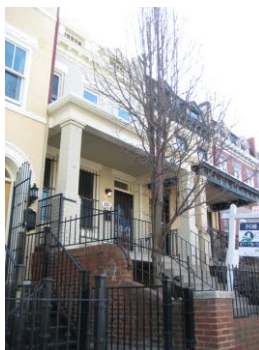
Path: C:\Users\CHRS\Documents\CHRS
Databases\F&G Street - 2 to 11th
St\Database\Pictures\Square 0810\
File: 625_4th_Street_NE_facade_looking_SE.JPG
Date:: Photog:
Code:: R: Fr:

March 2010: Constructed in 1913 by T.A. Jameson, this two-story, three-bay Classical Revival-style rowhouse is one of four rowhouses constructed from the same permit (#2513). The dwelling is constructed of brick and set on a solid raised foundation. The façade (west elevation) is faced with pressed stretcher-bond brick. A sloping roof caps the dwelling and features a false mansard roof of slate shingles. A molded cornice with scrolled modillions extends between corbeled brick firewalls. Twin, front-gabled dormers punctuate the mansard. The dormers have a front-gabled pediment with molded cornice, raking boards, and ornamental plant motif molding supported architecturally by paneled pilasters. Eight-light, wood-sash windows pierce the dormers. The façade features a one-story, full-width porch set on a brick pier foundation with decorative concrete block infill. Capped by a flat roof, the porch has a molded cornice and is supported by brick columns complete with metal balusters. Window openings on the façade hold 1/1, double-hung, vinyl-sash windows. The main entry, located in the southern bay of the first story, has a single-leaf, paneled wood door with three lights and single-light transom. The raised basement is pierced by a single-leaf, paneled wood door flanked by 1/1, double-hung, vinyl-sash windows. All of the façade openings have concrete sills and lug lintels. The east (rear) elevation of the main block has 1/1, double-hung, vinyl-sash windows with concrete sills and two-course, rowlock brick segmental arches.

The two-story, two-bay addition, based on its form and materials, was constructed c. 2000. This addition replaced an original two-story porch or projection. Clad in Hardieplank siding and capped by a shed roof, the addition is fenestrated with two-light, sliding vinyl-sash windows. The first story was not visible from the public right-of-way.

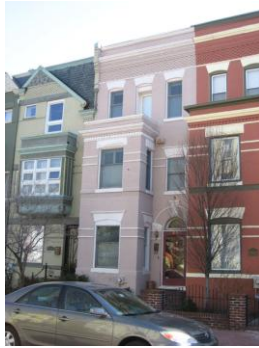
Path: **C:\Users\CHRS\Documents\CHRS
Databases\F&G Street - 2 to 11th
St\Database\Pictures\Square 0810**

March 2010: Constructed in 1892 by J. H. Hunt, this three-story, two-bay Queen Anne-style rowhouse is one of six rowhouses constructed from the same permit (#1074). The dwelling is constructed of brick and set on a solid raised foundation. The façade (west elevation) is faced with pressed stretcher-bond brick. Strings of coping extend through the first- and second-story openings and serve to form a thin cornice above the third-story openings. A sloping roof caps the dwelling and features a brick parapet wall replete with checkerboard panel, corbeled table, and molded cornice. The main entry, located in the southern bay of the first story, holds a single-leaf, paneled wood door with transom set in a round arched doorway. A soldier brick arch with drip molding features decorative molded imposts and keystone. Window openings on the façade hold 1/1, double-hung, vinyl-sash windows with concrete sills and soldier brick segmental arches with drip molding. A single-leaf, wood-frame glass door is located in the central bay of the third story. This opening provides access to the roof of the projecting bay. The façade features a two-story rectangular bay capped by a flat roof with a brick parapet wall consisting of brick dentils and two molded cornices. The bay has the same molded strings as the main block in addition to a two-course brick sill course on the first and second stories and a thin molded string above the second-story openings. Fenestration consists of 1/1, double-hung, vinyl-sash windows. The first-story openings have soldier brick segmental arches with drip molding. Second-story openings have rock-faced concrete lug lintels. The east (rear) elevation fenestration was not visible from the public right-of-way.

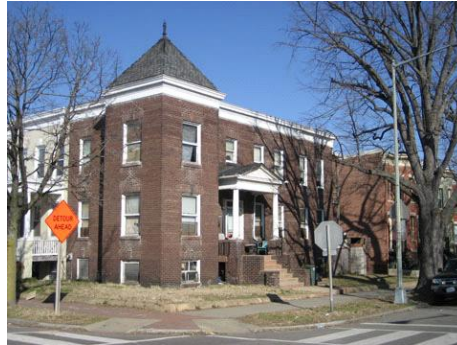
Path: **C:\Users\CHRS\Documents\CHRS
Databases\F&G Street - 2 to 11th
St\Database\Pictures\Square 0810\
File: 604_5th_Street_NE_rear_looking_NE.JPG**

March 2010: This single-family dwelling is located on a corner lot northwest of the intersection of 5th Street, N.E. and F Street, N.E. This semi-detached dwelling is attached to 420 F Street, N.E. to the west. With a setback of approximately twenty feet from both 5th Street, N.E. and F Street, N.E., this dwelling maintains the visual site line found down both streets. The level, grassy yard is lined by a concrete curb along the concrete and brick sidewalks. A concrete walkway extends from 5th Street, N.E. to a set of concrete and brick steps and the main entry. An alley forms the northern boundary of the property, along which is a one-story, one-bay garage.

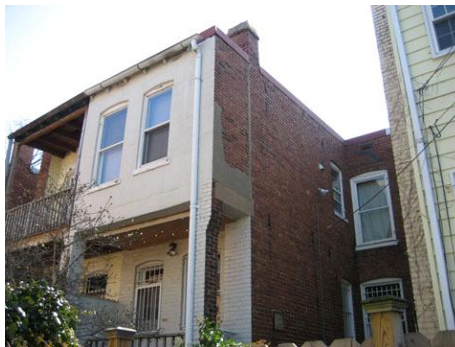
March 2010: Constructed in 1911 by M.L. Gottwals, this two-story, three-bay Classical Revival-style rowhouse was one of five similar buildings constructed from the same permit (#3812). Set on a raised basement, this masonry structure has a rectangular form with a rear ell. The façade (south elevation) has stretcher-bond brick coursing. A sloping roof caps the dwelling and includes a molded metal cornice with a plain frieze anchored at each end by glyphs. The façade features a one-story, full-width porch set on a brick pier foundation. The flat roof, supported by Tuscan columns set on brick piers, has an ogee-molded cornice and overhanging eaves. Square wood balusters complete the porch. Window openings on the façade hold 1/1, double-hung, vinyl-sash windows. All of the façade openings have concrete sills and splayed brick flat arches with concrete keystones. The main entry, located in the western bay of the first story, holds a single-leaf, paneled wood door set in a narrow, square-edge wood surround. The single-light transom has been covered with wood. Beneath the porch are two, 1/1, double-hung, vinyl-sash windows and a single-leaf door opening (door not visible). The north (rear) elevation of the main block has 1/1, double-hung, vinyl-sash windows with concrete sills and two-course, rowlock brick segmental arches.

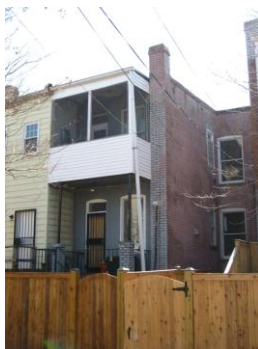
The two-story, two-bay brick ell has a shed roof and an interior brick chimney located in the northwest corner. A two-story porch with a shed roof is located on the rear of the ell. The porch is set on a brick pier foundation and has metal supports. The first story is finished with twisted metal balusters. The second story has been partially enclosed with vinyl siding. Fenestration consists of 1/1, double-hung, vinyl-sash windows with concrete sills and two-course, rowlock brick segmental arches. A single-leaf flush wood door with single-light transom is located on the first story of the rear elevation. The second story has a single-leaf, wood-frame glass door.

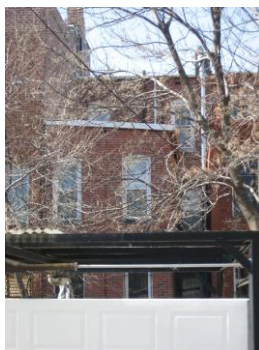
Path: C:\Users\CHRS\Documents\CHRS
Databases\F&G Street - 2 to 11th
St\Database\Pictures\Square 0810\
File: 639_4th_Street_NE_rear_looking_W.JPG
Date:: Photog:
Code:: R: Fr:

March 2010: Constructed in 1892 by J. H. Hunt, this three-story, two-bay Queen Anne-style rowhouse is one of six similar rowhouses constructed from the same permit (#1074). The building closely mirrors the dwelling to the south, 637 4th Street, N.E. Set on a solid brick foundation, this masonry structure has stretcher-bond brick coursing. The façade (west elevation) features a clipped front-gable offset by a mansard roof of slate shingles. A checkerboard brick panel, decorative plant motif, and a molded metal cornice accentuate the gable. The mansard features a small, molded metal cornice with denticulated brick molding along the north edge of the façade. This element serves as an anchor for the roof and provides for the installation of a decorative down spout. An interior-side brick chimney pierces the roof of the main block.

Highlighting the foundation are quatrefoil panels set below the first-story window opening. The first story holds paired, 1/1, double-hung, vinyl-sash windows set in a narrow, square-edge wood surround. Located in the southern bay of the first story is a single-leaf wood door with light and single-light transom. Set in a narrow, square-edge wood surround, this opening also features an egg-and-dart architrave. A concrete sill course and lug stone lintel string complete the first-story.
