Resource All Data Report

ID Number: 0834-0053

Rowhouse, 505 G Street, N.E. **Common**

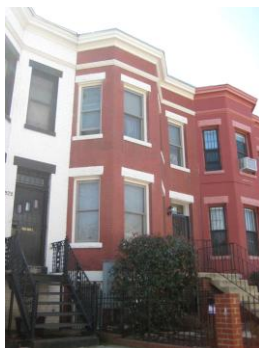
Path: C:\Users\CHRS\Documents\CHRS
Databases\F&G Street - 2 to 11th
St\Database\Pictures\Square 0834\
File: 507_G_Street_NE_facade_looking_SW.JPG
Date:: Photog:
Code:: R: Fr:

March 2010: This two-story, two-bay, Queen Anne-style rowhouse was constructed by Pumphrey and Palmer from the design of Edward O. Volland in 1908. It is one of four rowhouses constructed from the same permit (#0054). The dwelling is constructed of brick and is set on a solid concrete foundation; the façade (north elevation) is faced with stretcher-bond pressed brick. A sloping roof caps the dwelling and is highlighted by a molded metal cornice, a plain brick frieze, and a molded metal architrave. A single-leaf paneled wood door is located in the westernmost bay of the first story on the façade. This opening is highlighted by a rectangular one-light transom and a rock-faced concrete-lug lintel. Concrete steps with metal hand rails provide access to the main entrance. Below these steps, the foundation is pierced by a single-leaf paneled wood door. A three-sided, canted bay with rounded edges projects from the easternmost bay of the façade and rises the full height of the dwelling. The bay shares the material treatment of the main block. All openings on the façade hold 1/1, double-hung, vinyl-sash windows with rock-faced concrete sills and lintels.

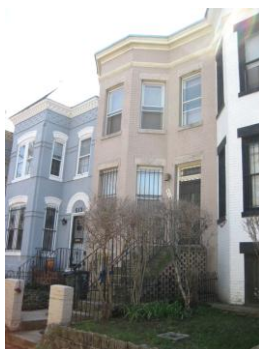
Path: **C:\Users\CHRS\Documents\CHRS
Databases\F&G Street - 2 to 11th
St\Database\Pictures\Square 0834\
File: 511_G_Street_NE_facade_looking_SE.JPG
Date:: Photog:
Code:: R: Fr:**

March 2010: This two-story, two-bay, Queen Anne-style rowhouse was constructed by Pumphrey and Palmer from the design of Edward O. Volland in 1908. It is one of four rowhouses constructed from the same permit (#0054). The dwelling is constructed of brick and is set on a solid concrete foundation; the façade (north elevation) is faced with stretcher-bond pressed brick. A sloping roof caps the dwelling and is highlighted by a molded metal cornice, a plain brick frieze, and a molded metal architrave. A single-leaf paneled wood door with a single light is located in the westernmost bay of the first story on the façade. This opening is highlighted by a rectangular one-light transom and a rock-faced concrete-lug lintel. Concrete steps with metal hand rails provide access to the main entrance. Below these steps, the foundation is pierced by a single-leaf door that was obscured by a metal security door. A three-sided, canted bay with rounded edges projects from the easternmost bay of the façade and rises the full height of the dwelling. The bay shares the material treatment of the main block. All openings on the façade hold 1/1, double-hung, wood-sash windows with rock-faced concrete sills and lintels.

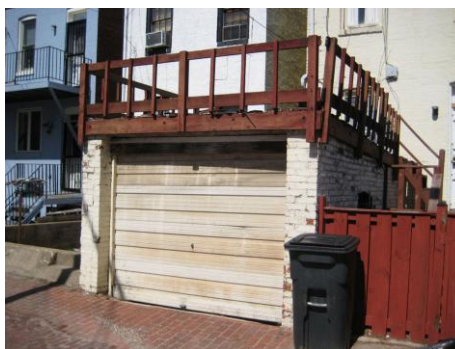
Path: **C:\Users\CHRS\Documents\CHRS
Databases\F&G Street - 2 to 11th
St\Database\Pictures\Square 0834\
File: 511_G_Street_NE_garage_looking_NW.JPG
Date:: Photog:
Code:: R: Fr:**

March 2010: A one-story, one-bay garage is located south of the dwelling and was constructed ca. 1925. Noted on the 1928 Sanborn map, the garage is constructed of five-course, American-bond brick and is set on a solid foundation. A

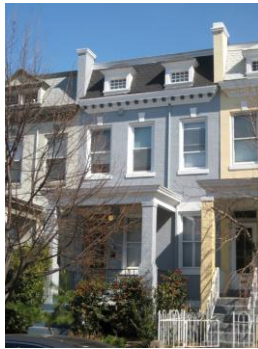
Path: **C:\Users\CHRS\Documents\CHRS
Databases\F&G Street - 2 to 11th
St\Database\Pictures\Square 0834\
File: 639_5th_Street_NE_facade_looking_SE.JPG**

March 2010: This two-and-a-half-story, three-bay Classical Revival-style rowhouse was constructed in 1909 by M.L. Gottwals from the design of Edward O. Volland. It is one of four similar rowhouses constructed from the same permit (#1352). The brick structure sits on a solid concrete foundation. The dwelling is capped by a sloping roof that is fronted by a false mansard of slate fish scale shingles between two brick firewalls on the façade (west elevation). The mansard is pierced by hipped dormers with slate shingles that hold twelve-light fixed wood windows. A molded metal cornice with modillions and dentils completes the roof. The façade is faced with stretcher-bond brick. The foundation is pierced by a vinyl sliding window and a 1/1, double-hung, vinyl-sash window with concrete-lug lintels. The northernmost bay of the first story holds a single-leaf paneled wood door with lights and a one-light wood transom with a concrete-lug lintel. All other openings on the façade hold 1/1, double-hung, wood-sash windows with concrete sills. Openings on the first story have concrete-lug lintels while openings on the second story have splayed brick lintels with concrete keystones. A one-story, one-bay porch projects from the façade and is set on a brick pier foundation. The porch has a sloped roof with overhanging eaves and a molded cornice and is supported by square brick posts. Metal balusters encircle the porch, which is accessed via concrete steps in the northern end bay.
