# Resource All Data Report

# ID Number: 0858-0802

**Capitol Hill H Street (2009)**

**Permit Research  
Reconnaissance Survey**

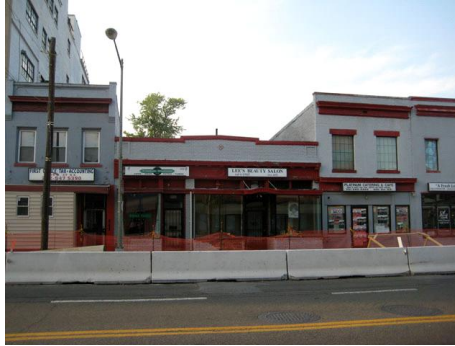
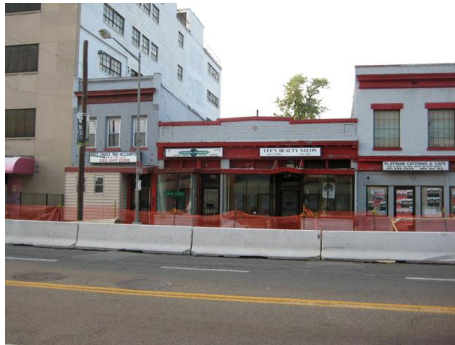
File: **H Street\_646\_facade\_looking\_NE.JPG**

Resource Type: **Building** Status Current: **Extant**  
Desig. Status: **Historic** Quality:  
Purpose: **Store** Condition: **Good**

**June 2009:** Constructed in 1896, this one-story, two-bay building shares a façade with 648 H Street, NE and has a rectangular form. The building is constructed of brick and is set on a solid concrete foundation. The façade (south elevation) has been faced with stretcher-bond brick, while the rear elevation is constructed of American-bond brick. A sloping roof caps the building, though the roofing material was not visible from the public right-of-way. A molded cornice with modillions and end brackets stretches across the full façade and also features a paneled wood frieze. A soldier brick string course runs across the façade above the cornice. A parapet, faced with stretcher-bond bricks and topped with concrete finishes the roof. A diamond-shaped panel is centrally located within the parapet and recessed brick panels with rowlock brick surrounds are sited on opposing sides of the façade. An exterior-rear brick chimney rises from the north elevation and has a parged cap. The easternmost bay contains a single-leaf metal-frame glass door with a one-light metal transom. A one-story bay projects from the westernmost bay of the façade and is set on solid foundation faced with brick. The first story of the façade is sheltered by a one-story, one-bay awning, with a molded cornice.

A one-story addition is located on the rear elevation of the building and was constructed ca. 1955. The addition is constructed of concrete blocks and is set on a solid concrete block foundation. A shed roof caps the addition and is covered with pebbles. The western bay of the addition is clad with vinyl siding. A single-leaf metal door pierces the rear elevation of the addition.

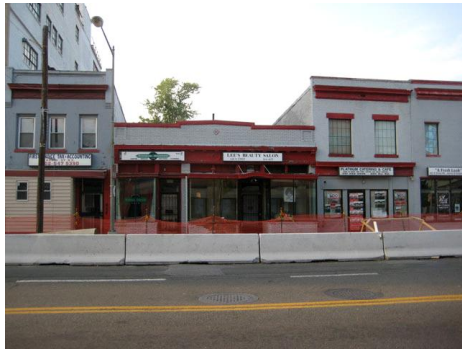
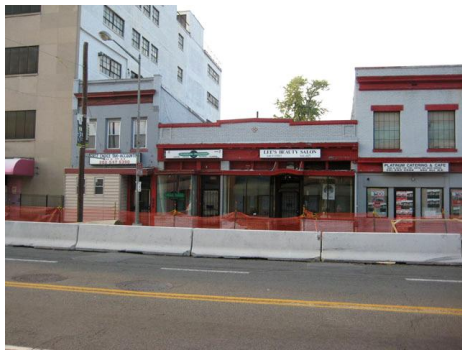
Path: **C:\Users\CHRS\Documents\CHRS  
Databases\H Street - 2 to 15th  
St\Database\Pictures\0858\  
File: **H Street\_648\_facade\_looking\_NE.JPG**  
Date:: Photog:  
Code:: R: Fr:**

Resource Type: **Building** Status Current: **Extant**  
Desig. Status: **Historic** Quality:  
Purpose: **Store** Condition: **Good**

**June 2009: Constructed in 1896, this one-story, three-bay building shares a façade with 646 H Street, NE and has a rectangular form. The building is constructed of brick and is set on a solid concrete foundation. The façade (south elevation) has been faced with stretcher-bond brick, while the rear elevation is constructed of American-bond brick. A sloping roof caps the building, though the roofing material was not visible from the public right-of-way. A molded cornice with modillions and end brackets stretches across the full façade and also features a paneled wood frieze. A soldier brick string course runs across the façade above the cornice. A parapet, faced with stretcher-bond bricks and topped with concrete finishes the roof. A diamond-shaped panel is centrally located within the parapet and recessed brick panels with rowlock brick surrounds are sited on opposing sides of the façade. An exterior-rear brick chimney rises from the north elevation and has a parged cap. The central bay contains a single-leaf meal-frame glass door with a one-light metal transom. One-story storefront bays flank the door and are set on a solid foundation faced with brick. The first story of the façade is sheltered by a one-story, one-bay awning, with a molded cornice.**

**A one-story addition is located on the rear elevation of the building and was constructed ca. 1955. The addition is constructed of concrete blocks and is set on a solid concrete block foundation. A shed roof caps the addition and is covered with pebbles. The western bay of the addition is clad with vinyl siding. A single-leaf metal door pierces the rear elevation of the addition.**

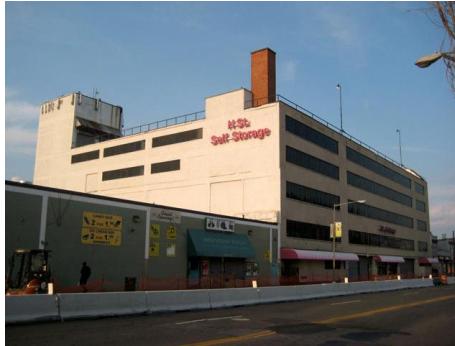
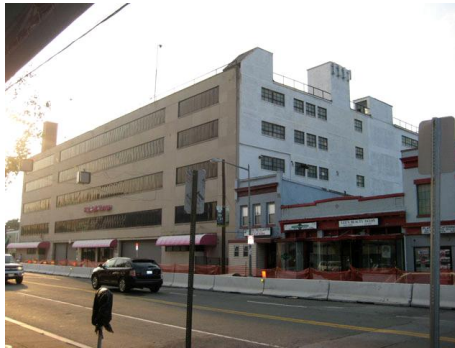
Path: **C:\Users\CHRS\Documents\CHRS  
Databases\H Street - 2 to 15th  
St\Database\Pictures\0858\  
File: **H Street\_624\_facade\_looking\_NE.JPG**  
Date:: Photog:  
Code:: R: Fr:**

**June 2009:** Constructed in 1951, this five-story commercial storage warehouse replaced the Apollo Theatre, which had been constructed in 1913. The building is constructed of concrete blocks and is set on a solid concrete block foundation. The façade (south elevation) is faced with large, concrete panels. A flat roof caps the building. A metal balustrade encircles the roof of the building. An interior brick chimney rises from the southwest corner and has a plain cap. The central bay of the ground floor consists of paired triple one-light metal fixed windows with one-light metal sidelights. The bay is flanked by a single roll-up metal door to the east and paired roll-up metal doors to the west. The westernmost bay projects from the façade and is constructed of concrete blocks. The bay is fenestrated with triple one-light metal fixed windows. The easternmost bay of the façade also projects and is constructed of concrete blocks. A band of fixed one-light metal windows spans the façade of the bay. The bands of original fenestration of the upper stories of the façade have been covered with metal sheeting, though the concrete sills remain. The fenestration of the east (side) elevation consists of single and paired 6/3, double-hung, metal-sash windows with concrete sills. Additionally, the northernmost bays contain paired 6/3, double-hung, metal-sash windows flanked by 4/2, double-hung, metal-sash windows. The original fenestration of the west (side) and rear (north) elevations have been covered with metal sheeting or infilled with concrete blocks.

A two-story wing is located on the rear elevation of the building and is original to and shares the same material treatment as the main block. A flat roof caps the wing and is encircled by a balustrade of metal poles. Most fenestration has been covered with metal sheeting. An elevator shaft, constructed of concrete blocks, rises from the northwest corner of the wing and rear elevation of the building and is original to and shares the same material treatment as the main block.

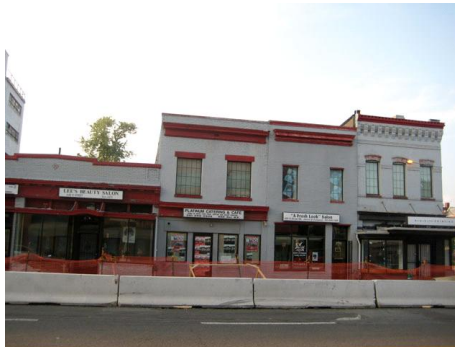
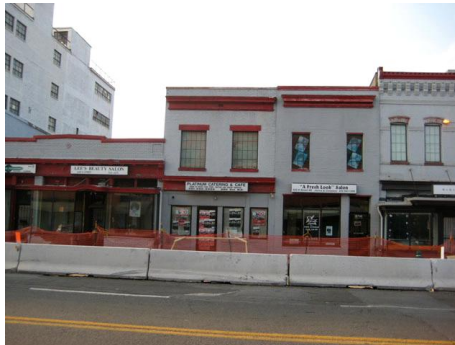
Path: C:\Users\CHRS\Documents\CHRS Databases\H Street - 2 to 15th St\Database\Pictures\0858\  
 File: H Street\_652\_facade\_looking\_NE.JPG  
 Date:: Photog:  
 Code:: R: Fr:

**June 2009: Constructed between 1869 and 1871, this two-story, two-bay building was originally constructed as a single dwelling. The building is constructed of brick and is set on a solid brick foundation; the façade (south elevation) is faced with stretcher-bond brick. A sloping roof caps the dwelling, however, the roofing material was not visible from the public right-of-way. An ogee-molded cornice spans the façade and is sited beneath the brick parapet. The easternmost bay of the façade contains a single-leaf metal-frame glass door with a one-light metal transom and concrete lintel. The westernmost bay contains triple one-light fixed metal windows with one-light metal transoms. A concrete lintel stretches across the top of the door and window bays. The two second story window openings contain twelve-light metal casement windows with rowlock brick sills and concrete lintels. The original window openings of the rear (north) elevation have been infilled with brick, however, the two-course, rowlock brick segmental arches are still visible.**

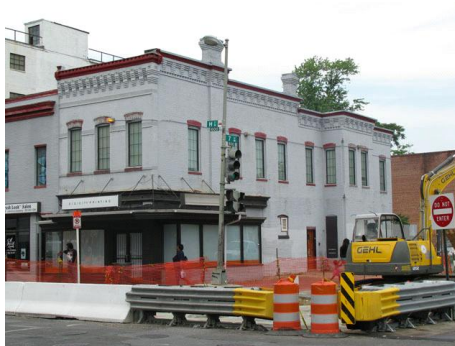
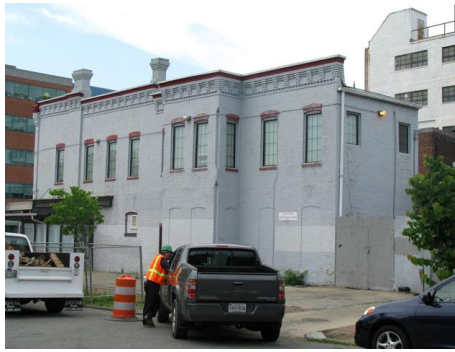
Path: C:\Users\CHRS\Documents\CHRS  
Databases\H Street - 2 to 15th  
St\Database\Pictures\0858\  
File: H Street\_654\_side\_elevation\_looking\_SW.JPG  
Date:: Photog:  
Code:: R: Fr:

**May 2009:** This two-story, three-bay building was constructed in 1888 and has a rectangular form. Set on a solid foundation, this brick building has seven-course, American-bond brick coursing. The Italianate-style building has a brick parapet with a prominent brick corbels with rosettes, indented brick molding, and a denticulated cornice. Two interior-side brick chimneys with corbeled caps extend from the east (side) elevation. The façade (south elevation) and part of the east elevation feature a projecting storefront bay. The bay is fenestrated with single-light display windows and a double-leaf, metal-frame glass door. A wrap-around roof caps the projecting bay and features a molded cornice and metal signs on the roof. The roof is partially supported by metal chains anchored to the façade wall with rosettes. The second story of the façade is pierced by three, single-light, vinyl-sash casements with twelve-light false muntins. The openings have concrete sills joined by a fluted band. Additional window opening details include a segmental soldier brick arch with pearls and a fluted string bisecting the openings. A third fluted string extends above the façade second-story openings. The east (side) elevation is pierced by single-light, vinyl-sash casements with twelve-light false muntins. These openings have concrete sills and two-course, rowlock brick segmental arches. The first story window openings have been bricked. A single-leaf metal door with light is located south of the projecting bay, which is two-stories in height and two-bays wide. The bay has fenestration consistent with the east elevation and features recessed corners. The north (rear) elevation has two first-story window openings that have been enclosed with brick. The second story has two, single-light, vinyl-sash casements with nine-light false muntins and no surrounds.

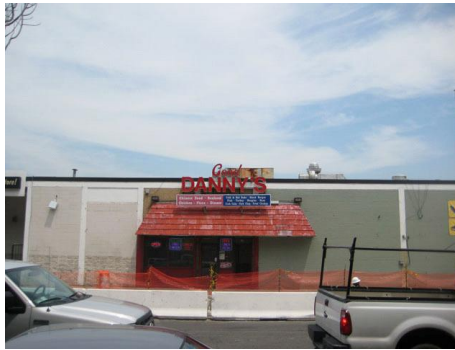
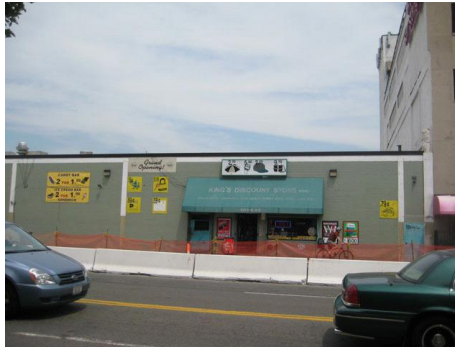
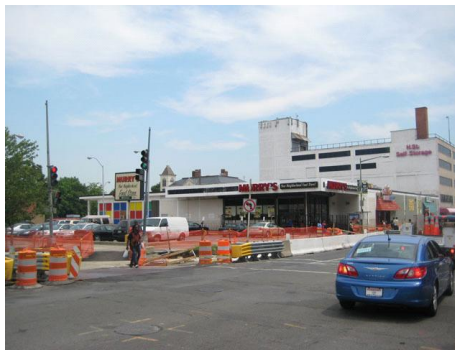
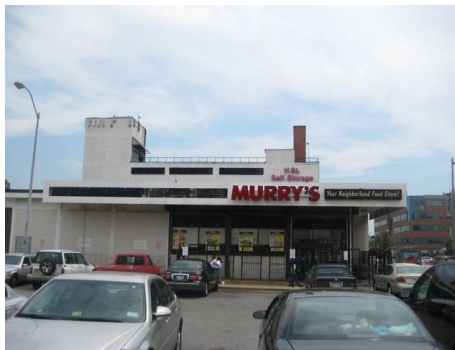
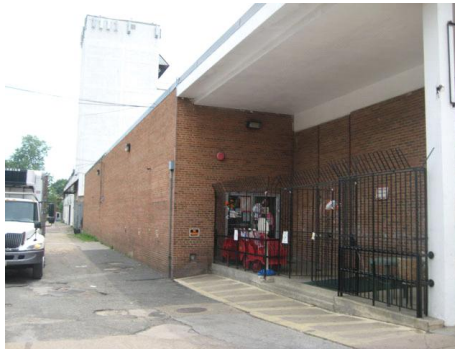
Path: C:\Users\CHRS\Documents\CHRS  
Databases\H Street - 2 to 15th  
St\Database\Pictures\0858\  
File: H Street\_616\_looking\_NE.JPG  
Date:: Photog:  
Code:: R: Fr:

**May 2009:** This one-story commercial building was constructed in 1963. Set on a solid foundation, this masonry building is constructed of concrete block with various veneers. A flat roof caps the building, though the roofing material was not visible from the public right-of-way. The building supports four businesses, with the dominant business being Murry's. Murry's is located in the southwest corner of the building and enjoys storefront along H Street, NE as well as along the west elevation. Good Danny's Carryout occupies the middle storefront along H Street, NE. This establishment also has a 610 H Street, NE address. The eastern storefront along H Street, NE belongs to King's Discount Store. King's has a 620 H Street, NE address. The fourth business associated with this building is located in the northwest corner. Love & Care Child Development Center has a 616 H Street, NE address and fronts the parking lot west of the building and the alley to the north.

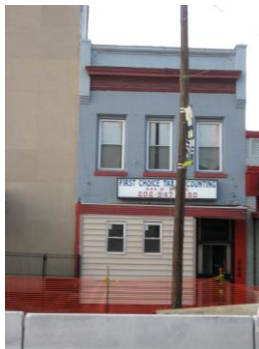
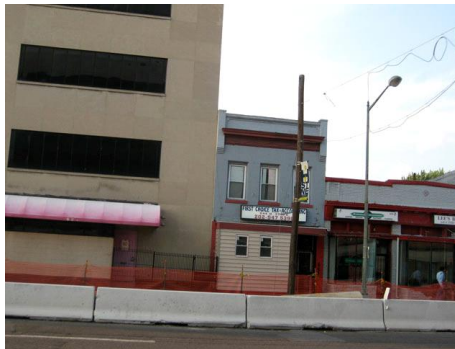
Path: C:\Users\CHRS\Documents\CHRS Databases\H Street - 2 to 15th St\Database\Pictures\0858\  
 File: H Street\_644\_facade\_looking\_N.JPG  
 Date:: Photog:  
 Code:: R: Fr:

Resource Type: **Building** Status Current: **Extant**  
Desig. Status: **Historic** Quality:  
Purpose: **Residential** Condition: **Fair**

**May 2009:** H.R. Howenstein constructed this two-story, three-bay single dwelling in 1911. It currently has residential space on the second story and a commercial unit on the first story. The brick building is set on a solid brick foundation; both are faced with stretcher-bond brick. A brick parapet wall flanked by firewalls partially obscures the sloping roof. Below the parapet wall is a metal cornice with a wide frieze featuring garland detailing. A clear view of the solid foundation was obscured by a one-story projecting bay addition that spans the western two-thirds of the façade (south elevation). The projection is fenestrated by two 1/1, double-hung, vinyl-sash windows. It is clad in vinyl siding and is capped by a flat roof that extends to the east, protecting the easternmost bay that holds a single-leaf paneled wood door. Above the door is a one-light transom. The second story is fenestrated by 1/1, double-hung, vinyl-sash windows with concrete sills and concrete lug lintels. The east and west (side) elevations are obscured by adjoining buildings.

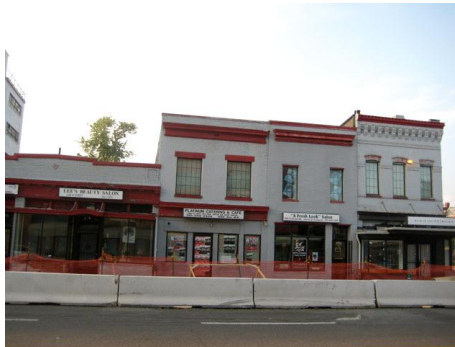
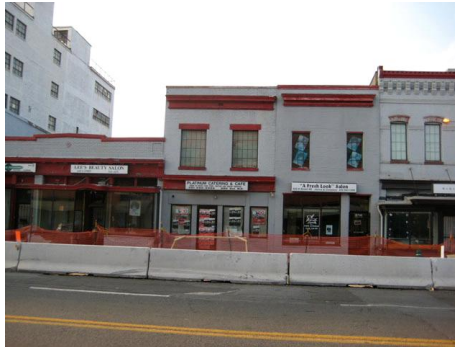
Path: C:\Users\CHRS\Documents\CHRS Databases\H Street - 2 to 15th St\Database\Pictures\0858\  
 File: H Street\_650\_facade\_looking\_NE.JPG  
 Date:: Photog:  
 Code:: R: Fr:

Purpose: **Residential** Condition: **Fair**

**May 2009: This two-story, two-bay single dwelling was constructed between 1869 and 1871. The brick building is set on a solid brick foundation. The first story and foundation are covered in metal sheeting. The second story of the façade (south elevation) is faced with stretcher-bond brick. A brick parapet wall capped by metal flashing obscures the roof. Below the parapet wall is a cornice with a plain frieze. A similar architrave is located above the first story. The first story is fenestrated with one-light fixed windows and a single-leaf metal-frame glass door. The second story is fenestrated by multi-light fixed windows with concrete sills and concrete lug lintels. The east and west (side) elevations are obscured by adjoining buildings.**
