Resource All Data Report

ID Number: 0890-0022

727 **7th Street** **NE** **Current**

Single Dwelling, 727 7th Street, N.E. **Common**

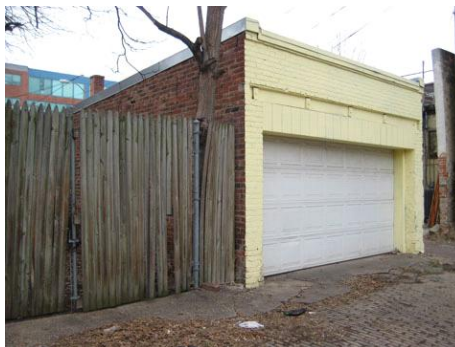
Path: **C:\Users\CHRS\Documents\CHRS
Databases\F&G Street - 2 to 11th
St\Database\Pictures\Square 0890\
File: 727_7th_Street_NE_garage_looking_NW.JPG**
Date:: Photog:
Code:: R: Fr:

January 2010: A one-story, one-bay garage is located east of the dwelling and was constructed c. 1925. The garage is constructed of five-course, American-bond brick and is set on a solid brick foundation. The façade is pierced by a roll-up paneled metal door, which is topped by a lintel clad with T-111 siding. A metal lintel is sited above the T-111 lintel. The opening that pierces the north elevation is boarded with T-111

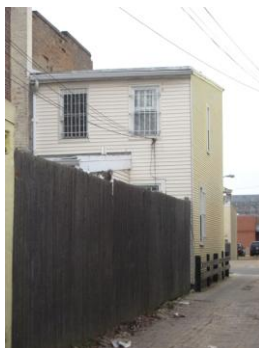
Path: C:\Users\CHRS\Documents\CHRS
Databases\F&G Street - 2 to 11th
St\Database\Pictures\Square 0890\
File: 727_7th_Street_NE_rear_looking_SW.JPG
Date:: Photog:
Code:: R: Fr:

January 2010: Constructed 1873-1874, this two-story, two-bay vernacular single-family dwelling was influenced by the Italianate style. The wood-frame dwelling is clad with wood clapboard siding and is set on a solid poured foundation. A sloping roof caps the dwelling. A prominent molded cornice projects from the façade and features scrolled modillions and brackets. The northernmost bay of the first story holds a single-leaf paneled wood door and a one-light wood transom. A square-edged wood surround highlights the opening. The southernmost bay contains paired 1/1, double-hung, vinyl-sash windows with false 9/1 vinyl muntins. A one-story, full-width porch spans the façade and is set on a solid poured concrete foundation. The flat roof has overhanging eaves and is supported by brick posts with concrete molded capitals. Square wood balusters complete the porch. The second story openings hold 1/1, double-hung, vinyl-sash windows with false 6/1 vinyl muntins. All window openings on the façade have square-edged wood surrounds. The north elevation is pierced by 1/1, double-hung, vinyl-sash windows with false 4/1 vinyl muntins. Square-edged wood surrounds complete the openings. The rear (east) elevation is pierced by 6/6, double-hung, wood-ash windows and a 1/1, double-hung, vinyl-sash window. All windows have wood sills and aluminum surrounds.

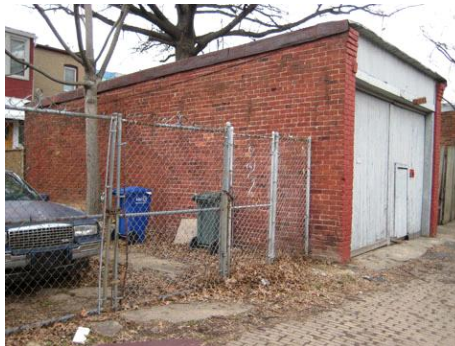
Path: C:\Users\CHRS\Documents\CHRS
Databases\F&G Street - 2 to 11th
St\Database\Pictures\Square 0890\
File: 723_7th_Street_NE_garage_looking_NW.JPG
Date:: Photog:
Code:: R: Fr:

January 2010: A one-story, one-bay garage is located east of the dwelling and was constructed c. 1925. The garage is constructed of six-course, American-bond brick and is set on a solid brick foundation. A sloping roof caps the garage. The

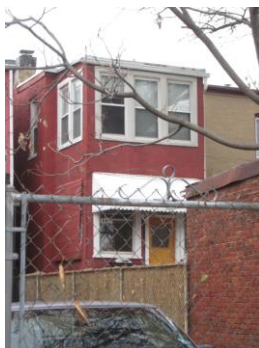
Path: C:\Users\CHRS\Documents\CHRS
Databases\F&G Street - 2 to 11th
St\Database\Pictures\Square 0890\
File: 723_7th_Street_NE_rear_looking_NW.JPG
Date:: Photog:
Code:: R: Fr:

A two-story ell extends from the northernmost bay of the rear (east) elevation and is original. The ell is constructed of brick and is set on a solid foundation. The ell has been parged and is capped by a sloping roof. Two interior chimneys rise from the south elevation and is parged. Visible fenestration consists of 1/1 double-hung windows.

A two-story, full-width addition projects from the rear elevation of the ell and was constructed c. 1940 and is first noted on the 1960 Sanborn map. The addition is constructed of brick and is capped by a sloping roof. Visible fenestration consists of single, paired, and triple 1/1, double-hung, vinyl-sash windows and a single-leaf wood door with one-light. A self-supporting metal awning shelters the first story of the rear elevation. Horizontal siding has covered a first story opening of the south elevation.

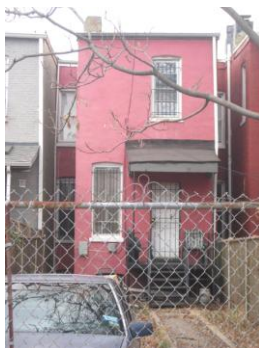
Path: C:\Users\CHRS\Documents\CHRS
Databases\F&G Street - 2 to 11th
St\Database\Pictures\Square 0890\
File: 721_7th_Street_NE_rear_looking_W.JPG
Date:: Photog:
Code:: R: Fr:

A two-story ell extends from the northernmost bay of the rear elevation and is original to the main block. The ell is constructed of brick that has been parged and is set on a solid foundation. A sloping roof caps the ell. An interior chimney rises from the ell and is parged. Visible fenestration consists of a 1/1, double-hung, vinyl-sash window, a 2/2, double-hung, wood-sash window and a single-leaf paneled metal door. All windows have concrete sills and are set in segmental openings. A one-story, one-bay shed-roofed porch shelters the door. The porch is set on a metal post foundation and metal posts also support its roof.

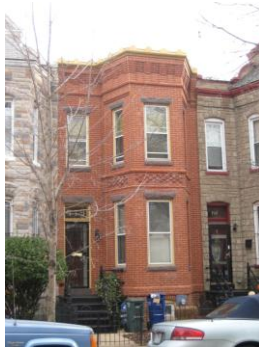
Path: **C:\Users\CHRS\Documents\CHRS
Databases\F&G Street - 2 to 11th
St\Database\Pictures\Square 0890\
File: 719_7th_Street_NE_facade_looking_E.JPG**

January 2010: Constructed in 1891, this two-story, two-bay Queen Anne-style rowhouse is constructed of brick and is set on a solid, raised foundation. The façade (west elevation) is faced with stretcher-bond brick. A four-course brick waterable spans the façade and is located above the foundation. A sloping roof caps the dwelling and is fronted along the façade by a corbeled brick cornice with metal cresting. A string course, composed of nebule molding, spans the façade and is sited below the cornice. The northernmost bay of the first story holds a single-leaf paneled wood door with lights and a one-light wood transom. A stone lintel tops the transom. Cast iron steps with railings provide access to the door. The second story window opening holds a 1/1, double-hung, vinyl-sash window. A three-sided, canted bay rises the full height of the dwelling and projects from the southernmost bay of the façade. The canted bay has the material treatment of the main block and is topped by a corbeled brick cornice with metal cresting. A checkerboard brick panel spans the canted bay between the first and second story windows and is topped by a nebule-molded string course. All window openings of the bay, except the foundation, hold 1/1, double-hung, vinyl-sash windows. The foundation is pierced by paired one-light vinyl sliding windows. All first and second windows have stone sills and lintels. The foundation window features a rowlock brick segmental arch.

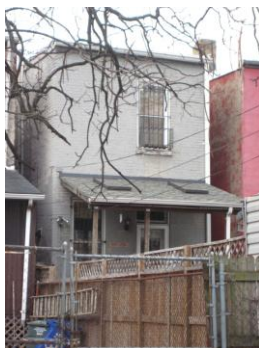
Path: C:\Users\CHRS\Documents\CHRS
Databases\F&G Street - 2 to 11th
St\Database\Pictures\Square 0890\
File: 719_7th_Street_NE_rear_looking_NW.JPG
Date:: Photog:
Code:: R: Fr:

A two-story ell extends from the northernmost bay of the rear (east) elevation and is original. The ell is constructed of American-bond brick and is set on a solid foundation. A sloping roof caps the ell. Visible fenestration consists of 1/1, double-hung, vinyl-sash windows and a single-leaf door with lights and a one-light transom. All window openings have two-course, rowlock brick segmental arches and concrete sills. A one-story, full-width porch spans the rear elevation and was constructed c. 1980. A wood-frame porch is noted on the 1928 Sanborn map. The shed roof of the porch is covered with asphalt shingles and is pierced by two rectangular panels (either solar panels or skylights). Square wood posts support the porch roof.

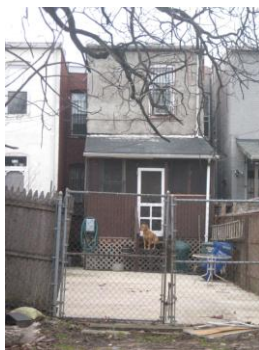
Path: C:\Users\CHRS\Documents\CHRS
Databases\F&G Street - 2 to 11th
St\Database\Pictures\Square 0890\
File: 717_7th_Street_NE_rear_looking_W.JPG
Date:: Photog:
Code:: R: Fr:

A two-story ell extends from the northernmost bay of the rear elevation and is original. The ell is constructed of brick and is set on a solid foundation. The rear elevation is parged. A sloping roof caps the ell. Visible fenestration consists of 1/1, double-hung, vinyl-sash windows, which have rowlock brick sills and are set in segmental openings.

A one-story, full-width screened porch projects from the rear elevation of the ell and was constructed c. 1980. A wood-frame addition is noted on the 1928 Sanborn map. The screened porch is set on a wood pier foundation that has been covered with wood lattice. A shed roof, covered with asphalt shingles, caps the enclosed porch and is supported by square wood posts. A solid balustrade of T-111 siding partially encloses the screened porch. Wood steps provide access to a single-leaf screened wood door.

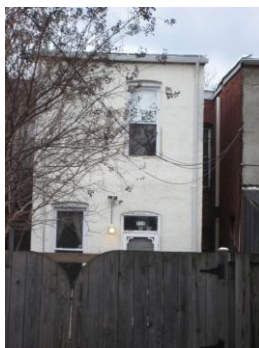
Path: C:\Users\CHRS\Documents\CHRS
Databases\F&G Street - 2 to 11th
St\Database\Pictures\Square 0890\
File: 715_7th_Street_NE_rear_looking_W.JPG
Date:: Photog:
Code:: R: Fr:

A two-story ell extends from the northernmost bay of the rear elevation and is original. The ell is constructed of seven-course, American-bond brick and is set on a solid foundation. The rear elevation is parged. A sloping roof caps the ell. Visible fenestration consists of 1/1, double-hung, vinyl-sash windows and a single-leaf paneled wood door with lights and a one-light transom. The door and windows are set in segmental openings.

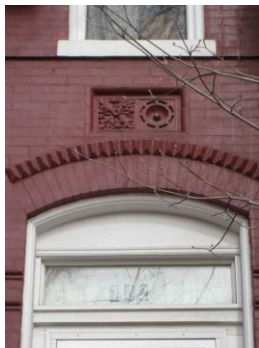
Path: C:\Users\CHRS\Documents\CHRS
Databases\F&G Street - 2 to 11th
St\Database\Pictures\Square 0890\
File: 702_G_Street_NE_molding_detail.JPG

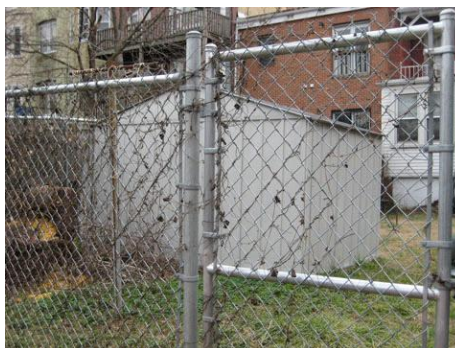
Path: C:\Users\CHRS\Documents\CHRS
Databases\F&G Street - 2 to 11th
St\Database\Pictures\Square 0890\
File: 708_G_Street_NE_shed_looking_SE.JPG
Date:: Photog:
Code:: R: Fr:

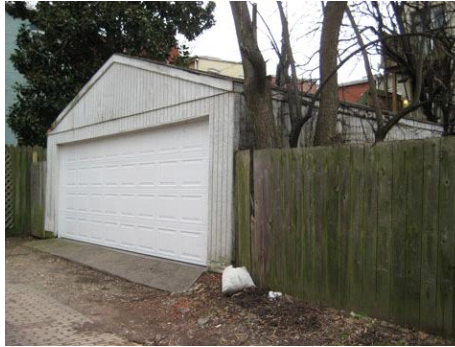
Path: C:\Users\CHRS\Documents\CHRS
Databases\F&G Street - 2 to 11th
St\Database\Pictures\Square 0890\
File: 716-
718_G_Street_NE_garage_looking_SE.JPG
