Resource All Data Report

ID Number: 0891-0813

Name(s)	Type of Name
Single Dwelling, 647 7th Street, N.E.	Common

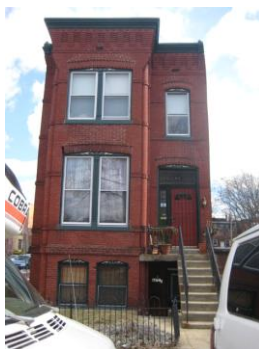
Path: **C:\Users\CHRS\Documents\CHRS
Databases\F&G Street - 2 to 11th
St\Database\Pictures\Square 0891\
File: 647_7th_Street_NE_facade_looking_E.JPG**
Date:: Photog:
Code:: R: Fr:

March 2010: Constructed in 1890 by Thomas Trebeil, this two-story, two-bay Queen Anne-style single dwelling has Italianate influences and was constructed from permit #0570. The dwelling is constructed of seven-course American-bond brick and is set on a solid, raised concrete foundation. The façade (west elevation) is faced with pressed stretcher-bond brick. A four-course brick watertable spans the façade and is located above the foundation. A sloping roof caps the dwelling and an interior brick chimney pierces the roof. A metal ogee-molded cornice complements a molded brick course and a corbeled brick table. Multiple stringcourses, composed of two courses of brick, span the façade. The southernmost bay of the first story holds a single-leaf, replacement paneled wood door with lights, a one-light wood transom, and a three-light wood side-light. A soldier brick segmental arch with brick pearl cap tops the transom. Concrete steps with metal railings provide access to the concrete stoop and door. The stoop is supported by a brick pier and has a turned metal balustrade. The second story window opening holds a 1/1, double-hung, vinyl-sash window. A three-sided, rectangular bay with molded brick chamfered corners rises the full height of the dwelling and projects from the northernmost bay of the façade. The bay has the material treatment of the main block. All window openings on the bay, except the foundation, hold paired 1/1, double-hung, vinyl-sash windows. All openings on the façade are highlighted by concrete-lug sills and soldier brick segmental arches with brick pearl caps. The foundation is pierced by two 1/1, double-hung, wood-sash windows with rowlock brick segmental arches. A single-leaf paneled metal door with lights pierces the foundation in the southern end bay and provides access to a basement unit. The side (north) elevation is fenestrated with 1/1, 2/2, and 6/6 double-hung, wood-sash windows. Window openings are highlighted by concrete-lug sills and two-course rowlock brick segmental arches.

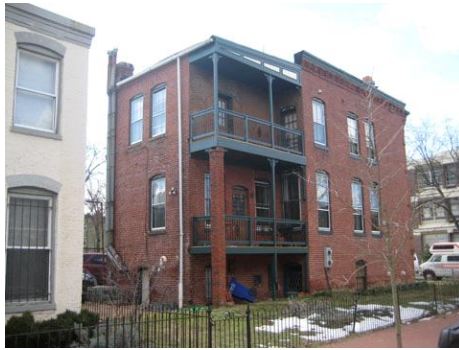
Path: C:\Users\CHRS\Documents\CHRS
Databases\F&G Street - 2 to 11th
St\Database\Pictures\Square 0891\
File: 647_7th_Street_NE_rear_and_side_looking_S
W.JPG

A two-story ell extends from the southernmost bay of the rear elevation and is original. The ell is constructed of brick and is set on a solid foundation. Visible fenestration at basement level consists of a single-leaf door and window openings set in two-course rowlock brick segmental arches. A two-story wood porch is set within the ell. It is supported by a square brick pier and wood posts, both with scrolled wood brackets, and has wood and metal balusters. The second story has a sloped roof. The first story openings hold a single-leaf paneled wood door with multiple lights and 2/2, double-hung, wood-sash windows. All are highlighted by two-course rowlock brick segmental arches. The second story is fenestrated by a single-leaf paneled wood door with lights with a lug lintel. A single-leaf wood multi-light door in a segmental opening on the second story and a 2/2, double-hung, wood-sash window in a segmental opening on the first story are located on the rear (east) elevation of the main block. The rear elevation of the ell is fenestrated by a single-leaf door opening on the foundation, a 2/2, double-hung, wood-sash window on the first story, and 6/6, double-hung, wood-sash windows on the second story. The openings are highlighted by two-course rowlock brick segmental arches, and the windows have rowlock brick sills. A brick chimney with parged cap is located in the southeast corner of the ell.

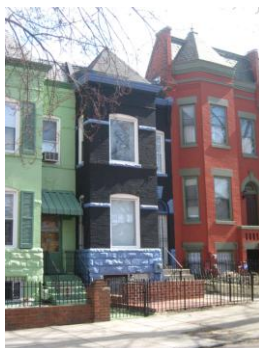
Path: C:\Users\CHRS\Documents\CHRS
Databases\F&G Street - 2 to 11th
St\Database\Pictures\Square 0891\
File: 635_7th_Street_NE_facade_looking_SE.JPG
Date:: Photog:
Code:: R: Fr:

March 2010: Designed and constructed by George S. Cooper in 1891, this two-story, two-bay Queen Anne-style dwelling is one of two twin dwellings constructed from permit #0652. The dwelling is constructed of brick and is set on a solid, raised brick foundation that has been faced with rusticated concrete. A rusticated concrete belt course spans the façade (west elevation) on the first and second stories. A sloping roof caps the dwelling and an interior brick chimney pierces the roof. A false mansard roof runs along the façade and is clad with asphalt shingles. The mansard is complemented by an ogee-molded metal cornice with pressed brick and brick dentils below. A molded string course runs below a plain brick frieze. The southernmost bay of the first story holds a single-leaf metal French door. The door opening is highlighted by a semicircular one-light transom set in a semicircular soldier brick arch with rusticated concrete keystone. Concrete steps with metal railings provide access to the door. The second story window opening holds a 1/1, double-hung, vinyl-sash window. A three-sided, rectangular bay rises the full height of the dwelling and projects from the northernmost bay of the façade. The bay has the material treatment of the main block and is capped by a pyramidal roof with asphalt shingles. All window openings on the bay, except the foundation, hold fixed vinyl windows. All openings on the façade are highlighted by rusticated concrete-lug sills and brick segmental arches. The foundation of the bay is pierced by a single-leaf paneled metal door and a 1/1, double-hung, wood-sash window with a rowlock brick sill.

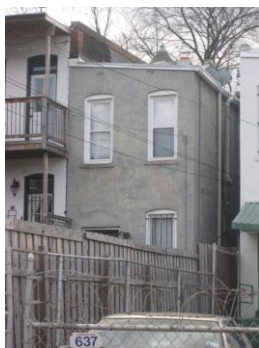
Path: C:\Users\CHRS\Documents\CHRS
Databases\F&G Street - 2 to 11th
St\Database\Pictures\Square 0891\
File: 635_7th_Street_SE_rear_looking_W.jpg
Date:: Photog:
Code:: R: Fr:

A two-story ell extends from the southernmost bay of the rear (east) elevation and is original. The ell, which has been parged, is constructed of brick and is set on a solid foundation. The rear of the ell is fenestrated with 1/1, double-hung, vinyl-sash windows set in segmental openings with rowlock brick sills. The first story of the ell is fenestrated by a single-leaf door in the southernmost bay.

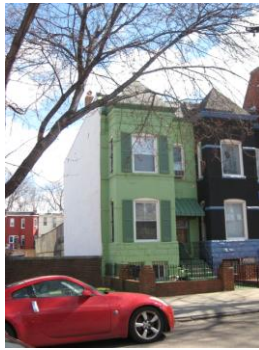
Path: C:\Users\CHRS\Documents\CHRS
Databases\F&G Street - 2 to 11th
St\Database\Pictures\Square 0891\
File: 637_7th_Street_NE_facade_looking_SE.JPG
Date:: Photog:
Code:: R: Fr:

March 2010: Designed and constructed by George S. Cooper in 1891, this two-story, two-bay Queen Anne-style dwelling is one of two twin dwellings constructed from permit #0652. The dwelling is constructed of brick and is set on a solid, raised brick foundation that has been faced with rusticated concrete. A rusticated concrete belt course spans the façade (west elevation) on the first and second stories. A sloping roof caps the dwelling and an interior brick chimney with parged cap pierces the roof. A false mansard roof runs along the façade and is clad with slate shingles. The mansard is complemented by an ogee-molded metal cornice with pressed brick and brick dentils below. A molded string course runs below a plain brick frieze. The southernmost bay of the first story holds a single-leaf flush wood door with one light. The door opening is highlighted by a semicircular soldier brick arch with rusticated concrete keystone and a self-supporting metal awning. Concrete steps with metal railings provide access to the door. The second story window opening holds a 1/1, double-hung, vinyl-sash window. A three-sided, rectangular bay rises the full height of the dwelling and projects from the northernmost bay of the façade. The bay has the material treatment of the main block and is capped by a pyramidal roof with slate shingles and a metal finial. All window openings on the bay, except the foundation, hold 1/1, double-hung, vinyl-sash windows. All openings on the façade are highlighted by rusticated concrete-lug sills and brick segmental arches. The foundation of the bay is pierced by two vinyl sliding windows. The north (side) elevation has been parged.

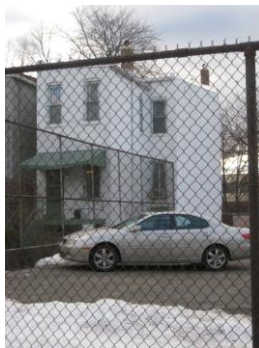
Path: C:\Users\CHRS\Documents\CHRS
Databases\F&G Street - 2 to 11th
St\Database\Pictures\Square 0891\
File: 637_7th_Street_NE_rear_looking_SW.JPG
Date:: Photog:
Code:: R: Fr:

A two-story ell extends from the southernmost bay of the rear (east) elevation and is original. The ell, which has been parged, is constructed of brick and is set on a solid foundation. The main block is fenestrated with an opening at basement level (not visible) and 1/1, double-hung, vinyl-sash windows with concrete-lug sills in segmental openings on the first and second stories. The rear of the ell is also fenestrated in the same manner. A one-story, one-bay porch extends from the ell and is supported by square brick piers. A metal awning shelters the porch and is supported by circular metal posts. The first story of the ell is fenestrated by a single-leaf paneled door with lights. An interior brick chimney with parged cap is located on the north side of the ell.

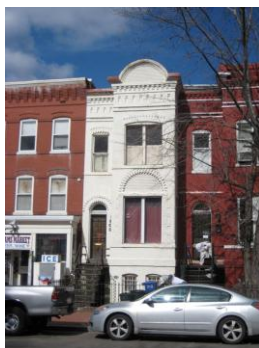
Path: C:\Users\CHRS\Documents\CHRS
Databases\F&G Street - 2 to 11th
St\Database\Pictures\Square 0891\
File: 702-
702.5_F_Street_NE_facade_looking_NW.JPG

March 2010: This two-story, two-bay Queen Anne-style rowhouse with Romanesque influences was constructed in 1891. Built by Wright and Stockett, this rowhouse is one of six constructed from the same permit (#0852). The brick dwelling is set on a raised, solid brick foundation and is faced with pressed brick. A sloping roof caps the dwelling and is fronted along the façade by a molded metal cornice and a corbeled brick cornice below. Additional string courses, composed of molded brick, and panels of dogtooth brick span the façade beneath a brick frieze. A molded brick watertable is located above the foundation, and brick sill courses travel across the façade beneath the first and second story window openings. The westernmost bay of the foundation is pierced by a single-leaf paneled wood door. Steps from the front yard provide access to the opening. The westernmost bay of the first story holds a single-leaf paneled wood door with a semicircular one-light transom. The opening is highlighted by a staggered soldier brick semicircular arch and topped by brick nailhead molding. Cast iron stairs with gas pipe hand rails provide access to the primary entrance. The second story opening holds a 1/1, double-hung, wood-sash window with a staggered soldier brick segmental arch with brick nailhead molding. A three-sided, rectangular bay extends from the easternmost bay of the façade and rises the full height of the dwelling. The bay has the material treatment of the façade and features a corbeled chamfered corner on the foundation and rounded corners above. It is capped by a segmental pediment that features prismatic nailhead molding. The bay is fenestrated with paired one-light fixed wood windows and 1/1, double-hung, wood-sash windows. The first story opening is highlighted by rusticated brick quoining and a stone lintel. A semicircular panel with prismatic nailhead molding sits atop the lintel. The foundation is pierced by 6/6, double-hung, wood-sash windows with rowlock brick arches.

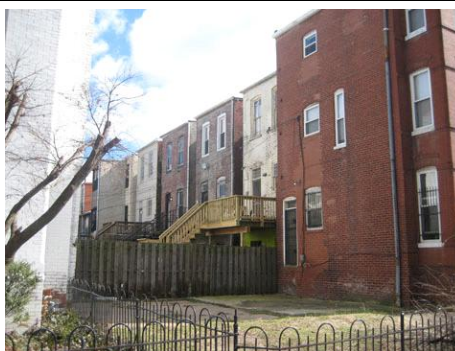
Path: C:\Users\CHRS\Documents\CHRS
Databases\F&G Street - 2 to 11th
St\Database\Pictures\Square 0891\
File: 702_F_Street_NE_rear_looking_SE.jpg

A two-story ell projects from the westernmost bay of the rear (north) elevation and is original to the dwelling. A one-story wood deck projects from the first story of the ell and is supported by square wood posts and has square wood balusters. It is accessible from the yard via wood steps with railings. The foundation level was not fully visible due to obstruction by the rear fence. The first story is fenestrated by a single-leaf door with a one-light transom and a wood-sash window with a rowlock brick segmental arch. The second story openings hold 2/2, double-hung, wood-sash windows with concrete-lug sills and two-course, rowlock brick segmental arches.

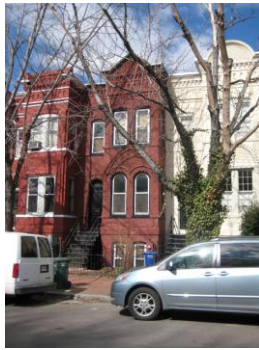
Path: C:\Users\CHRS\Documents\CHRS
Databases\F&G Street - 2 to 11th
St\Database\Pictures\Square 0891\
File: 706_F_Street_NE_facade_looking_NW.JPG
Date:: Photog:
Code:: R: Fr:

March 2010: This two-story, two-bay Queen Anne-style rowhouse with Romanesque influences was constructed in 1891. Built by Wright and Stockett, this rowhouse is one of six constructed from the same permit (#0852). The brick dwelling is set on a raised, solid brick foundation and is faced with pressed brick. A sloping roof caps the dwelling and is fronted along the façade by a molded metal cornice and a corbeled brick cornice below. Additional brick string courses and panels of dogtooth brick span the façade beneath a brick frieze. A molded brick watertable is located above the foundation, and brick sill courses travel across the façade beneath the first and second story window openings. The westernmost bay of the foundation is pierced by a single-leaf flush wood door. Steps from the front yard provide access to the opening. The westernmost bay of the first story holds a single-leaf paneled wood door with a blind semicircular one-light transom. The opening is highlighted by a staggered soldier brick segmental arch and topped by brick nailhead molding. Cast iron steps with gas pipe railings provide access to the primary entrance. The second story opening holds a 1/1, double-hung, vinyl-sash window with a staggered soldier brick segmental arch capped by brick nailhead molding. A three-sided, rectangular bay extends from the easternmost bay of the façade and rises the full height of the dwelling. The bay has the material treatment of the façade and features a corbeled chamfered corner on the foundation and rounded corners above. It is capped by a gabled pediment that features prismatic nailhead molding. The bay is fenestrated with 1/1, double-hung, round-headed vinyl-sash windows on the first story. These openings are highlighted by concrete-lug sills and staggered soldier brick semicircular arches capped by molded brick. The two openings on the south elevation of the bay share a pointed arch with a prismatic nailhead panel and molded brick cap. Openings on the second story hold 1/1, double-hung, vinyl-sash windows with concrete-lug sill and staggered soldier brick segmental arches capped by brick nailhead molding. The foundation is pierced by 1/1, double-hung, vinyl-sash windows with rowlock brick segmental arches.

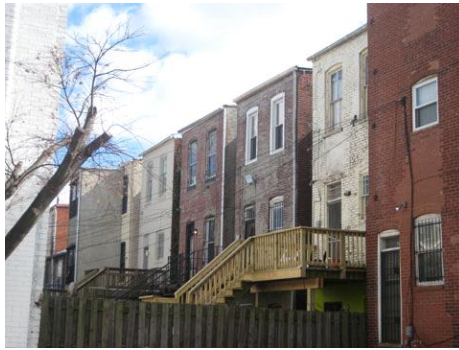
Path: C:\Users\CHRS\Documents\CHRS
Databases\F&G Street - 2 to 11th
St\Database\Pictures\Square 0891\
File: 706_F_Street_NE_rear_looking_SE.jpg
Date:: Photog:
Code:: R: Fr:

A two-story ell projects from the westernmost bay of the rear (north) elevation and is original to the dwelling. The foundation level was not visible due to obstruction by the rear fence. The first story is fenestrated by a single-leaf door with a one-light transom highlighted by a rowlock brick segmental arch. Metal steps with railings provide access to the entryway. All other openings hold 1/1, double-hung, vinyl-sash windows with rowlock brick segmental arches.
