Resource All Data Report

ID Number: 0960-0053

Rowhouse, 603 10th Street, N.E. **Common**

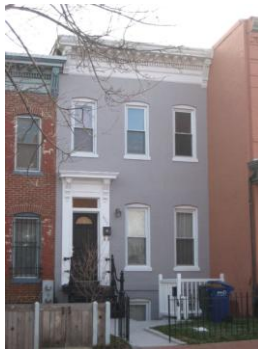
Path: C:\Users\CHRS\Documents\CHRS
Databases\F&G Street - 2 to 11th
St\Database\Pictures\Square 0960\
File: 603_10th_Street_NE_facade_looking_SE.JPG
Date:: Photog:
Code:: R: Fr:

March 2010: Constructed in 1876, this two-story, three-bay Italianate-style single-family rowhouse is one of ten rowhouses constructed from the same permit (#1). The dwelling is constructed of brick and is set on a solid, raised foundation. The façade (west elevation) is faced with stretcher-bond brick. A molded watertable spans the façade and is located above the foundation. A sloping roof caps the dwelling and is highlighted by a prominent molded metal cornice with modillions, dentil molding, end brackets and a frieze. An interior-side brick chimney rises from the north (side) elevation and has been partially parged. A single-leaf paneled door pierces the foundation. The northernmost bay of the first story holds a replacement, single-leaf paneled wood door with lights and a one-light transom. A simple molded hood with scrolled consoles surmounts the door opening, which is flanked by wood pilasters. Cast iron steps and railings provide access to the primary entrance. All window openings on the façade hold 1/1, double-hung, vinyl-sash windows and have concrete sills and soldier brick segmental arches. The rear (east) elevation is fenestrated with 1/1, double-hung, vinyl-sash windows and glass blocks. All visible openings have concrete sills and soldier brick segmental arches.

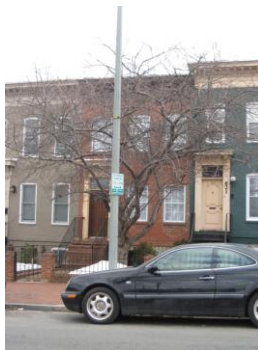
Path: C:\Users\CHRS\Documents\CHRS
Databases\F&G Street - 2 to 11th
St\Database\Pictures\Square 0960\
File: 623_10th_Street_NE_facade_looking_NE.JPG
Date:: Photog:
Code:: R: Fr:

March 2010: Constructed in 1876, this two-story, three-bay Italianate-style single-family rowhouse is one of three rowhouses constructed from the same permit (#4). The dwelling is constructed of seven-course, American-bond brick and is set on a solid, raised and parged foundation. A three-course brick watertable spans the façade and is located above the foundation. A sloping roof caps the dwelling and is highlighted by a prominent molded wood cornice with modillions, dentil molding, end brackets and a frieze. An interior-side brick chimney rises from the north (side) elevation of the dwelling. A single-leaf paneled wood door with lights pierces the foundation. The northernmost bay of the first story holds a single-leaf paneled wood door with lights and a one-light transom. A simple molded hood with foliated consoles surmounts the door opening, which is flanked by wood pilasters. Brick steps with metal hand rails provide access to the primary entrance. All window openings on the façade hold 1/1, double-hung, vinyl-sash windows with false 6/6 vinyl muntins and have soldier brick segmental arches and rowlock brick sills. The rear (east) elevation is fenestrated with a 1/1, double-hung, vinyl-sash window, a 1/1, double-hung, vinyl-sash window with false 6/6 vinyl muntins, and a single-leaf paneled metal door with lights. All openings are surmounted by soldier brick segmental arches and the windows also have rowlock brick sills.

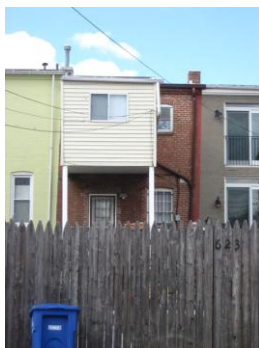
Path: C:\Users\CHRS\Documents\CHRS
Databases\F&G Street - 2 to 11th
St\Database\Pictures\Square 0960\
File: 623_10th_Street_NE_rear_looking_W.JPG
Date:: Photog:
Code:: R: Fr:

A second story enclosed addition projects from the southernmost bay of the rear elevation and is noted on the 1928 Sanborn map. The wood-frame addition is clad with vinyl siding and is supported by square wood posts. A shed roof caps the addition, which is fenestrated with sliding one-light vinyl windows.

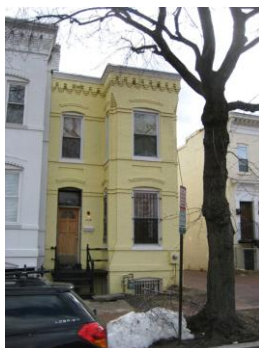
Path: C:\Users\CHRS\Documents\CHRS
Databases\F&G Street - 2 to 11th
St\Database\Pictures\Square 0960\
File: 629_10th_Street_NE_facade_looking_SE.JPG
Date:: Photog:
Code:: R: Fr:

March 2010: Constructed in 1890 by Charles A. Summerlott, this two-story, two-bay Queen Anne-style single-family dwelling was influenced by the Italianate style. The dwelling is constructed of brick and is set on a solid brick foundation; the façade (west elevation) is faced with pressed stretcher-bond brick. A three course brick watertable is located above the foundation. Brick sill courses span the façade below the first and second story window openings, which are also bisected by two other brick string courses. A sloping roof caps the dwelling and is highlighted by a molded cornice and corbeled brick cornice. An interior-side chimney rises from the south (side) elevation of the dwelling and is parged. A single-leaf wood door pierces the foundation of the dwelling. The northernmost bay of the first story holds a single-leaf paneled wood door with lights and a one-light wood transom. A soldier brick segmental arch with header cap surmounts the transom. Cast iron steps and railings provide access to the primary entrance. The second story opening holds a 1/1, double-hung, vinyl-sash window. A three-sided, rectangular bay projects from the southernmost bay of the façade and rises the full height of the dwelling. The bay has the material treatment of the main block and is fenestrated with 1/1, double-hung, vinyl-sash windows. All first and second story windows have concrete sills and soldier brick segmental arches with header brick caps. The foundation window is topped by a two-course, rowlock brick segmental arch. Decorative recessed brick panels divide the first and second stories. The south (side) elevation is fenestrated with 1/1, double-hung, vinyl-sash windows, which have concrete sills and two-course, rowlock brick segmental arches. The rear (east) elevation is pierced by sliding glass doros and a 1/1, double-hung, vinyl-sash window.

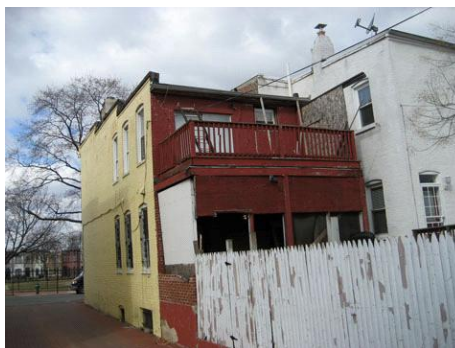
Path: C:\Users\CHRS\Documents\CHRS
Databases\F&G Street - 2 to 11th
St\Database\Pictures\Square 0960\
File: 629_10th_Street_NE_rear_looking_NW.JPG
Date:: Photog:
Code:: R: Fr:

A two-story, full-width porch extends from the rear (east) elevation of the dwelling and is first noted on the 1904 Sanborn map. This porch, judging by the materials, was constructed c. 1960. The wood-frame porch is set on a solid foundation and has a flat roof, which supports a second story deck. The first story has been partially enclosed with T-111 siding. Square wood balusters encircle the second story.

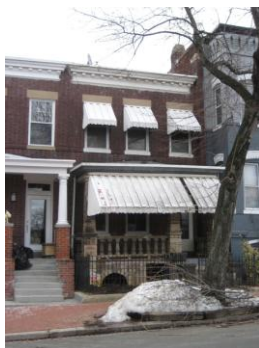
Path: C:\Users\CHRS\Documents\CHRS
Databases\F&G Street - 2 to 11th
St\Database\Pictures\Square 0960\
File: 635_10th_Street_NE_facade_looking_SE.JPG
Date:: Photog:
Code:: R: Fr:

March 2010: Constructed in 1910 by Wright & Hopkins, this two-story, three-bay Classical Revival-style single-family rowhouse is one of three rowhouses constructed from the same permit (#6682). The dwelling is constructed of brick and is set on a solid concrete foundation; the façade (west elevation) is faced with Flemish-bond brick. A brick sill course spans the first and second stories. A sloping roof caps the dwelling and is highlighted by a molded cornice with modillions. A single-leaf paneled metal door pierces the foundation. The southernmost bay of the first story holds a single-leaf paneled wood door and a one-light transom. All window openings on the façade hold 1/1, double-hung, vinyl-sash windows and have concrete sills and lintels. Metal awnings shelter the second story openings. A one-story, two-bay porch spans the façade and is set on a stone foundation. The flat roof of the porch has overhanging eaves and is supported by battered stone posts that are set on stone supports. A metal awning projects from the façade of the porch. A 1/1, double-hung, vinyl-sash window pierces the rear (east) elevation. A three-sided, canted bay projects from the northernmost bay of the rear elevation and is original. Visible fenestration consists of 1/1, double-hung, vinyl-sash windows. All window openings on the rear elevation have two-course, rowlock brick segmental arches and wood sills.

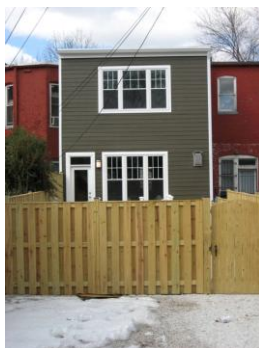
Path: C:\Users\CHRS\Documents\CHRS
Databases\F&G Street - 2 to 11th
St\Database\Pictures\Square 0960\
File: 637_10th_Street_NE_rear_looking_W.JPG
Date:: Photog:
Code:: R: Fr:

A two-story, full-width addition is located on the rear (east) elevation and was constructed c. 2008. The wood-frame addition is clad with Hardiplank siding and is set on a solid foundation. A sloping roof caps the addition. Visible fenestration consists of a single-leaf wood-frame glass door with a one-light transom and tripartite windows composed of 1/1, double-hung, vinyl-sash windows with false 6/1 vinyl muntins.

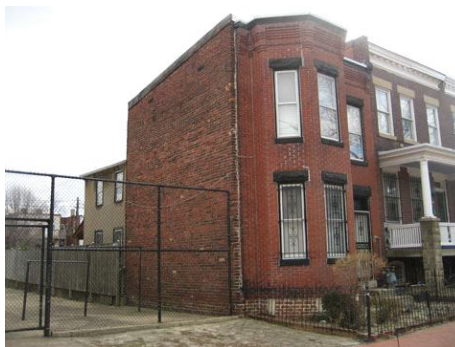
Path: C:\Users\CHRS\Documents\CHRS
Databases\F&G Street - 2 to 11th
St\Database\Pictures\Square 0960\
File: 641_10th_Street_NE_facade_looking_SE.JPG
Date:: Photog:
Code:: R: Fr:

March 2010: Constructed c. 1905, this two-story, two-bay Queen Anne-style single-family dwelling is constructed of five-course, American-bond brick and is set on a solid foundation. The façade (west elevation) is faced with stretcher-bond brick. A sloping roof caps the dwelling and is highlighted by a corbeled brick cornice. The southernmost bay of the façade holds a single-leaf paneled wood door and a one-light transom. A stone lintel tops the transom. The second story opening holds a 1/1, double-hung, vinyl-sash window. A three-sided, canted bay extends from the northernmost bay of the façade and rises the full height of the dwelling. The bay has the material treatment of the main block and is fenestrated with 1/1, double-hung, vinyl-sash windows. All windows on the façade have concrete sills and stone lintels. The foundation openings have been infilled with brick.
