# Resource All Data Report

**ID Number: 1031-0108**

**Rowhouse, 300 Tennessee Avenue, N.E. Common**

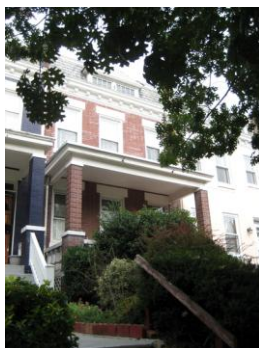
Path: C:\Users\CHRS\Documents\CHRS  
Databases\Capitol Hill Phase 1D - 11 to 15th  
St\Database\Pictures\Square 1031 - Re-Sized\  
File: 306\_Tennessee\_Avenue\_NE\_facade\_looking\_  
W.JPG

**October 2010:** Constructed in 1914 by Harry A. Kite, this two-story, three-bay Classical Revival-style single-family rowhouse is one of eight similar dwellings constructed from the same permit (#2959). Set on a solid concrete foundation, this brick dwelling is faced with Flemish-bond brick. A sloping roof caps the building and is accented by a false mansard roof of slate shingles. A molded metal cornice with block modillions finishes the false mansard roof, which is marked by a pedimented dormer. Paired eight-light wood windows pierce the dormer. An exterior-rear brick chimney rises from the northwest elevation and has a plain cap. The façade (southeast elevation) is fenestrated with a single-leaf, paneled wood door (surmounted by a single-light transom) and 1/1, double-hung, vinyl-sash windows. Concrete sills and lintels finish each opening. A one-story, full-width porch spans the façade and is set on a brick pier foundation with wood lattice infill. The flat roof, complemented by overhanging eaves, is supported by brick posts, which are set on brick pedestals.

A two-story, full-width enclosed porch is located on the rear (northwest) elevation of the dwelling. The wood-frame enclosed porch is clad with vinyl siding and is capped by a sloping roof. Visible fenestration consists of 1/1, double-hung, vinyl-sash windows. A one-story deck, set on a square wood post foundation, is located on the rear elevation of the enclosed porch.

A one-story, one-bay attached garage extends from the foundation of the rear elevation. The brick garage is capped by a flat roof. A roll-up, paneled metal door pierces the northwest elevation of the garage.

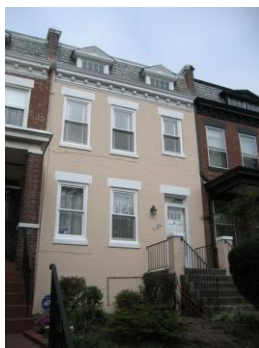
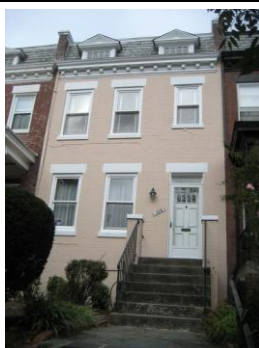
Path: C:\Users\CHRS\Documents\CHRS  
Databases\Capitol Hill Phase 1D - 11 to 15th  
St\Database\Pictures\Square 1031 - Re-Sized\  
File: 308\_Tennessee\_Avenue\_NE\_facade\_looking\_  
W.JPG

**October 2010:** Constructed in 1914 by Harry A. Kite, this two-story, three-bay Classical Revival-style single-family rowhouse is one of eight similar dwellings constructed from the same permit (#2959). Set on a solid concrete foundation, this brick dwelling is faced with Flemish-bond brick. A sloping roof caps the building and is accented by a false mansard roof of slate shingles. A molded metal cornice with block modillions finishes the false mansard roof, which is marked by two pedimented dormers. Each dormer is pierced by an eight-light wood window. An exterior-rear brick chimney rises from the northwest elevation and has a plain cap. The façade (southeast elevation) is fenestrated with a single-leaf, paneled wood door with lights (surmounted by a single-light transom) and 1/1, double-hung, wood-sash windows. Concrete sills and lintels finish each opening. The original one-story, full-width porch has been removed.

A one-story, one-bay attached garage extends from the foundation of the rear elevation. The brick garage is capped by a flat roof, which serves as a deck. Fenestration consists of a 6/6, double-hung, wood-sash window and a roll-up, paneled metal door.

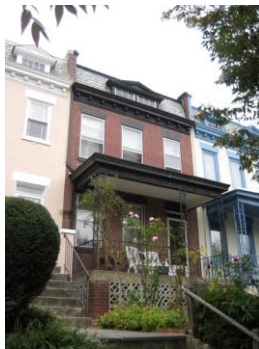
Path: **C:\Users\CHRS\Documents\CHRS  
Databases\Capitol Hill Phase 1D - 11 to 15th  
St\Database\Pictures\Square 1031 - Re-Sized\  
File: 310\_Tennessee\_Avenue\_NE\_facade\_looking\_  
W.JPG**

**October 2010:** Constructed in 1914 by Harry A. Kite, this two-story, three-bay Classical Revival-style single-family rowhouse is one of eight similar dwellings constructed from the same permit (#2959). Set on a solid concrete foundation, this brick dwelling is faced with Flemish-bond brick. A sloping roof caps the building and is accented by a false mansard roof of slate shingles. A molded metal cornice with block modillions finishes the false mansard roof, which is marked by a pedimented dormer. Paired six-light wood windows pierce the dormer. An exterior-rear brick chimney rises from the northwest elevation and has a plain cap. The façade (southeast elevation) is fenestrated with a single-leaf, wood-frame glass door (surmounted by a single-light transom) and 1/1, double-hung, wood-sash windows. Concrete sills and lintels finish each opening. A one-story, full-width porch spans the façade and is set on a brick pier foundation with decorative concrete block infill. The flat roof, complemented by overhanging eaves, is supported by metal filigree posts. A single-leaf, paneled wood door with lights pierces the rear (northwest) elevation of the foundation.

A one-story, one-bay attached garage extends from the foundation of the rear elevation. The brick garage is capped by a flat roof, which serves as a deck. Fenestration consists of a 6/6, double-hung, wood-sash window and a roll-up, wood door.

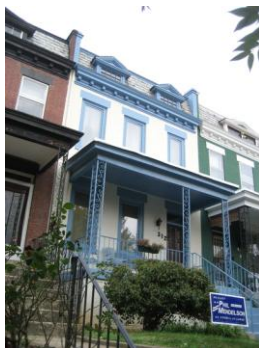
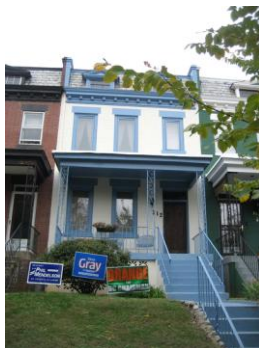
Path: C:\Users\CHRS\Documents\CHRS  
Databases\Capitol Hill Phase 1D - 11 to 15th  
St\Database\Pictures\Square 1031 - Re-Sized\  
File: 312\_Tennessee\_Avenue\_NE\_facade\_looking\_  
NW.JPG

**October 2010:** Constructed in 1914 by Harry A. Kite, this two-story, three-bay Classical Revival-style single-family rowhouse is one of eight similar dwellings constructed from the same permit (#2959). Set on a solid concrete foundation, this brick dwelling is faced with Flemish-bond brick. A sloping roof caps the building and is accented by a false mansard roof of slate shingles. A molded metal cornice with block modillions finishes the false mansard roof, which is marked by two pedimented dormers. An eight-light wood window pierces each dormer. An exterior-rear brick chimney rises from the northwest elevation and has a plain cap. The façade (southeast elevation) is fenestrated with a single-leaf, paneled wood door (surmounted by a single-light transom) and single-light wood casement windows. Concrete sills and lintels finish each opening. A one-story, full-width porch spans the façade and is set on a brick pier foundation with decorative concrete block infill. The flat roof, complemented by overhanging eaves, is supported by metal filigree posts. Two single-leaf, wood-frame glass doors mark the rear (northwest) elevation of the dwelling, in addition to several single-light wood casement windows. Three-course, rowlock brick segmental arches top most openings.

A one-story, one-bay attached garage extends from the foundation of the rear elevation. The original vehicular opening, located on the northwest elevation, has been enclosed. The brick garage is capped by a flat roof, which serves as a deck. Fenestration consists of a single-leaf wood door and double-hung, wood-sash windows.

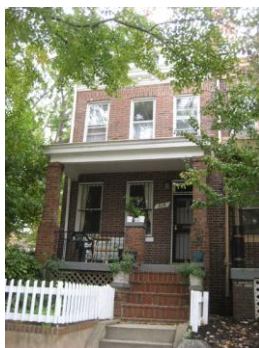
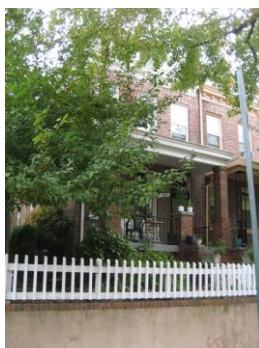
Path: C:\Users\CHRS\Documents\CHRS  
Databases\Capitol Hill Phase 1D - 11 to 15th  
St\Database\Pictures\Square 1031 - Re-Sized\  
File: 315\_13th\_Street\_NE\_facade\_looking\_SE.JPG

**October 2010:** Constructed in 1914 by Harry A. Kite, this two-story, three-bay Classical Revival-style single-family rowhouse is one of four similar dwellings constructed from the same permit (#2303). Set on a solid, concrete foundation, this brick dwelling is faced with Flemish-bond brick. A gauged brick stringcourse ornaments the façade and is located above the second story openings. A sloping roof caps the building and is accented by a false mansard roof of slate shingles. A molded metal cornice with block modillions finishes the false mansard roof, which is marked by two pedimented dormers. A one-light vinyl window with false six-light vinyl muntins pierces each dormer. An interior-side brick chimney pierces the roof and has a plain cap. The façade (west elevation) is fenestrated with a single-leaf, paneled wood door with lights (topped by a single-light transom) and 1/1, double-hung, wood-sash windows. Concrete sills finish each opening. A one-story, full-width porch spans the façade and is set on a brick pier foundation with wood lattice infill. The flat roof, featuring overhanging eaves, is supported by brick posts, which are set upon brick pedestals. The north (side) elevation is fenestrated by six-light wood awning windows. The rear (east) elevation is pierced by two single-leaf, multi-light doors and 1/1, double-hung, vinyl-sash windows. Two-course, rowlock brick segmental arches surmount most openings.

A two-story, full-width porch, capped by a sloping roof, spans the rear elevation of the dwelling. Set on a brick pier foundation, the porch has been screened on the first story and a solid balustrade encircles the second story. Square wood posts support the sloping roof.
