# Resource All Data Report

**ID Number: 1033NW-003**

**Rowhouse, 1301 C Street, N.E.** **Common**

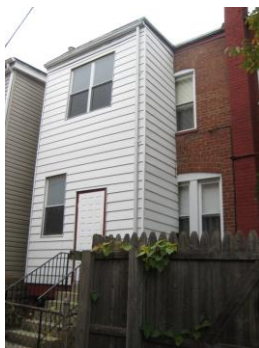
File: 1303\_C\_Street\_NE\_rear\_looking\_NW.jpg

A two-story, enclosed porch is located on the rear (south) elevation of the dwelling and is set on a brick pier foundation. The wood-frame porch is clad with aluminum siding and is capped by a sloping roof. Visible fenestration consists of a single-leaf, paneled door and single and paired 1/1, double-hung, vinyl-sash windows.

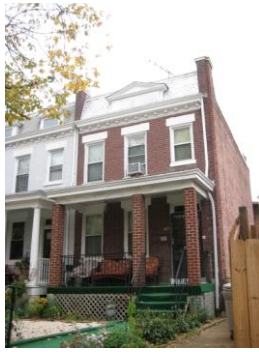
Path: C:\Users\CHRS\Documents\CHRS  
Databases\Capitol Hill Phase 1D - 11 to 15th  
St\Database\Pictures\Square 1033NW - Re-  
Sized\  
File: 234\_Tennessee\_Avenue\_SE\_facade\_looking\_  
SW.JPG

**October 2010:** Constructed in 1912 by Harry A. Kite, this two-story, three-bay Classical Revival-style single-family rowhouse is one of twelve similar dwellings constructed from the same permit (#1571). Set on a solid concrete foundation, this brick dwelling is faced with Flemish-bond brick. A sloping roof caps the building and is complemented by a false mansard roof. Slate shingles cover the false mansard roof, which is accented by a molded metal cornice with block modillions. A blind pedimented dormer marks the false mansard roof. An exterior-rear brick chimney rises from the northwest elevation and has a plain cap. The façade (southeast elevation) is fenestrated with a single-leaf door (surmounted by a single-light transom) and 1/1 double-hung, vinyl-sash windows. Each opening is topped by a concrete lintel. A one-story, full-width porch spans the facade and is set on a brick pier foundation with wood lattice. The flat roof, featuring overhanging eaves, is supported by brick posts. Metal balusters finish the porch. The rear (northwest) elevation is fenestrated with 1/1, double-hung, vinyl-sash windows, paired, one-light vinyl sliding windows, and single-leaf, flush wood doors with lights. Each opening is topped by a three-course, rowlock brick segmental arch.

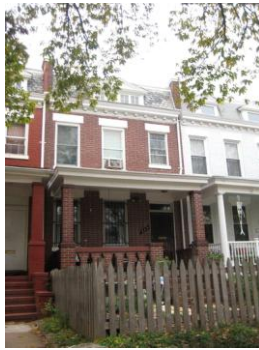
Path: C:\Users\CHRS\Documents\CHRS  
Databases\Capitol Hill Phase 1D - 11 to 15th  
St\Database\Pictures\Square 1033NW - Re-  
Sized\  
File: 230\_Tennessee\_Avenue\_SE\_facade\_looking\_  
NW.JPG

**October 2010: Constructed in 1912 by Harry A. Kite, this two-story, three-bay Classical Revival-style single-family rowhouse is one of twelve similar dwellings constructed from the same permit (#1571). Set on a solid concrete foundation, this brick dwelling is faced with Flemish-bond brick. A sloping roof caps the building and is complemented by a false mansard roof. Slate shingles cover the false mansard roof, which is accented by a molded metal cornice with block modillions. A pedimented dormer marks the false mansard roof and holds paired four-light wood casement windows. An exterior-rear brick chimney rises from the northwest elevation and has a plain cap. The façade (southeast elevation) is fenestrated with a single-leaf door (surmounted by a single-light transom) and 1/1 double-hung, vinyl-sash windows. Each opening is topped by a concrete lintel. A one-story, full-width porch spans the facade and is set on a brick pier foundation with brick infill. A three-light wood window pierces the foundation of the porch. The flat roof, featuring overhanging eaves, is supported by brick posts. Brick balusters finish the porch. The rear (northwest) elevation is fenestrated with 1/1, double-hung, vinyl-sash windows.**

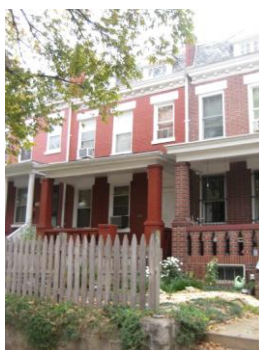
Path: C:\Users\CHRS\Documents\CHRS  
Databases\Capitol Hill Phase 1D - 11 to 15th  
St\Database\Pictures\Square 1033NW - Re-  
Sized\  
File: 228\_Tennessee\_Avenue\_NE\_looking\_W.JPG  
Date:: Photog:  
Code:: R: Fr:

**October 2010:** Constructed in 1912 by Harry A. Kite, this two-story, three-bay Classical Revival-style single-family rowhouse is one of twelve similar dwellings constructed from the same permit (#1571). Set on a solid concrete foundation, this brick dwelling is faced with Flemish-bond brick. A sloping roof caps the building and is complemented by a false mansard roof. Slate shingles cover the false mansard roof, which is accented by a molded metal cornice with block modillions. Two pedimented dormers mark the false mansard roof and each holds a multi-light wood awning window. An exterior-rear brick chimney rises from the northwest elevation and has a plain cap. The façade (southeast elevation) is fenestrated with a single-leaf door (surmounted by a single-light transom) and 1/1 double-hung, vinyl-sash windows. Each opening is topped by a concrete lintel. A one-story, full-width porch spans the facade and is set on a brick pier foundation with brick infill. The flat roof, featuring overhanging eaves, is supported by brick posts set upon brick pedestals. Brick balusters finish the porch.

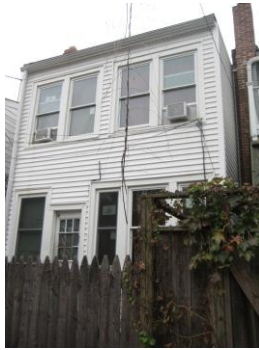
Path: C:\Users\CHRS\Documents\CHRS  
Databases\Capitol Hill Phase 1D - 11 to 15th  
St\Database\Pictures\Square 1033NW - Re-  
Sized\  
File: 228\_Tennessee\_Avenue\_NE\_rear\_looking\_E.j  
pg

A two-story enclosed porch, capped by a sloping roof, extends from the rear elevation of the dwelling. The wood-frame enclosed porch is clad with vinyl siding and is set on a brick pier foundation with concrete block infill. Visible fenestration consists of a single-leaf, paneled metal door with lights and 1/1, double-hung, vinyl-sash windows.

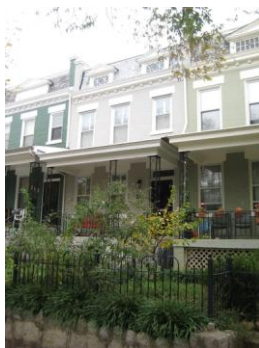
Path: C:\Users\CHRS\Documents\CHRS  
Databases\Capitol Hill Phase 1D - 11 to 15th  
St\Database\Pictures\Square 1033NW - Re-  
Sized\  
File: 220\_Tennessee\_Avenue\_NE\_looking\_W.JPG  
Date:: Photog:  
Code:: R: Fr:

**October 2010:** Constructed in 1912 by Harry A. Kite, this two-story, three-bay Classical Revival-style single-family rowhouse is one of twelve similar dwellings constructed from the same permit (#1571). Set on a solid concrete foundation, this brick dwelling is faced with Flemish-bond brick. A sloping roof caps the building and is complemented by a false mansard roof. Slate shingles cover the false mansard roof, which is accented by a molded metal cornice with block modillions. Two pedimented dormers mark the false mansard roof and each holds a multi-light wood window. An exterior-rear brick chimney rises from the northwest elevation and has a plain cap. The façade (southeast elevation) is fenestrated with a single-leaf door (surmounted by a single-light transom) and 1/1 double-hung, vinyl-sash windows. Each opening is topped by a concrete lintel. A one-story, full-width porch spans the facade and is set on a brick pier foundation with decorative concrete block infill. The flat roof, featuring overhanging eaves, is supported by metal filigree posts. Metal balusters finish the porch. The rear (northwest) elevation is pierced by single-leaf, wood-frame glass doors and 1/1, double-hung, vinyl-sash windows. A three-course, rowlock brick segmental arch tops each opening.
