Resource All Data Report

Rowhouse, 1418 G Street, N.E. **Common**

Capitol Hill - Phase 1D

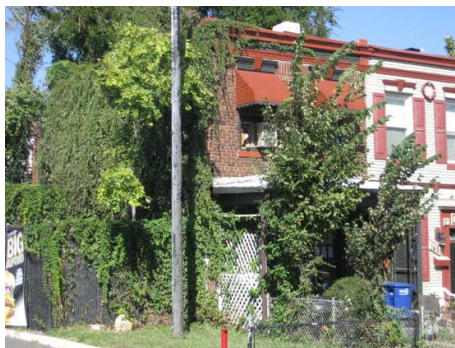
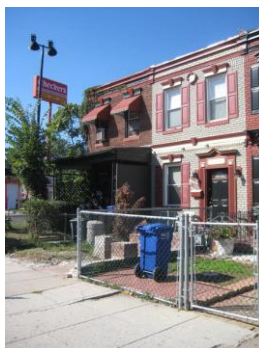
Purpose: **Rowhouse** Condition: **Good**

October 2010: This two-story, two-bay rowhouse was constructed in 1916 by owner/builder George T. and George Y. Worthington. Designed by A.E. Landvoigt, this building is one of four similar rowhouses constructed from the same permit (#5646). The Colonial Revival-style dwelling is constructed of five-course, American-bond brick and is capped by a sloping roof edged with a molded metal cornice. A molded metal stringcourse lines the bottom edge of the frieze. Fenestration consists of 1/1, double-hung, vinyl-sash windows with concrete lug sills and a single-leaf entry. Openings on the façade (south elevation) are capped by molded pediments and upper-story openings are sheltered by metal awnings. A basketweave brick stringcourse serves as a continuous lintel on the upper story. A one-story, one-bay porch shelters the first story of the dwelling. The shed roof is supported by metal filigree posts. The rear (north) elevation was not accessible.

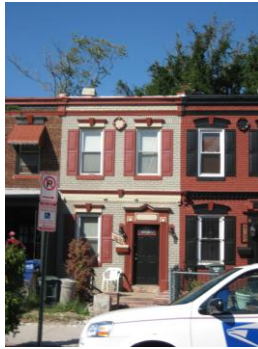
Purpose: **Rowhouse** Condition: **Good**

October 2010: This two-story, two-bay rowhouse was constructed in 1916 by owner/builder George T. and George Y. Worthington. Designed by A.E. Landvoigt, this building is one of four similar rowhouses constructed from the same permit (#5646). The Colonial Revival-style dwelling is constructed of five-course, American-bond brick and is capped by a sloping roof edged with a molded metal cornice. A molded metal stringcourse lines the bottom edge of the frieze. Fenestration consists of 1/1, double-hung, vinyl-sash windows with concrete lug sills and molded pediments with keystones and a single-leaf entry. Window openings are edged with inoperable paneled shutters and the entry is edged with a Colonial Revival-style surround composed of paneled pilasters and a pediment with a paneled frieze. A basketweave brick stringcourse serves as a continuous lintel on the upper story and an intermediate molded metal cornice with dentils and a keystone is located above the first-story openings. The rear (north) elevation was not accessible.

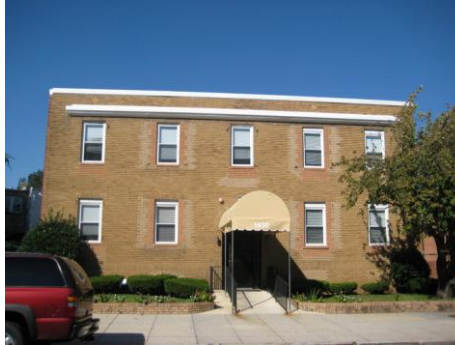
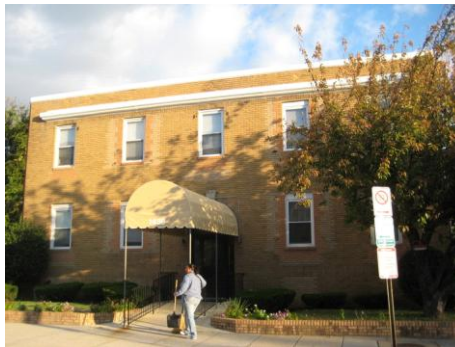
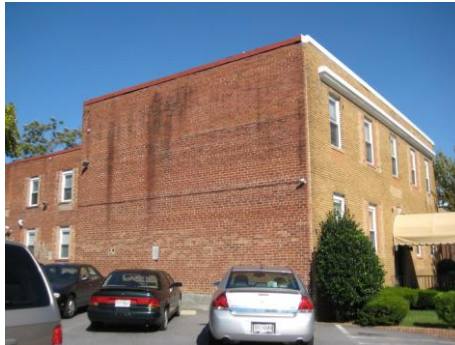
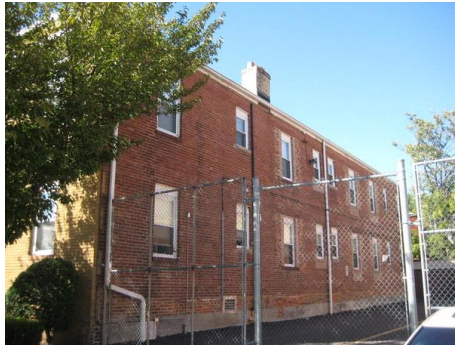
October 2010: This two-story, five-bay apartment building was constructed in 1925 by owner/builder G.H. Swann. Designed by George T. Santmyers, this building is a restrained interpretation of the Colonial Revival style. Set on a solid concrete foundation that is parged, the building is constructed of six-course, American-bond brick faced with stretcher-bond brick on the façade (south elevation). The 12-unit building has an L-shaped form with a two-story ell on the rear (north) elevation. The flat roof has a parapet with metal coping and is pierced by an interior-side brick chimney with a plain cap. The frieze is ornamented with diamonds laid in brick and a molded metal cornice with a basketweave brick stringcourse is located above the second-story openings. A soldier-brick stringcourse capped by a rowlock brick stringcourse lines the watertable level of the building. The building is fenestrated with 1/1, double-hung, vinyl-sash windows with brick rowlock sills and soldier-brick lintels and a single-leaf metal-frame class door edged with one-light sidelights and capped by a semicircular transom with a soldier-brick surround. A fabric canopy extends from the entry and shelters the walkway in front of the building. Window openings on the side elevations have brick rowlock sills. The rear elevation was not accessible.

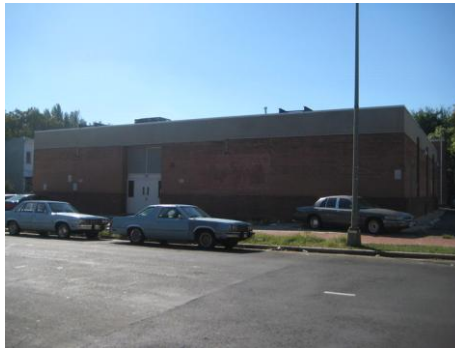
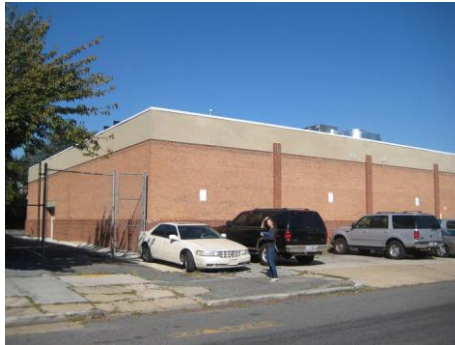
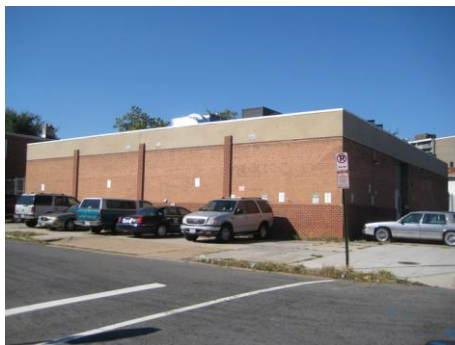
Purpose: **Medical facility** Condition: **Fair**

October 2010: This one-story square building was constructed ca. 1985. Set on a solid concrete foundation faced with brick, the concrete-block structure is faced with stretcher-bond brick. The flat roof is edged with metal coping and has a parged frieze. Brick buttresses line the side (north and side) elevations, which have no fenestration. Double-leaf doors are located on the façade (east elevation) and rear (west) elevation. The opening on the façade is edged with sidelights and capped by a tall two-light transom. The 1999 Sanborn Insurance map indicates the building was used as the Maternity, Infant, and Child Center for the D.C. Department of Health. According to the Real Property database, the property is currently privately owned and is used for medical/commercial purposes.

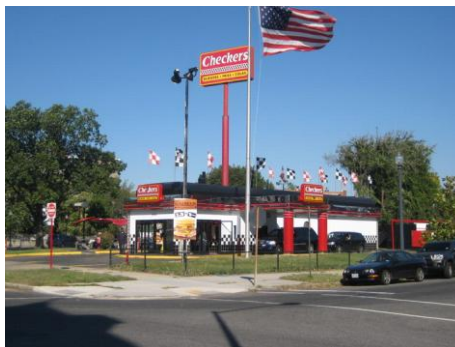
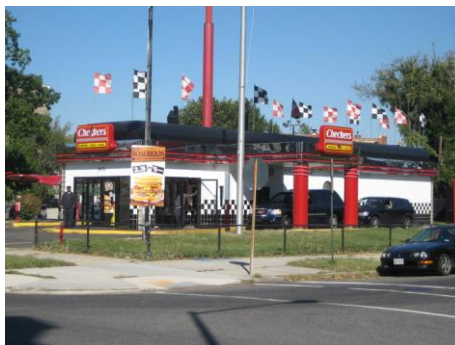
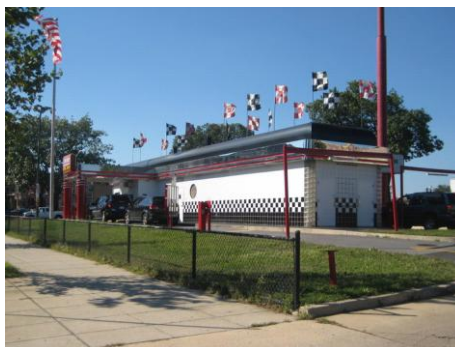
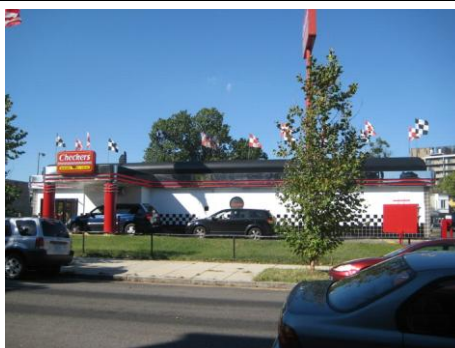
October 2010: This one-story, one-bay building was constructed ca. 1995. The rectangular concrete-block structure is capped by a flat roof with metal coping and a stainless-steel frieze ornamented with neon lights. The lower half of the secondary elevations are faced with glazed black and white tiles laid in a checkerboard pattern. The building is fenestrated with paired one-light metal sliding windows, fixed metal windows, and single-leaf doors. The cross shape of the building is formed by two drive-throughs that extend from the side (north and south) elevations of main block. The flat roofs of the one-story drive-throughs are supported by concrete pillars.

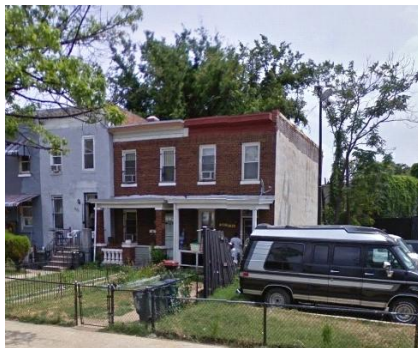
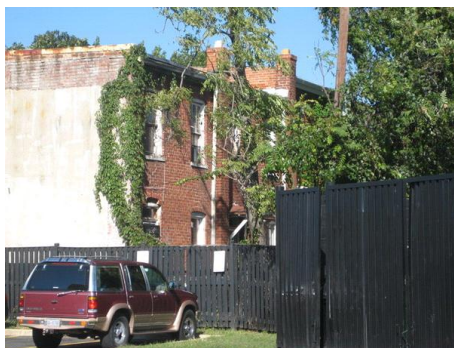
October 2010: This two-story, two-bay single dwelling was constructed in 1916 by owner/builders George Y. and George Y. Worthington. Designed by A.E. Landvoigt, the building is one of two similar dwellings constructed from the same permit (#5647). The Colonial Revival-style building sits on a solid concrete foundation and is constructed of five-course American-bond brick. The west (side) elevation is parged. The sloping roof has a boxed cornice and a basketweave brick frieze. Fenestration consists of 1/1, double-hung, vinyl-sash windows with concrete lug sills and a single-leaf entry with a one-light transom. The first story is sheltered by a one-story, one-bay full-width porch. Set on a solid concrete foundation, the porch has a flat roof supported by square wood posts. The rear (south) elevation has an exterior brick chimney with a plain cap. Windows hold 2/2, double-hung, wood sash with concrete lug sills. Openings on the rear, including the single-leaf entry, have two-course rowlock brick segmental arches.

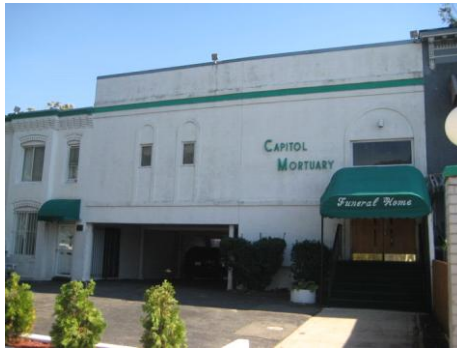
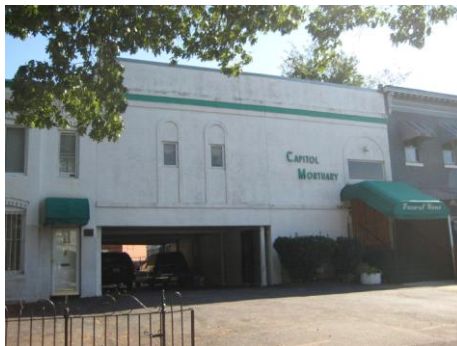
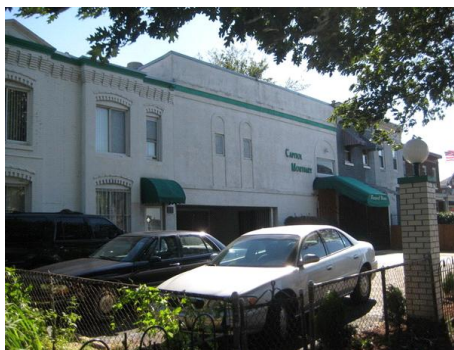
October 2010: This two-story, two-bay building was constructed in 1931 as a single dwelling by Lemke & Thornton for owner Anthony Curto. Designed by W.A. Loveless, the brick building sits on a raised solid brick foundation and is parged on the façade (north elevation). The flat roof is edged with metal coping and concrete bands line the lower edge of the frieze. The building is fenestrated on the façade with double-leaf doors capped by a one-light transom with a blind semicircular transom above. The entry is sheltered by a fabric awning. Post 1960, the adjacent dwelling at 1427 was demolished and a two-story addition was constructed on the east (side) elevation. The masonry structure has an open first story that serves as a carport and drive-through to the rear parking lot. The addition has the same material treatment as the main block. The façade is fenestrated with two one-light vinyl casement windows over a plain spandrel. Each window has a parged surround and a blind round-arched transom. The rear (south) elevation was not accessible.

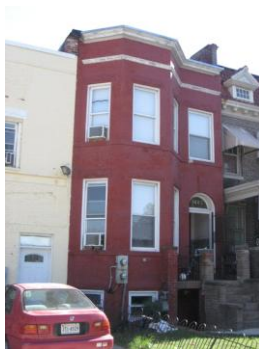
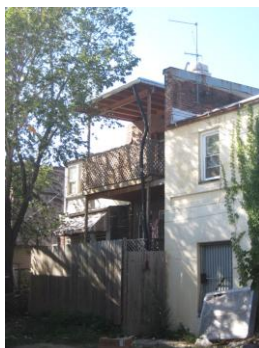
October 2010: This two-story, two-bay single dwelling was constructed in 1912 by Henry Wahl for Mrs. Julia A. Lauxman (permit #4618). Designed by Julius Wenig, the building blends the Queen Anne style with minimal influence of the Romanesque Revival style. The building is composed of a rectangular main block with a three-sided canted bay on the façade (north elevation) and a two-story ell on the rear (south) elevation. Set on a solid raised concrete foundation, the brick building is faced with stretcher-bond brick. The sloping roof is ornamented with a molded metal cornice. Fenestration consists of 1/1, double-hung, vinyl-sash windows with concrete lug sills and rock-faced concrete lintels and a single-leaf entry with a semicircular transom. The entry has a gauged brick surround with a keystone and imposts. A molded metal stringcourse lines the lower edged of the frieze and two-course brick stringcourses serve as continuous sills on the façade. A two-story porch is located on the rear elevation. It has a shed roof supported by square woos posts and a lattice balustrade on both stories. No other details were visible.

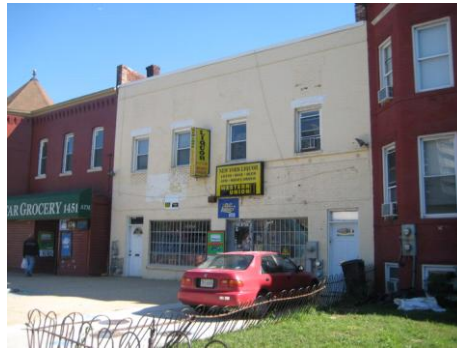
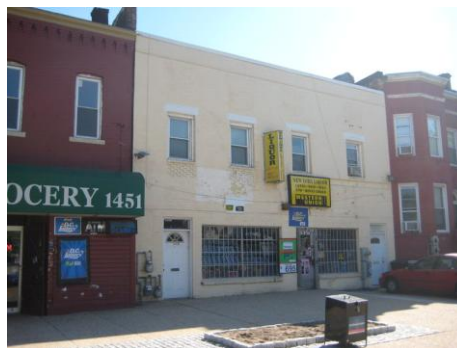
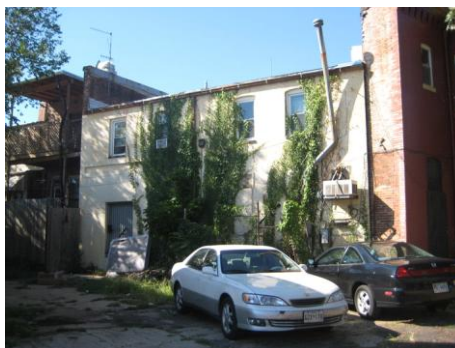
October 2010: This two-story, three-bay commercial building was constructed in 1908 by Jones & Peters Construction Company for the Dickey Brothers. Designed by John C. Deichmann, the building's original use was a feed store (permit #2536). Set on a solid concrete foundation, this brick building is faced with stretcher-bond brick and is capped by a sloping roof with metal coping. The fenestration of the building has been altered on both stories. The first story contains three single-leaf entries with one-light transoms (one in each bay) and large multiple-light fixed and hopper metal windows with brick rowlock sills. The upper story contains 1/1, double-hung, vinyl-sash windows that sit on a checkerboard brick spandrel and have a concrete lug lintel. The openings have either been shortened or moved, as brick infill is visible above the windows. The rear elevation is parged and is fenestrated with 1/1, double-hung, vinyl-sash windows and single-leaf entries.

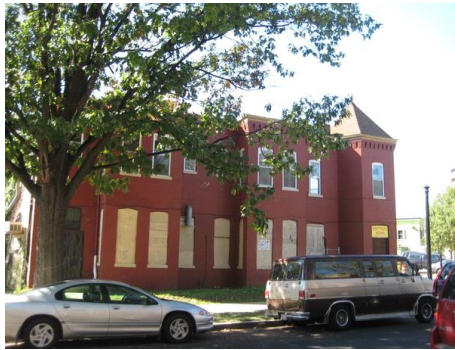
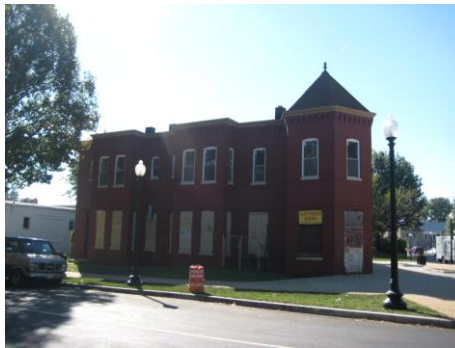
October 2010: This two-story, three-bay building was constructed in 1901 by Frank J. Hessler for Henrietta Adams. Designed by Harry B. Davis, the Queen Anne-style building was originally constructed as a store and residence (permit #1938). The building is composed of a triangular main block with a two-story polygonal bay on the northeast corner and two rectangular projecting bays on the east (side) elevation. The brick building sits on a solid concrete foundation and is faced with stretcher-bond brick. It has a sloping roof pierced by three interior brick chimneys with plain caps and is edged with a molded metal cornice with brick corbeling. The corner bay is capped by an asphalt-shingled pyramidal roof with a metal finial. The original entry on the first story of the corner bay and all first-story window and door openings on the east elevation have been boarded with plywood. The main entry is now located on the north elevation and is flanked by one-story projecting bays covered with corrugated metal. A fabric awning spans the north elevation. Upper-story openings hold 1/1, double-hung, vinyl-sash windows with concrete lug sills and three-course rowlock brick segmental arches. A two-course brick stringcourse serves as a continuous sill on the upper story.
