Resource All Data Report

ID Number: 1054-0217

1400 **C Street** **NE** **Current**

Rowhouse, 1400 C Street, N.E. **Common**

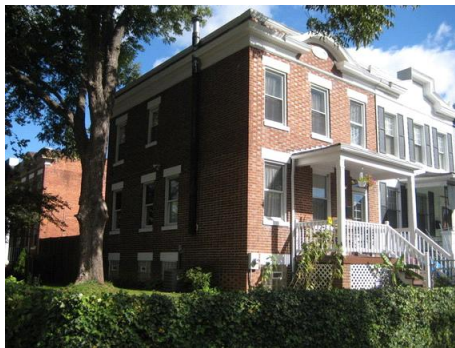
Path: C:\Users\CHRS\Documents\CHRS
Databases\Capitol Hill Phase 1D - 11 to 15th
St\Database\Pictures\Square 1054 - Re-Sized\
File: 1400_C_Street_NE_facade_looking_NE.JPG
Date:: Photog:
Code:: R: Fr:

October 2010: Constructed in 1910 by Samuel Masson, this two-story, three-bay Classical Revival-style single-family rowhouse is one of 23 similar rowhouses constructed from the same permit (#6666). Set on a solid concrete foundation, this brick dwelling is faced on the façade (south elevation) with Flemish-bond brick. A sloping roof caps the dwelling and is fronted by a brick parapet wall. A molded metal cornice with thin dentils and a fascia board extends across the façade and down the west (side) elevation. A segmental open pediment rises from the center of the cornice on the façade. An exterior-rear brick chimney with plain cap is located on the north elevation. The easternmost bay on the façade holds a single-leaf, paneled wood door, which is topped by a single-light transom and concrete lug lintel. Window openings hold 1/1, double-hung, vinyl sash with concrete sills and lug lintels. A one-story, one-bay porch projects from the façade. Set on a brick pier foundation with lattice infill, the porch has a half-hipped roof of asphalt shingles supported by channeled wood posts. Square balusters encircle the porch, which is accessed via brick-clad steps. The west (side) elevation is fenestrated with 1/1, double-hung, vinyl-sash windows with concrete sills and lug lintels. Glass block fills the basement openings. The north (rear) elevation has 1/1, double-hung, vinyl-sash windows with concrete sills. A combination door/window opening holds a single-leaf, multi-light door with single-light transom and a 1/1 window. All openings have two-course, rowlock brick segmental arches.

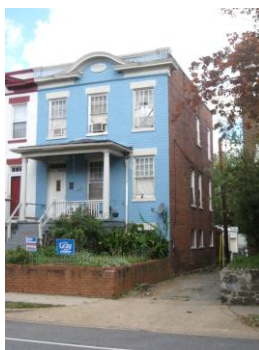
Path: C:\Users\CHRS\Documents\CHRS
Databases\Capitol Hill Phase 1D - 11 to 15th
St\Database\Pictures\Square 1054 - Re-Sized\
File: 1408_C_Street_NE_facade_looking_NW.jpg
Date:: Photog:
Code:: R: Fr:

October 2010: Constructed in 1910 by Samuel Masson, this two-story, three-bay Classical Revival-style single-family rowhouse is one of 23 similar rowhouses constructed from the same permit (#6666). Set on a solid raised concrete foundation, this brick dwelling is faced on the façade (south elevation) with Flemish-bond brick. A sloping roof caps the dwelling and is fronted by a brick parapet wall. A molded metal cornice with thin dentils and a fascia board extends across the façade and features a segmental open pediment with returns rising from the center. An exterior-rear brick chimney with plain cap is located on the north elevation. The westernmost bay on the façade holds a single-leaf, paneled wood door with light topped by a single-light transom and concrete lug lintel. Window openings hold 12/1, double-hung, wood sash with concrete sills and lug lintels. A one-story, one-bay porch is located on the façade. Set on a brick pier foundation with lattice infill, this wood porch has a half-hipped, asphalt-shingled roof with overhanging eaves. Tuscan columns support the roof while square wood balusters front the porch. The east (side) elevation has 2/2, double-hung, wood-sash windows with concrete sills and two-course, rowlock brick segmental arches. The north (rear) elevation, faced with five-course, American-bond brick, has 2/2, double-hung, wood-sash windows with concrete sills and two-course, rowlock brick segmental arches. A combination door/window opening holds a single-leaf, paneled metal door with multi-lights topped by a two-light transom flanked to the east by a 1/1, double-hung, vinyl-sash windows with 6/6 false muntins. A two-course, rowlock brick segmental arch completes the opening.

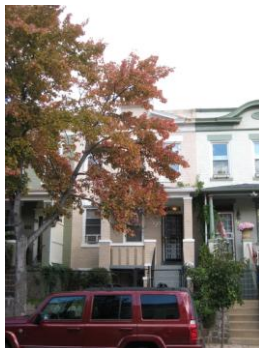
Path: C:\Users\CHRS\Documents\CHRS
Databases\Capitol Hill Phase 1D - 11 to 15th
St\Database\Pictures\Square 1054 - Re-Sized\
File: 1414_C_Street_NE_facade_looking_N.JPG
Date:: Photog:
Code:: R: Fr:

October 2010: Constructed in 1910 by Samuel Masson, this two-story, three-bay Classical Revival-style single-family rowhouse is one of 23 similar rowhouses constructed from the same permit (#6666). Set on a solid concrete foundation, this brick dwelling is faced on the façade (south elevation) with Flemish-bond brick. A sloping roof caps the dwelling and is fronted by a brick parapet wall. A molded metal cornice with a stepped pediment rises from the center of the cornice, revealing a single-light, fixed window. An exterior-rear brick chimney with plain cap is located on the north elevation. The façade is pierced by 1/1, double-hung, vinyl-sash windows with concrete sills and lug lintels. A single-leaf wood door is located in the easternmost bay and topped by a single-light transom. A one-story, one-bay porch adorns the façade. Set on a brick pier foundation, the porch is capped by a half hipped roof with overhanging eaves. Brick columns support the roof while brick balusters encircle the porch. The north (rear) elevation has a two-story porch capped by a shed roof. The porch is enclosed with vinyl and aluminum siding and pierced by 1/1, double-hung, vinyl-sash windows with 6/6 false muntins.

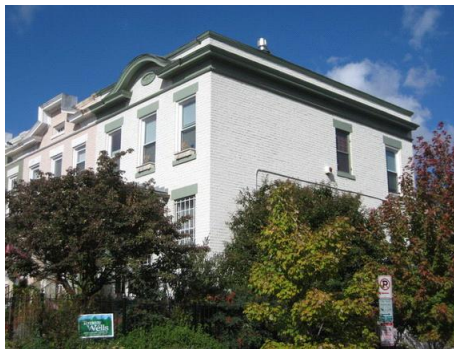
Path: C:\Users\CHRS\Documents\CHRS
Databases\Capitol Hill Phase 1D - 11 to 15th
St\Database\Pictures\Square 1054 - Re-Sized\
File: 1416_C_Street_NE_facade_looking_NE.jpg
Date:: Photog:
Code:: R: Fr:

October 2010: Constructed in 1910 by Samuel Masson, this two-story, three-bay Classical Revival-style single-family rowhouse is one of 23 similar rowhouses constructed from the same permit (#6666). Set on a solid raised concrete foundation, this brick dwelling is faced on the façade (south elevation) with Flemish-bond brick. A sloping roof caps the dwelling and is fronted by a brick parapet wall. A molded metal cornice with thin dentils and a fascia board extends across the façade and features a segmental open pediment with returns. The brick parapet and molded metal cornice extend down the east (side) elevation. An exterior-rear brick chimney with plain cap is located on the north elevation. The western bay on the façade holds a single-leaf, wood-frame door topped by a single-light transom and concrete lug lintel. Window openings hold 1/1, double-hung, vinyl sash with concrete sills and lug lintels. A one-story, two-bay porch is located on the façade. Set on a brick pier foundation with lattice infill, the porch has a half-hipped roof of asphalt shingles. Turned wood columns set on brick piers are accompanied by narrow wood balusters. Poured concrete steps access the porch deck. The east (side) elevation is fenestrated with 1/1, double-hung, vinyl-sash windows and a single-leaf, paneled wood door with lights. First- and second-story openings feature concrete sills and lug lintels. The north (rear) elevation has 1/1, double-hung, vinyl-sash windows with 2-course, rowlock brick segmental arches.

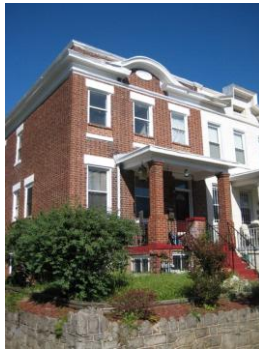
Path: C:\Users\CHRS\Documents\CHRS
Databases\Capitol Hill Phase 1D - 11 to 15th
St\Database\Pictures\Square 1054 - Re-Sized\
File: 1418_C_Street_NE_facade_looking_NE.JPG
Date:: Photog:
Code:: R: Fr:

October 2010: Constructed in 1910 by Samuel Masson, this two-story, three-bay Classical Revival-style single-family rowhouse is one of 23 similar rowhouses constructed from the same permit (#6666). Set on a solid raised concrete foundation, this brick dwelling is faced on the façade (south elevation) with Flemish-bond brick. A sloping roof caps the dwelling and is fronted by a brick parapet wall. A molded metal cornice with thin dentils and a fascia board extends across the façade and features a segmental open pediment with returns rising. An exterior-rear brick chimney with plain cap is located on the north elevation. The easternmost bay on the façade holds a single-leaf, paneled wood door with fanlight topped by a single-light transom and concrete lug lintel. Window openings hold 1/1, double-hung, vinyl sash with concrete sills and lug lintels. Second-story openings have been partially enclosed with brick to facilitate the installation of smaller-than-original replacement windows. Additional fenestration consists of a two-light, vinyl-sash basement window. A one-story, two-bay porch is located on the façade. Set on a brick pier foundation infilled with two-light, vinyl-sash windows, the porch has a half-hipped roof with overhanging eaves supported by brick columns. Metal balusters encircle the porch. The west (side) elevation has a full basement and is faced in Flemish-bond brick. The molded metal cornice and brick parapet are continued down the elevation off the façade. Window openings hold 1/1, double-hung, vinyl-sash windows with concrete sills and lintels. Some openings have been partially enclosed with brick while other feature 6/6 false muntins. Two-light, vinyl-sash sliding windows pierce the basement. A single-leaf, flush wood door with concrete lug lintel provides access to the basement.

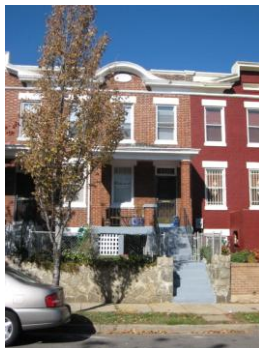
Path: C:\Users\CHRS\Documents\CHRS
Databases\Capitol Hill Phase 1D - 11 to 15th
St\Database\Pictures\Square 1054 - Re-Sized\
File: 1430_C_Street_NE_facade_looking_NE.JPG
Date:: Photog:
Code:: R: Fr:

October 2010: Constructed in 1910 by Samuel Masson, this two-story, three-bay Classical Revival-style single-family rowhouse is one of 23 similar rowhouses constructed from the same permit (#6666). Set on a solid raised concrete foundation, this brick dwelling is faced on the façade (south elevation) with Flemish-bond brick. A sloping roof caps the dwelling and is fronted by a brick parapet wall. A molded metal cornice with thin dentils and a fascia board extends across the façade and features a segmental open pediment with returns rising. An exterior-rear brick chimney with plain cap is located on the north elevation. The easternmost bay on the façade holds a single-leaf, paneled wood door with transom and concrete lug lintel. Window openings hold 12/1 double-hung, wood-sash windows and 1/1, double-hung, vinyl-sash windows. All have concrete sills and lug lintels. A one-story, two-bay porch is located on the façade. Set on a brick pier foundation with lattice infill, the porch has a half-hipped roof with overhanging eaves supported by brick columns. Metal balusters encircle the porch. The north (rear) elevation has 2/2, double-hung, wood-sash windows and 1/1, double-hung, vinyl-sash windows. Fixed-light windows pierce the basement. All openings have concrete sills and two-course, rowlock brick segmental arches. A single-leaf, paneled wood door with four lights and transom is located under the same segmental arch as a 2/2, double-hung, wood-sash window. This wide opening is sheltered by a one-story, one-bay porch set on a brick pier foundation. The porch has a metal awning roof supported by metal poles. Concrete steps provide access.
