Resource All Data Report

ID Number: 1046-0136

Single Dwelling, 1303 Potomac Avenue, S.E. Common

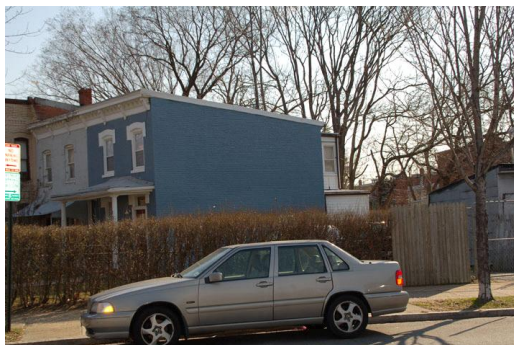
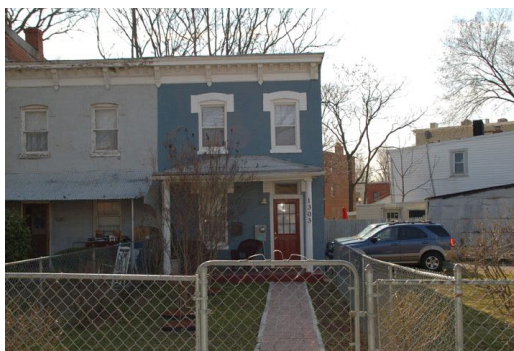
Path: C:\Users\CHRS\Documents\CHRS
Databases\SE Phase I - D to G
St\Database\Pictures\Square 1046\
File: 1303Potomac2_SE.JPG

November 2008: Constructed in 1878 for owner Daniel Dougherty, this two-story, two-bay Italianate-style single-family dwelling has a rectangular form. The dwelling is similar in style as 1305 Potomac Avenue, S.E.; both were constructed by Dougherty in the same year. The dwelling is constructed of brick and is set on a solid brick foundation. The brick coursing was not discernible from the public right-of-way because the brick has been painted. A sloping roof caps the dwelling and is enhanced by a molded cornice with scrolled modillions and brackets. The southwest bay of the façade (northwest elevation) holds a single-leaf paneled wood door with lights, a one-light rectangular transom. The door has a square-edged wood surround and is topped by a brick lintel hood. All window openings on the façade contain 1/1, double-hung, vinyl-sash windows with concrete sills and soldier brick segmental lintel hoods. A one-story, full-width porch spans the façade and is set on a solid poured concrete foundation. The half-hipped roof of the porch is covered with metal sheeting and is supported by Tuscan wood columns. The southwest (side) elevation does not have fenestration.

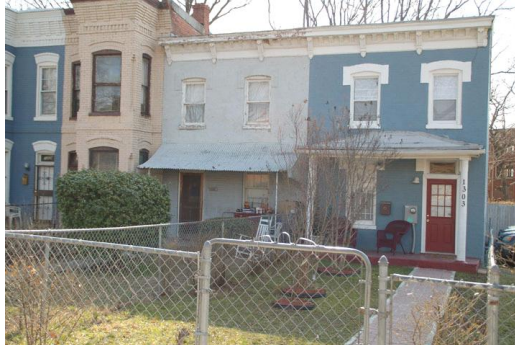
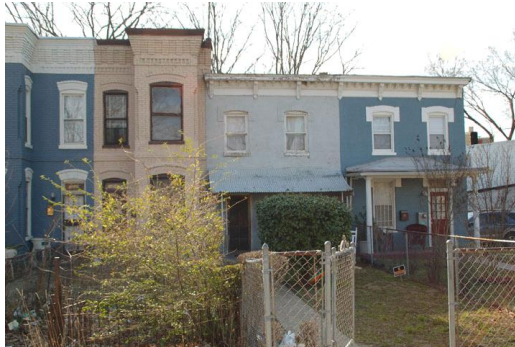
Path: C:\Users\CHRS\Documents\CHRS
Databases\SE Phase I - D to G
St\Database\Pictures\Square 1046\
File: 1305Potomac2_SE.JPG

November 2008: Constructed in 1878 for owner Daniel Dougherty, this two-story, two-bay Italianate-style single-family dwelling has a rectangular form. The dwelling is similar in style as 1303 Potomac Avenue, S.E.; both were constructed by Dougherty in the same year. The dwelling is constructed of brick and is set on a solid brick foundation. The brick coursing was not discernible from the public right-of-way because the brick has been painted. A sloping roof caps the dwelling and is enhanced by a molded cornice with scrolled modillions and brackets. The northeast bay of the façade (northwest elevation) holds a single-leaf paneled wood door and a one-light rectangular transom. All window openings on the façade contain 1/1, double-hung, wood-sash windows with concrete sills and soldier brick segmental lintel hoods. A one-story, full-width metal awning spans the façade and is set on a solid poured concrete foundation. Metal posts support the roof. The rear (southeast) elevation was not surveyed or photographed by the volunteer surveyor.
