HISTORIC AMERICAN BUILDING SURVEY DOCUMENTATION

CAPITOL PLACE, WASHINGTON, D.C.

September 2008

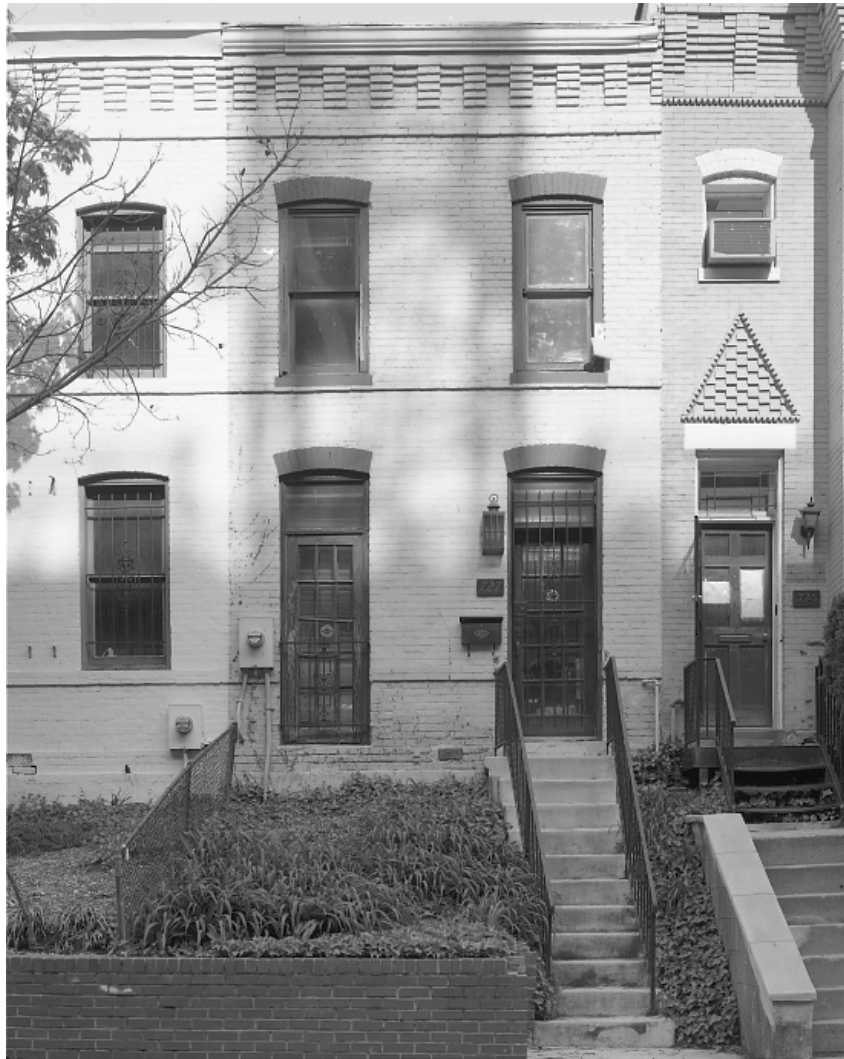
727 SECOND STREET, NORTHEAST, WASHINGTON, D.C.

- Location:** Northeast Quadrant, Square 752, Lot 856, Washington, D.C.
- Present Owner:** Station Townhouses, LLC, the Louis Dreyfus Property Group
- Present Use:** Vacant
- Significance:** Built circa 1887-1892, the row house at 727 Second Street is representative of modest brick row houses constructed in Washington, D.C. in the second half of the nineteenth century. Its brick construction, flat façade, and corbelled brick cornice are typical design elements of this housing type.

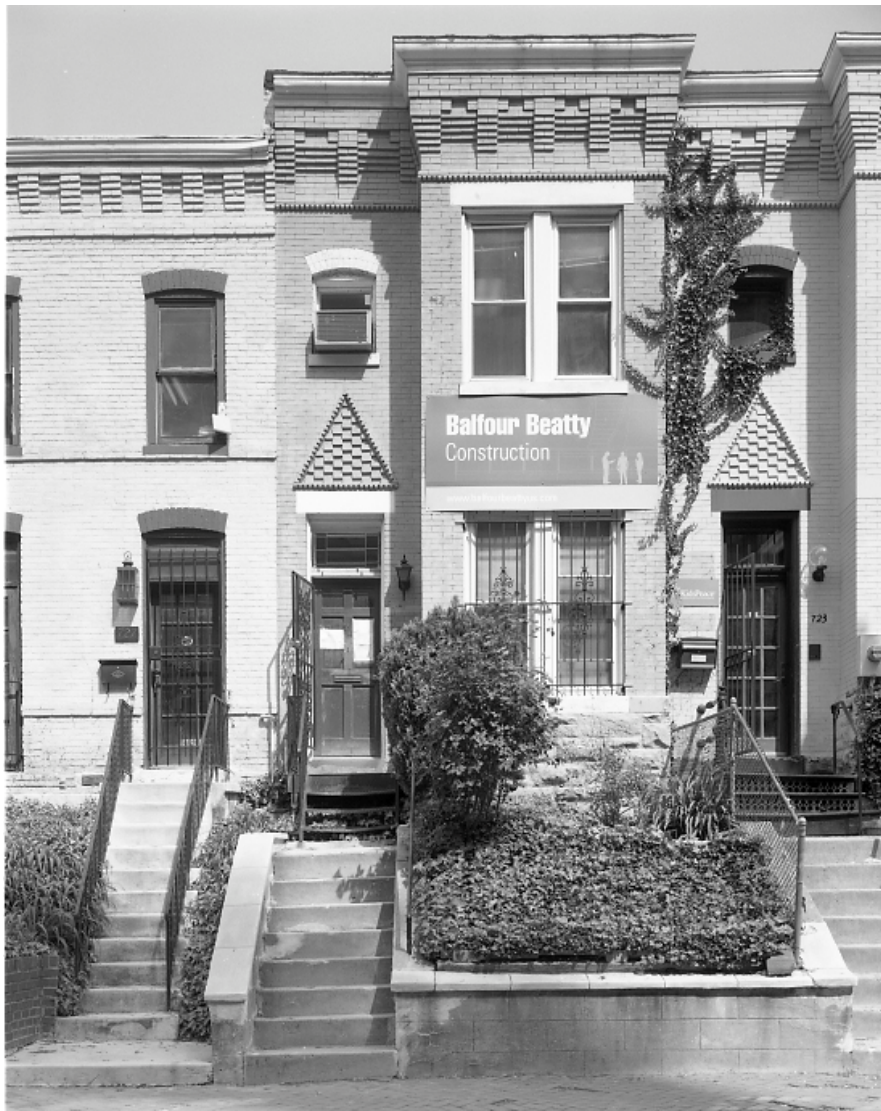
725 SECOND STREET, NORTHEAST, WASHINGTON, D.C.

- Location:** Northeast Quadrant, Square 752, Lot 811, Washington, D.C.
- Present Owner:** Station Townhouses, LLC, the Louis Dreyfus Property Group
- Present Use:** Offices
- Significance:** The row house at 725 Second Street is typical of modest two-story, projecting bay, brick row houses built during the late nineteenth century. It is representative of speculative building by developers during the building boom in Washington, D.C. during the latter decades of the nineteenth century. Diller B. Groff, a Washington, D.C. developer, constructed numerous row houses throughout the city in the latter decades of the nineteenth century.

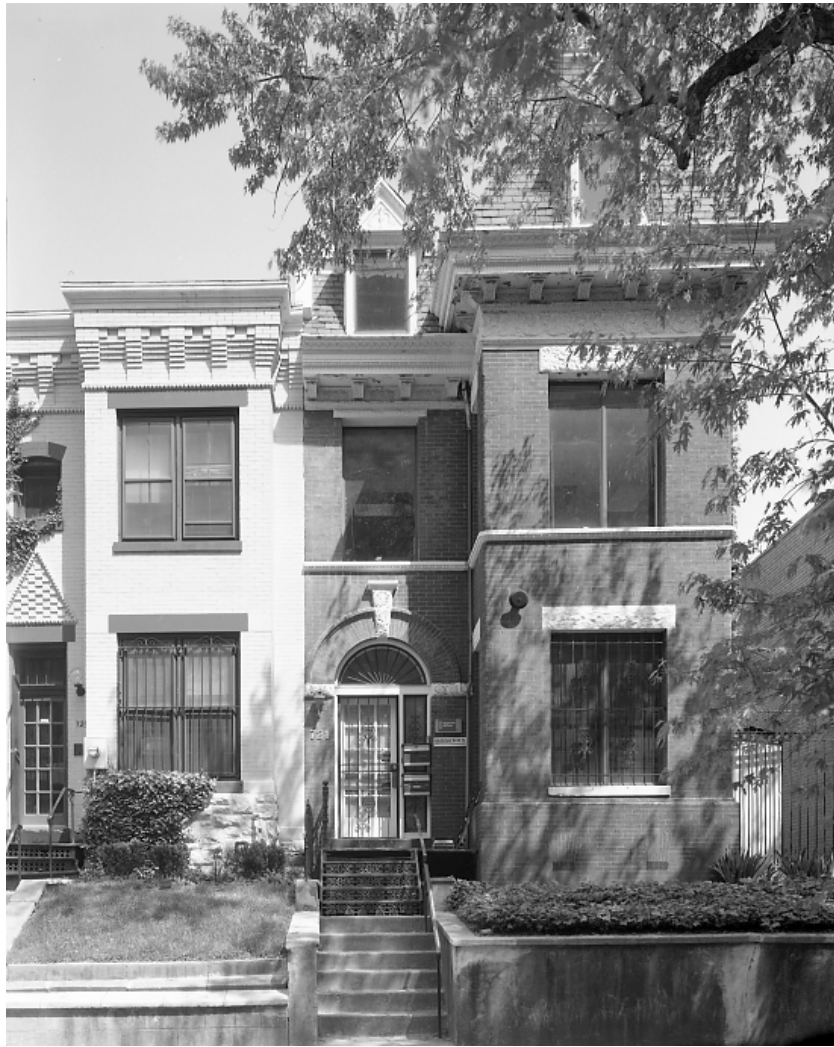
Significance: The single dwelling at 721 Second Street was the home and workshop of Albert S. Reavis for over thirty years. Reavis was a metalworker and crafted the metalwork for several well-known buildings around Washington, D.C. including the Wyoming Apartments and the Carnegie Library. It is likely that Reavis constructed the metalwork for his house as it is the only house on the block with an ornate metal cornice and other metal ornamentation. Compared to the more modest houses on the neighboring lots, the Queen Anne and Richardson Romanesque-influenced house is much more grand and elaborate.

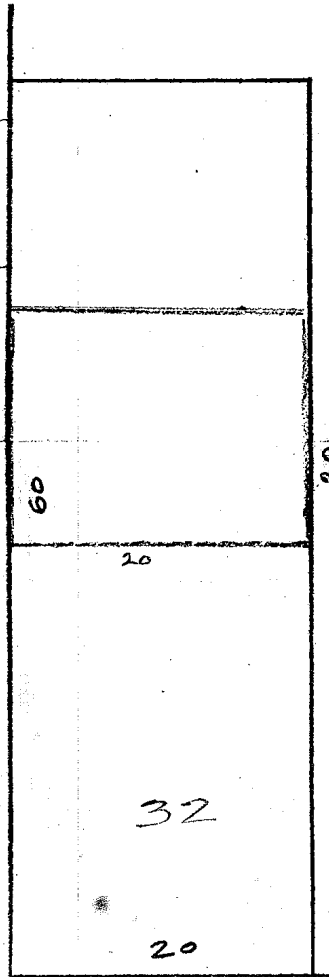
SOURCE: PERMIT # 2820, MARCH 18, 1908

2nd Street, East

Scale: 1 in. = 10 ft.

200 G Street, North

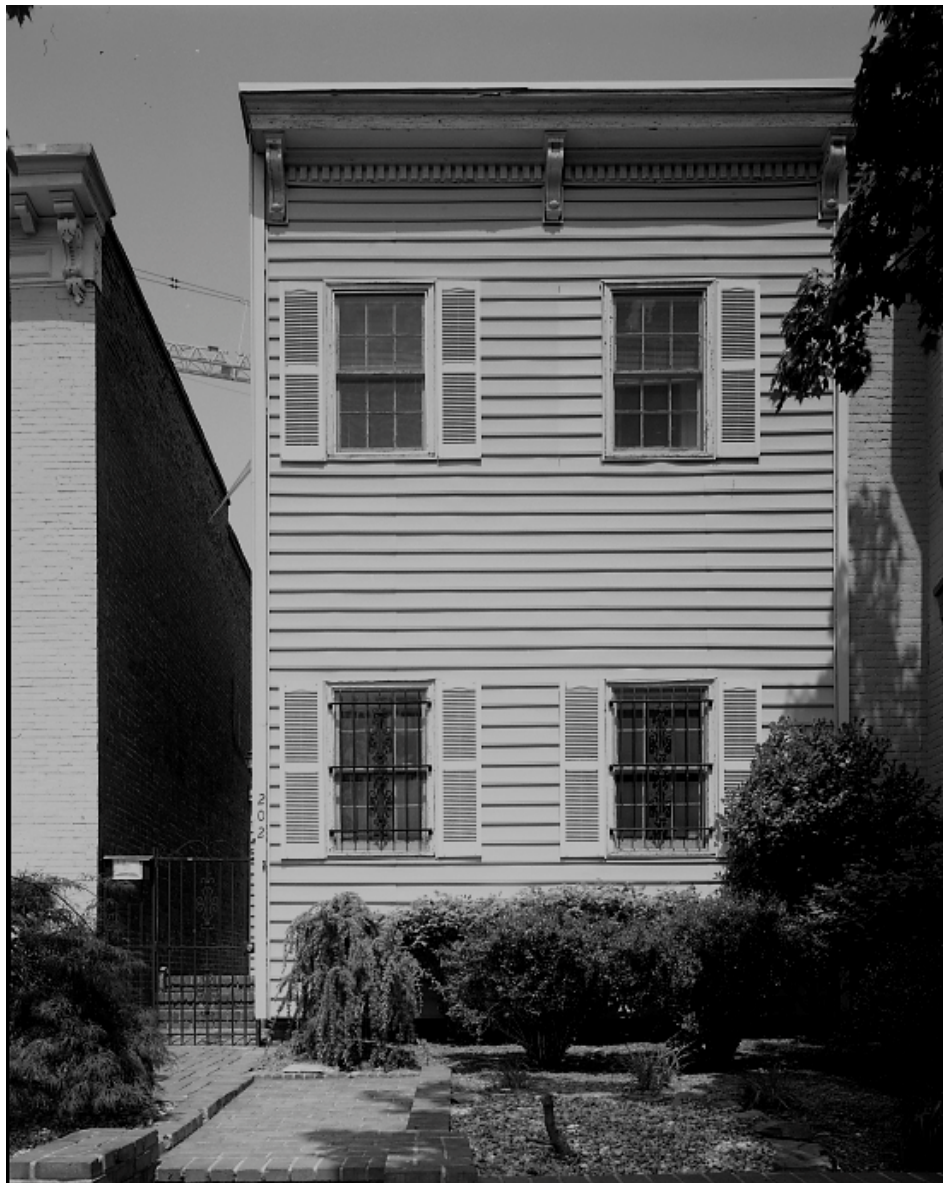
202 G STREET, NORTHEAST, WASHINGTON, D.C.

- Location:** Northeast Quadrant, Square 752, Lot 806, Washington, D.C.
- Present Owner:** Station Townhouses, LLC, the Louis Dreyfus Property Group
- Present Use:** Vacant
- Significance:** This circa 1876 single-family house is illustrative of a modest wood-frame urban dwelling constructed in the last quarter of the twentieth century. The house, with its flat façade and simple Italianate details, is one of the last frame houses to be constructed on the square prior to an act mandating all dwellings to be constructed of brick. Its irregular façade fenestration suggests that it might have been constructed with an adjacent two-story frame building at 204 G Street.

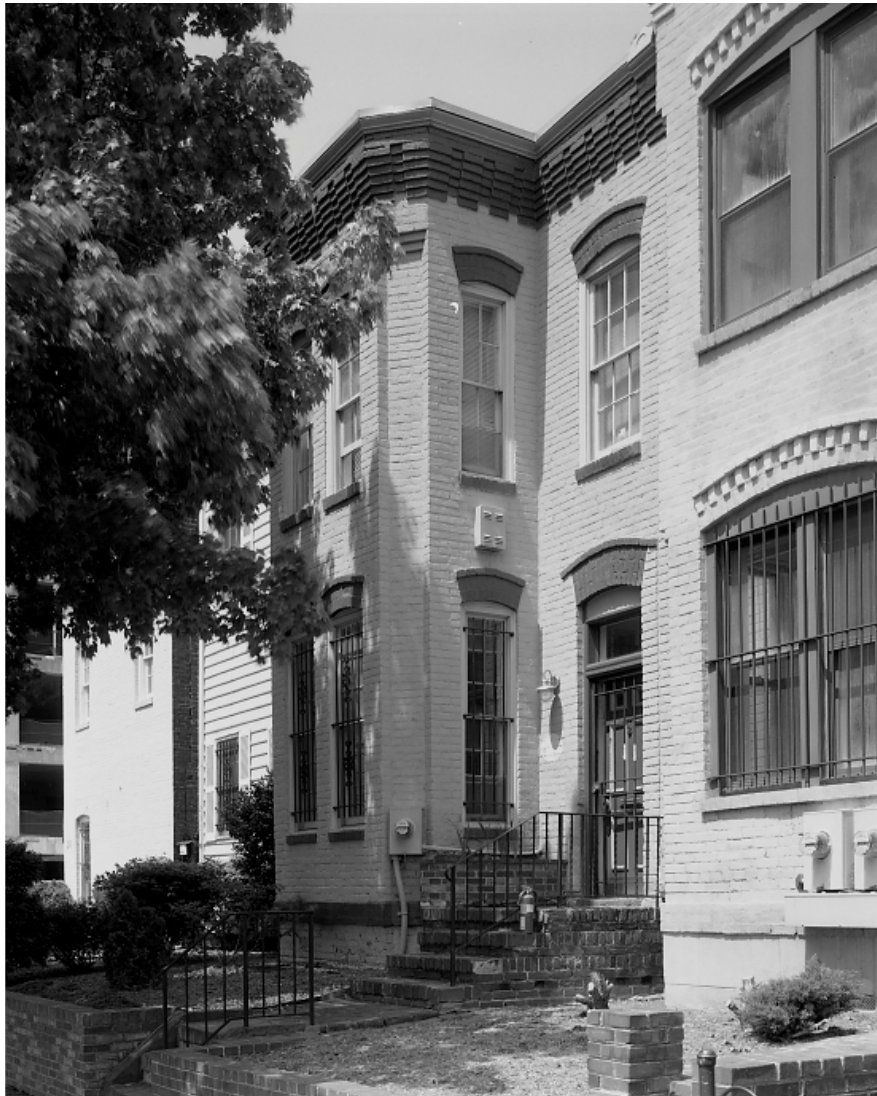
SIGNIFICANCE: The dwelling at 204 G Street is representative of the evolution of style and form of urban dwellings in Washington, D.C. from the mid to the late nineteenth century. The original building was a modest two-story frame dwelling constructed circa 1876-1877. It was built contemporary to 202 G Street and may have been used as an apartment to the adjacent house. The house was then enlarged by a more stylish Queen Anne-style brick addition in 1885.

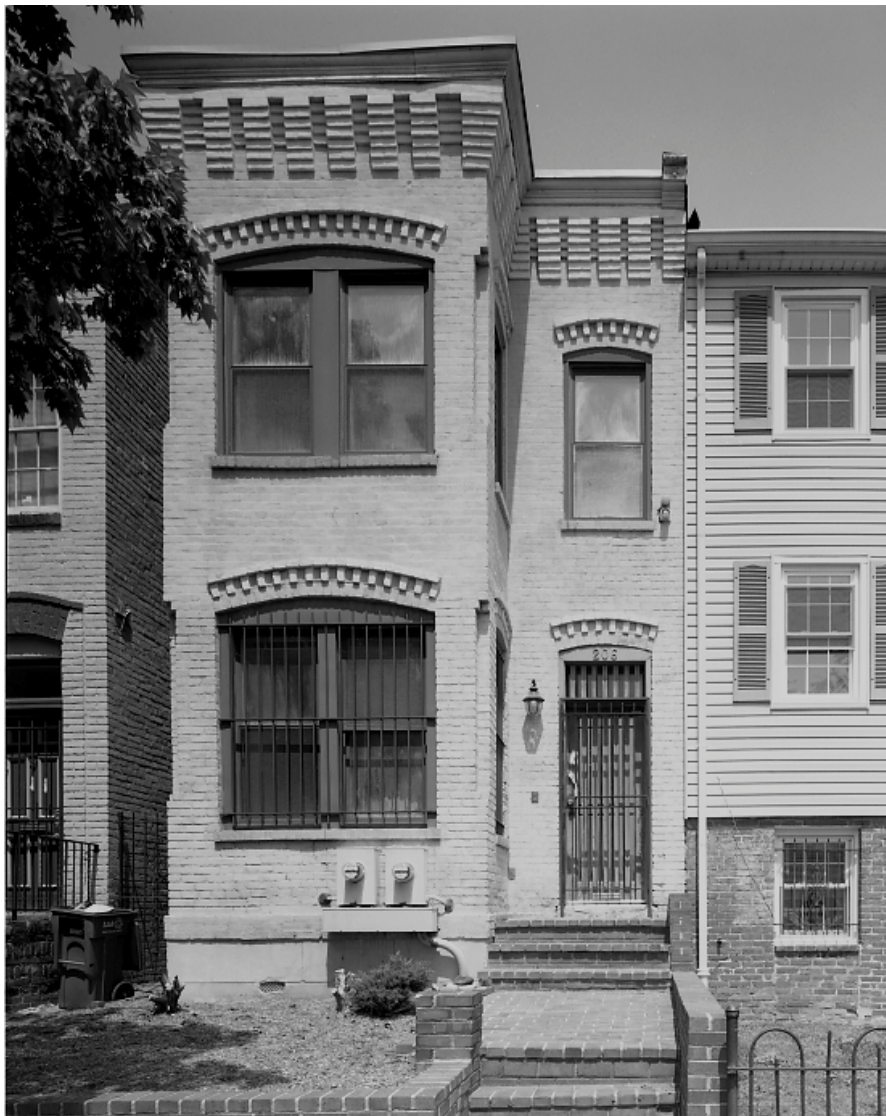
206 G STREET, NORTHEAST, WASHINGTON, D.C.

- LOCATION:** Northeast Quadrant, Square 752, Lot 804, Washington, D.C.
- PRESENT OWNER:** Station Townhouses, LLC, the Louis Dreyfus Property Group
- PRESENT USE:** Vacant
- SIGNIFICANCE:** This two-story brick dwelling is representative of brick working-class dwellings constructed in the latter decades of the nineteenth century. The two-story projecting bay on its façade and Italianate-style details are emblematic of row houses constructed in Washington, D.C. during the end of the nineteenth century.

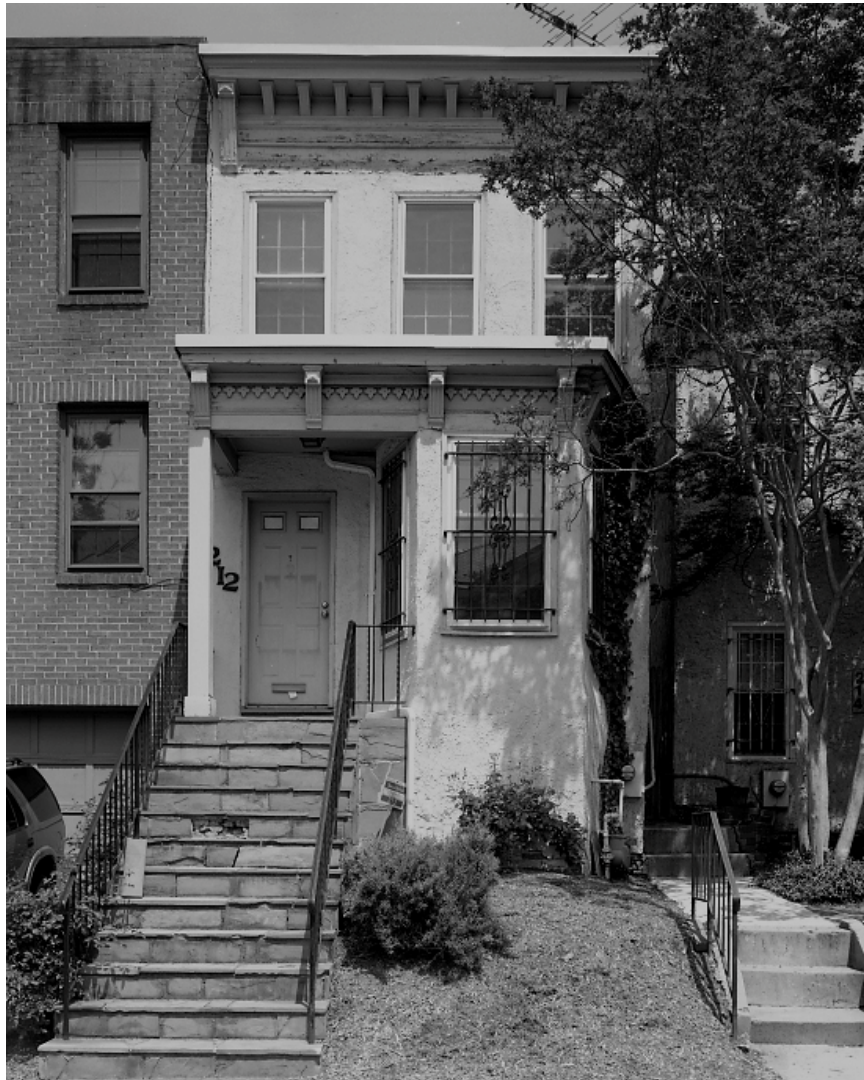
212 G STREET, NORTHEAST, WASHINGTON, D.C.

- Location:** Northeast Quadrant, Square 752, Lot 41 (802), Washington, D.C.
- Present Owner:** Station Townhouses, LLC, the Louis Dreyfus Property Group
- Present Use:** Vacant
- Significance:** The house at 212 G Street is exemplary of working-class urban housing constructed in Washington, D.C. mid-to-late nineteenth century. Unlike the majority of the houses in the neighborhood, this dwelling was constructed of wood frame (later covered in stucco) and was one of the earliest houses constructed on Square 752.

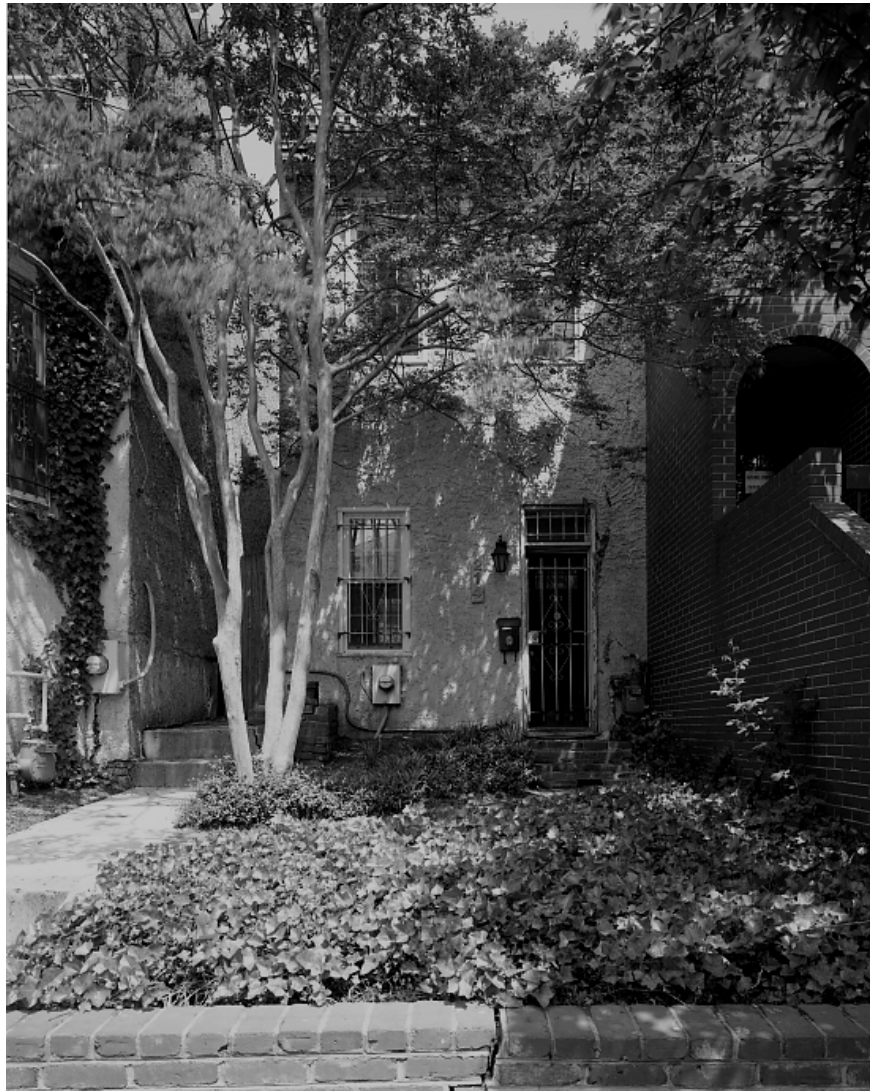
214 G STREET, NORTHEAST, WASHINGTON, D.C.

- Location:** Northeast Quadrant, Square 752, Lot 801 (previously part of Lot 3), Washington, D.C.
- Present Owner:** Station Townhouses, LLC, the Louis Dreyfus Property Group
- Present Use:** Vacant
- Significance:** This building, built circa 1855 is typical of modest frame dwellings constructed in the neighborhood of Swampoodle during the mid-nineteenth century. It is the oldest dwelling on the block and it appears to have been originally constructed as a twin dwelling. Its integrity has been compromised with the demolition of the adjacent dwelling at 216 G Street.
