Resource All Data Report

ID Number: 1063-0101

517 **Kentucky Avenue** **SE** **Current**

Rowhouse, 517 Kentucky Avenue, S.E. **Common**

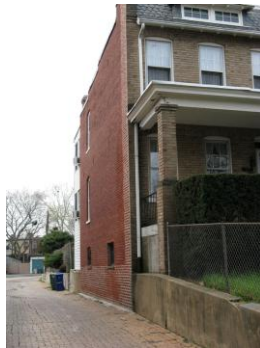
Path: **C:\Users\CHRS\Documents\CHRS
Databases\SE Phase I - D to G
St\Database\Pictures\Square 1063\
File: 517_KENTUCKYAVESE.JPG**

February 2008: Constructed in 1920 by T.A. Jameson, this two-story, three-bay Colonial Revival-style end unit rowhouse is one of nine similar rowhouses constructed from the same permit (#6106). The dwelling is constructed of brick and is set on a solid concrete foundation; the façade (northeast elevation) is faced with five-course, American-bond brick. A sloping roof caps the dwelling and is fronted along the façade by a false mansard roof. The false mansard roof is covered with fishscale slate shingles and features an overhanging eave with exposed rafter ends. A shed dormer projects from the false mansard roof and is covered with slate shingles. Overhanging eaves and exposed rafter ends complement the dormer, which is fenestrated with paired six-light wood windows (possibly awning). The northwestern bay of the first story holds a single-leaf paneled wood door with lights and a one-light rectangular wood transom. The transom is topped by a soldier brick segmental arch. A one-story, one-bay porch spans the façade and is set on a brick pier foundation. The roof of the porch has overhanging eaves and is supported by brick posts set on the brick piers. Metal balusters encircle the porch, which is accessed by a flight of poured concrete steps in the northwest end bay. All window openings on the façade hold 6/1, double-hung, wood-sash windows and have soldier brick segmental arches. The southeast (side) elevation is fenestrated with double-hung windows with concrete sills.

Roof Component	Material	Color	Treatment	Source
Mansard (False)	Slate		Fishscale Pattern	
Sloped	Not Visible		Not Visible	
Wall Component	Material	Color	Treatment	Source
Facade	Brick		American Bond	
Structure Component	Material	Feature		Source
Foundation	Concrete			
Walls	Brick

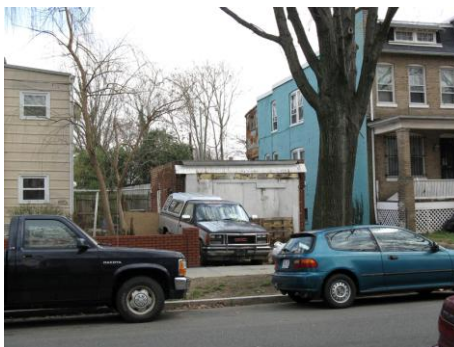
Path: C:\Users\CHRS\Documents\CHRS
Databases\SE Phase I - D to G
St\Database\Pictures\Square 1063\
File: 1401_ESTSE FROM 14STSE.JPG

March 2008: Constructed in 1897 by Charles W. King, this two-story, two-bay Italianate-style store and dwelling is the end unit and one of eleven similar rowhouses constructed from the same permit (#1530). The building is constructed of brick and is set on a solid concrete foundation; the façade (north elevation) and west (side) elevation are mostly faced with stretcher-bond pressed brick that has been painted. A sloping roof caps the dwelling and is fronted along the façade by a projecting cornice. A corbeled brick cornice runs along the west elevation. An interior-side brick chimney rises from the west elevation and has been painted. The first story opening on the façade holds a single-leaf paneled door and paired one-light fixed vinyl windows, which are topped by a band of one-light wood transoms. A square-edged wood surround highlights the opening which is spanned by a molded architrave with dentil molding. The second story window openings hold 1/1, double-hung, vinyl-sash windows and have concrete sills and lintels. The west elevation is fenestrated with 1/1, double-hung, vinyl-sash windows and have concrete sills and two-course, rowlock brick segmental arches. Additionally, a single-leaf door pierces the first story. A window opening and door opening on the first story have been infilled with plywood, though still retain their two-course, rowlock brick segmental arches.

A two-story, full-width block is located on the rear (south) elevation of the building and is noted on the 1928 Sanborn map. Possibly an original sleeping porch, the wood-frame block is clad with aluminum siding and is capped by a shed roof. Fenestration consists of 1/1, double-hung, vinyl-sash windows.

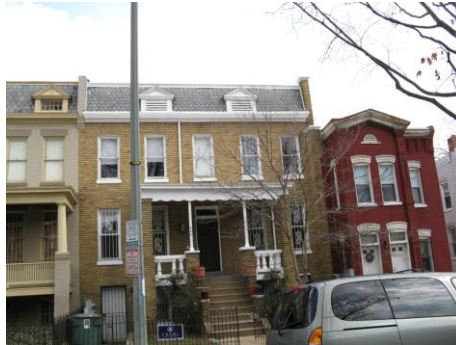
March 2008: Constructed in 1926 by H.E. Morris, this two-story, five-bay Colonial Revival-style single-family dwelling was designed by L.T. Burns. The dwelling is constructed of brick and is set on a solid concrete foundation; the façade (west elevation) is faced with five-course, American-bond brick. A sloping roof caps the dwelling and is fronted along the façade by a false mansard roof. The false mansard roof is covered with fishscale slate shingles and is complemented by a molded cornice with pearl molding. Two pedimented dormers project from the false mansard roof and feature raking wood cornices. Each dormer is pierced by a louvered wood vent. The northernmost bay of the foundation holds a single-leaf door. The central bay of the first story holds a single-leaf door and a one-light rectangular wood transom. All other openings on the façade hold 1/1, double-hung, wood-sash windows and have concrete sills. A one-story, three-bay porch shelters the primary entrance and flanking window openings and is set on a brick pier foundation. The roof of the porch has overhanging eaves, featuring scalloped trim, and is supported at the corners by brick posts. The interior bays are supported by square wood posts. Heavy balusters encircle the porch, which is accessed by poured concrete steps with brick wing walls in the central bay. The rear (east) elevation was not surveyed or photographed by the volunteer surveyor.

March 2008: This two-story dwelling is located on the east side of 14th Street, S.E. and is set back approximately ten feet from the concrete sidewalk. The dwelling is adjacent to 522 and 528-528 ½ 14th Street, S.E. The small front yard is landscaped with mature shrubs and foundation plantings and is encircled by a hairpin and picket metal fence. A short concrete walkway leads from the front steps of the dwelling and ends at the sidewalk. An alley is located at the rear of the property.
