# Resource All Data Report

**ID Number: 1077-0098**

**Rowhouse, 700 15th Street, S.E.** **Common**

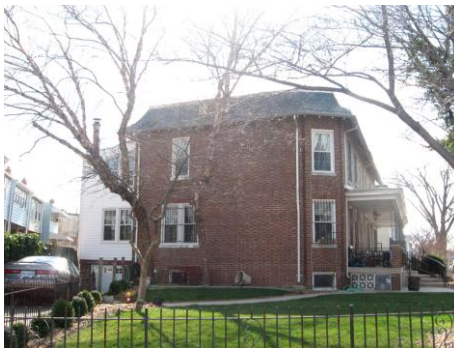
February 2008: Designed and constructed in 1915 by F.A. Norway, this two-story, two-bay, Colonial Revival-style single-family rowhouse is one of eight similar rowhouses constructed from the same permit (#0098). This dwelling is constructed of brick and is set on a solid concrete foundation. The dwelling is faced with Flemish-bond brick. The roofing type and material were not visible from the public right-of-way, but a false mansard covered with fish-scale slate shingles encircles the building. The mansard is pierced by shed-roofed dormers on the façade (west elevation) and north (side) elevation. Each dormer is fenestrated with an eight-light wood window (possibly fixed), which is flanked by wooden vents. Overhanging eaves with exposed rafter ends finish the roof. The southern bay of the first story holds a single-leaf paneled wood door with metal security door. A three-light wood sidelight is sited north of the door. A two-light wood transom and a soldier brick flat arch span the opening. The façade is fenestrated with 1/1, double-hung, vinyl-sash windows with false 6/6 vinyl muntins. These openings have concrete sills and soldier brick flat arches. A one-story, two-bay porch spans the façade and is set on a brick pier foundation with decorative concrete block infill. The roof of the porch has molded, overhanging eaves and is supported by metal filigree posts which are set on brick piers. Metal balusters and curved poured concrete steps with metal hand rails in the southern end bay complete the porch. The canted northwest corner of the dwelling shares the same material treatment and fenestration as the façade. The foundation is pierced by a one-light vinyl window (possibly awning) without a sill. The north (side) elevation is fenestrated with single and paired 1/1, double-hung, vinyl-sash windows with false 6/6 vinyl muntins and have concrete sills and soldier brick flat arches. Additionally, the foundation is pierced by a one-light vinyl window (possibly awning), which has a soldier brick flat arch.

A two-story, full-width block (possibly original) is located on the rear (east) elevation of the dwelling and is noted on the 1928 Sanborn map. The wood-frame addition is clad with German vinyl siding and is set on a solid, raised brick foundation, which serves as an integrated garage. The north elevation of the foundation is pierced by a roll-up paneled door with lights. A shed roof caps the addition. Visible fenestration consists of paired 1/1, double-hung, vinyl-sash windows with false 6/6 vinyl muntins. All windows have vinyl-clad surrounds. The rear (east) elevation was not surveyed or photographed by the volunteer surveyor.

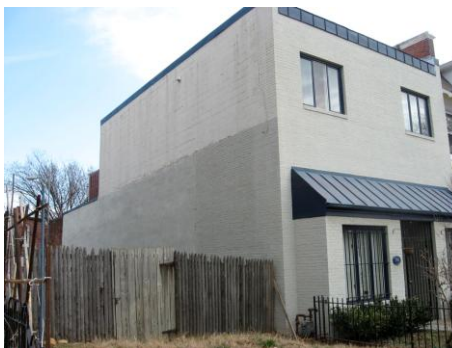
Path:    **C:\Users\CHRS\Documents\CHRS  
Databases\SE Phase I - D to G  
St\Database\Pictures\Square 1077\**  
File:    **708\_15STSE n side looking ESE.JPG**

**February 2008:** This rowhouse is located on the east side of 15th Street, S.E. and is set back approximately fifteen feet from the brick sidewalk. The south (side) elevation of the dwelling is adjacent to 710 15th Street, S.E. and a vacant grassy lot is located to the north. The dwelling is sited on a flat, grassy lot which features immature shrubs and trees and foundation plantings. A stone walkway leads from the primary entrance to the brick sidewalk. A metal fence encloses the front yard and an alley is located at the rear of the property.

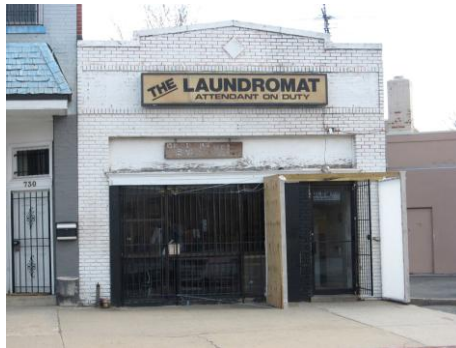
Path: C:\Users\CHRS\Documents\CHRS  
Databases\SE Phase I - D to G  
St\Database\Pictures\Square 1077\  
File: 732\_15STSE.JPG

**February 2008:** Designed and constructed in 1926 by Warren Spencer, this one-story, two-bay store was built from permit #6674. Influenced by the Italianate and Colonial Revival styles, the building, constructed of five-course American-bond brick, is set on a solid concrete foundation. The façade (west elevation) is faced with stretcher-bond brick that has been painted. The material of the shed roof was not visible from the public right-of-way, but a pedimented stepped gable parapet wall complements the roof on the façade. The parapet is edged with concrete coping. A decorative concrete diamond is inlaid below the gable of the parapet. The plain brick frieze is edged with rowlock bricks and a signboard is centrally located within the frieze. The southernmost bay holds a single-leaf, metal-frame glass door with a metal security door. A six-light, full-height storefront window is located to the north of the entry and is protected by metal security bars. An ogee-molded cornice with a plain frieze and blind transom span the openings on the façade. The rear (west) elevation was not surveyed or photographed by the volunteer surveyor.

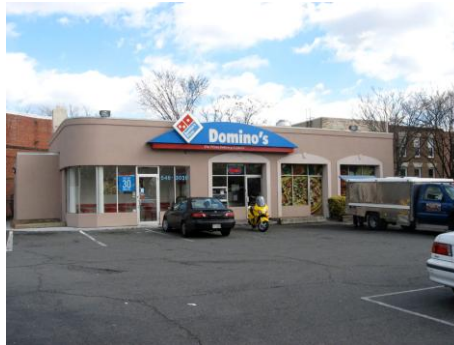
Path: C:\Users\CHRS\Documents\CHRS  
Databases\SE Phase I - D to G  
St\Database\Pictures\Square 1077\  
File: 1500\_PENN\_AVSE.JPG  
Date:: Photog:  
Code:: R: Fr:

**February 2008:** Based on its form, materials, and historic newspaper research, this commercial building was constructed ca. 1935. Set on a solid concrete foundation, this one-story, four-bay building replaced a gas station constructed in 1926 that was destroyed by a fire in 1935. The rectangular form, the horizontality, minimal ornamentation, curved façade, and streamlines of the building reflect the influence of the Moderne style in the second quarter of the twentieth century. As documented by the 1960 Sanborn Insurance map, this building was constructed for use as a gas station. It has since been rehabilitated for use as a commercial building/restaurant. The building sits on a solid concrete foundation and is constructed of concrete blocks covered with stucco. The materials of the flat roof were not visible from the public right-of-way, but a plain band covered with stucco encircles the façade, serving as a cornice. Metal ventilators pierce the roof and an interior brick chimney with a plain cap is located in the northwest corner. A signboard located on the façade partially extends above the roofline. The main entry to the building was originally located in the westernmost bay of the façade and provided access to the service counter. A replacement single-leaf metal-frame glass door with a one-light transom now serves as a secondary entry to the building. The entry is framed by large replacement storefront windows that curve around the edge of the façade to the northwest (side) elevation. The three vehicular service bays located east of the former main entry have been enclosed and used as entries and display windows. The bays hold single-leaf metal-frame glass doors with paired one-light storefront windows. A three-light transom spans each of the bays. Each bay is set in a segmentally-arched stucco surround with a keystone. A one-story, one-bay projecting bay is located on the northwest (side) elevation and shares the same material treatment as the façade. A single-leaf flush metal door is located on the northwest (side) elevation. The southeast (side) and rear (northeast) elevations of the building were not surveyed or photographed by the volunteer surveyor.
