Resource All Data Report

ID Number: 1091-0019

Rowhouse, 1600 Potomac Avenue, S.E. Common

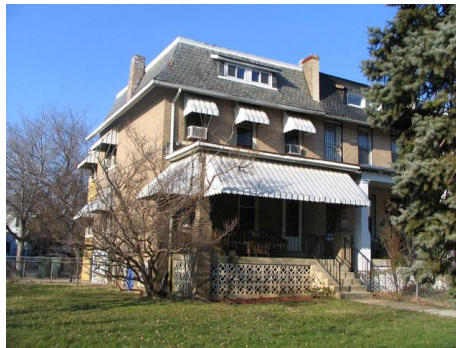
August 2008: This two-story, three-bay Colonial Revival-style rowhouse was constructed in 1919 by T.A. Jameson and is one of eight similar rowhouses constructed from the same permit (#3723). The dwelling is constructed of brick and is set on a solid concrete foundation. The façade (southeast elevation) and southwest (side) elevation are faced with five-course, American-bond brick. A false mansard roof rises from the façade and southwest elevation and is covered with fish scale slate shingles. The roof features flared, overhanging eaves. A shed dormer projects from the façade and is covered with slate shingles. Fenestration consists of paired sliding one-light vinyl windows. An interior-side brick chimney rises from the southwest elevation and pierces the false mansard. The northeastern bay of the first story of the façade holds a single-leaf door. A one-story, full-width porch spans the façade and is set on a brick pier foundation that has been infilled with decorative concrete blocks. The porch roof features overhanging eaves and is supported by brick posts set on the brick piers. Metal balusters encircle the porch, which is accessed by poured concrete steps in the northeastern end bay. Metal awnings project from the façade and side bays of the porch. The second story window openings hold double-hung windows and have concrete sills. Each window is sheltered by a metal awning. The southwest elevation is fenestrated with paired 1/1, double-hung, wood-sash windows and sliding one-light vinyl windows. All windows have concrete sills and soldier brick segmental arches. The foundation is additionally pierced by a roll-up paneled wood door with lights and a single-leaf door with a two-course rowlock brick segmental arch.

Roof Component	Material	Color	Treatment	Source
Mansard (False)	Slate		Fishscale Pattern	
Wall Component	Material	Color	Treatment	Source
Facade	Brick		American Bond	
Structure Component	Material	Feature		Source
Foundation	Concrete			
Walls	Brick

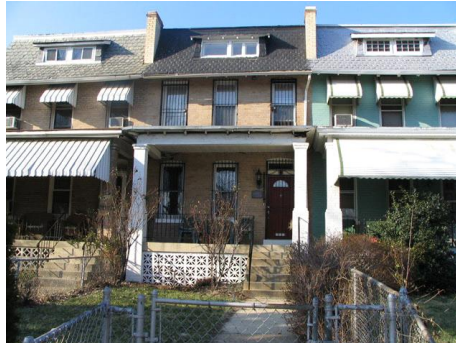
August 2008: This two-story, three-bay rowhouse was constructed in 1919 by T.A. Jameson and is one of eight similar rowhouses constructed from the same permit (#3723). The dwelling is constructed of brick and is set on a solid concrete foundation. The façade (southeast elevation) is faced with five-course, American-bond brick. A false mansard roof rises from the façade and is covered with fish scale shingles. The roof features an overhanging eave with exposed rafter ends. A shed dormer projects from the false mansard and has overhanging eaves and exposed rafter ends. Fenestration consists of a one-light wood awning window and a two-light wood awning window. The northeastern bay of the first story holds a single-leaf paneled door with lights and a one-light rectangular transom. A one-story, full-width porch spans the façade and is set on a brick pier foundation that has been infilled with decorative concrete blocks. The roof of the porch has overhanging eaves and is supported by brick posts set on the brick piers. Metal balusters encircle the porch, which is accessed by poured concrete steps in the northeastern end bay. All window openings on the façade hold 1/1, double-hung windows and have concrete sills. The southwestern bay of the second story holds a single-leaf wood-frame glass door.

The rear (northwest) elevation has a two-story, full-width block. Based on its form, as well as the 1928 Sanborn Fire Insurance Company map, this is an original feature and may have initially been a sleeping porch. The rear elevation was not surveyed or photographed by the volunteer surveyor. An outbuilding is noted on the D.C. Office of Planning GIS map, however, it was not photographed or surveyed by the volunteer surveyor.

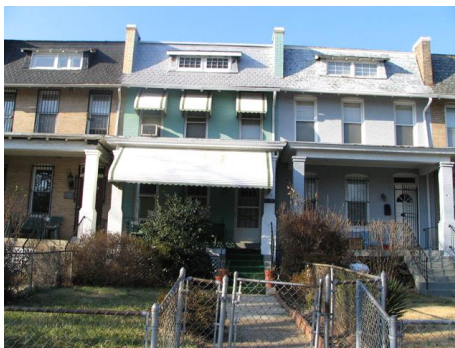
August 2008: This two-story, three-bay Colonial Revival-style rowhouse was constructed in 1919 by T.A. Jameson and is one of eight similar rowhouses constructed from the same permit (#3723). The dwelling is constructed of brick and is set on a solid concrete foundation. The façade (southeast elevation) is faced with five-course, American-bond brick that has been painted. A false mansard roof rises from the façade and is covered with fish scale shingles. The roof features an overhanging eave with exposed rafter ends. A shed dormer projects from the false mansard and has overhanging eaves and exposed rafter ends. Fenestration consists of paired twelve-light wood windows (possibly awning). The northeastern bay of the first story holds a single-leaf paneled door. A one-story, full-width porch spans the façade and is set on a brick pier foundation that has been infilled with wood lattice. The roof of the porch has overhanging eaves and is supported by brick posts set on the brick piers. Metal balusters encircle the porch, which is accessed by poured concrete steps in the northeastern end bay. A metal awning extends from the façade of the porch. All window openings on the façade hold 1/1, double-hung, vinyl-sash windows and have concrete sills.

August 2008: This two-story rowhouse is located on the northwest side of Potomac Avenue, S.E. and is set back approximately fifteen feet from the sidewalk. The dwelling is adjacent to 1602 and 1606 Potomac Avenue, S.E. The grassy front yard is landscaped with mature shrubs and foundation plantings and is enclosed by a metal chain-link fence. A concrete walkway leads from the primary entrance of the dwelling and ends at the sidewalk.

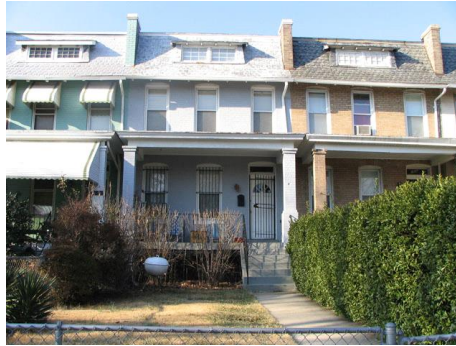
August 2008: This two-story, three-bay Colonial Revival-style rowhouse was constructed in 1919 by T.A. Jameson and is one of eight similar rowhouses constructed from the same permit (#3723). The dwelling is constructed of brick and is set on a solid concrete foundation. The façade (southeast elevation) is faced with five-course, American-bond brick that has been painted. A false mansard roof rises from the façade and is covered with fish scale shingles. The roof features an overhanging eave with exposed rafter ends. A shed dormer projects from the false mansard and has overhanging eaves and exposed rafter ends. Fenestration consists of paired twelve-light wood windows (possibly awning). The northeastern bay of the first story holds a single-leaf paneled door with lights and a one-light rectangular transom. A one-story, full-width porch spans the façade and is set on a brick pier foundation. The roof of the porch has overhanging eaves and is supported by brick posts set on the brick piers. Metal balusters encircle the porch, which is accessed by poured concrete steps in the northeastern end bay. All window openings on the façade hold 1/1, double-hung, vinyl-sash windows and have concrete sills and soldier brick segmental arches.

August 2008: This two-story rowhouse is located on the northwest side of Potomac Avenue, S.E. and is set back approximately fifteen feet from the sidewalk. The dwelling is adjacent to 1604 and 1608 Potomac Avenue, S.E. The grassy front yard is landscaped with mature shrubs and foundation plantings and is enclosed by a metal chain-link fence. A concrete walkway leads from the primary entrance of the dwelling and ends at the sidewalk. An alley is located northwest of the dwelling.

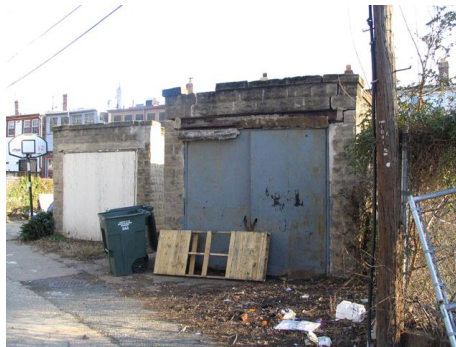
August 2008: A one-story, one-bay garage is located northwest of the dwelling and is noted on the 1928 Sanborn map. The garage is constructed of rock-faced concrete blocks and is set on a solid rock-faced concrete block foundation. A sloping roof caps the garage. The façade (northwest elevation) is

August 2008: This two-story, three-bay Colonial Revival-style rowhouse was constructed in 1919 by T.A. Jameson and is one of eight similar rowhouses constructed from the same permit (#3723). The dwelling is constructed of brick and is set on a solid concrete foundation. The façade (southeast elevation) is faced with five-course, American-bond brick. A false mansard roof rises from the façade and is covered with fish scale shingles. The roof features an overhanging eave with exposed rafter ends. A shed dormer projects from the false mansard and also has overhanging eaves and exposed rafter ends. Fenestration consists of paired twelve-light wood windows (possibly awning). The northeastern bay of the first story holds a single-leaf paneled door with lights and a one-light rectangular transom. A one-story, full-width porch spans the façade and is set on a brick pier foundation that has been infilled with wood lattice. The roof of the porch has overhanging eaves and is supported by brick posts set on the brick piers. Metal balusters encircle the porch, which is accessed by poured concrete steps in the northeastern end bay. All window openings on the façade hold 1/1, double-hung, vinyl-sash windows and have concrete sills and soldier brick segmental arches.

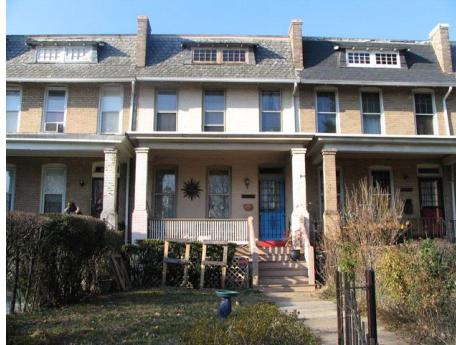
August 2008: A one-story, one-bay garage is located northwest of the dwelling and is noted on the 1928 Sanborn map. The garage is constructed of rock-faced concrete blocks and is set on a solid rock-faced concrete block foundation. A sloping roof caps the garage. Double-leaf wood doors pierce the

August 2008: This two-story, three-bay Colonial Revival-style rowhouse was constructed in 1919 by T.A. Jameson and is one of eight similar rowhouses constructed from the same permit (#3723). The dwelling is constructed of brick and is set on a solid concrete foundation. The façade (southeast elevation) is faced with five-course, American-bond brick. A false mansard roof rises from the façade and is covered with fish scale slate shingles. The roof features an overhanging eave with exposed rafter ends. A shed dormer projects from the false mansard and also has overhanging eaves and exposed rafter ends. Fenestration consists of paired twelve-light wood windows (possibly awning). The northeastern bay of the first story holds a single-leaf paneled wood door with lights and a one-light rectangular transom topped by a soldier brick segmental arch. A one-story, full-width porch spans the façade and is set on a brick pier foundation that has been infilled with wood lattice. The roof of the porch has overhanging eaves and is supported by brick posts set on the brick piers. Square wood balusters encircle the porch, which is accessed by wood steps in the northeastern end bay. All window openings on the façade hold 6/1, double-hung, wood-sash windows and have concrete sills and soldier brick segmental arches.

August 2008: This two-story rowhouse is located on the northwest side of Potomac Avenue, S.E. and is set back approximately fifteen feet from the sidewalk. The dwelling is adjacent to 1608 and 1612 Potomac Avenue, S.E. The grassy front yard is landscaped with mature shrubs and foundation plantings. A concrete walkway leads from the primary entrance of the dwelling and ends at the sidewalk. An alley and garage are located northwest of the dwelling.

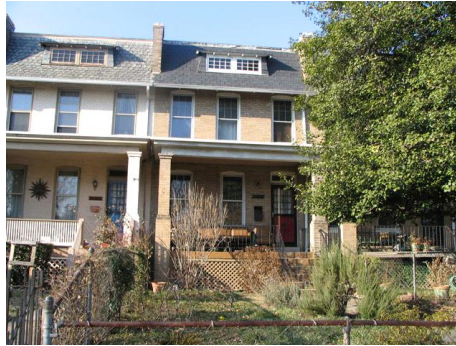
August 2008: This two-story, three-bay Colonial Revival-style rowhouse was constructed in 1919 by T.A. Jameson and is one of eight similar rowhouses constructed from the same permit (#3723). The dwelling is constructed of brick and is set on a solid concrete foundation. The façade (southeast elevation) is faced with five-course, American-bond brick. A false mansard roof rises from the façade and is covered with square butt slate shingles. The roof features an overhanging eave with exposed rafter ends. A shed dormer projects from the false mansard and also has overhanging eaves and exposed rafter ends. Fenestration consists of paired twelve-light wood windows (possibly awning). The northeastern bay of the first story holds a single-leaf paneled wood door with lights and a one-light rectangular transom topped by a soldier brick segmental arch. A one-story, full-width porch spans the façade and is set on a brick pier foundation that has been infilled with wood lattice. The roof of the porch has overhanging eaves and is supported by brick posts set on the brick piers. Metal balusters encircle the porch, which is accessed by poured concrete steps in the northeastern end bay. All window openings on the façade hold 6/1, double-hung, wood-sash windows and have concrete sills and soldier brick segmental arches.

August 2008: This two-story rowhouse is located on the northwest side of Potomac Avenue, S.E. and is set back approximately fifteen feet from the sidewalk. The dwelling is adjacent to 1610 and 1614 Potomac Avenue, S.E. The grassy front yard is planted with mature shrubs and foundation plantings. A walkway leads from the primary entrance of the dwelling and ends at the sidewalk. An alley is located northwest of the dwelling.

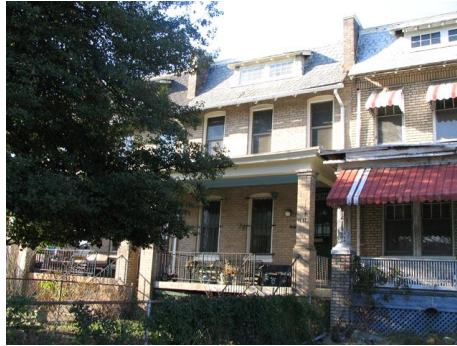
August 2008: This two-story, three-bay Colonial Revival-style rowhouse was constructed in 1919 by T.A. Jameson and is one of eight similar rowhouses constructed from the same permit (#3723). The dwelling is constructed of brick and is set on a solid concrete foundation. The façade (southeast elevation) is faced with five-course, American-bond brick. A false mansard roof rises from the façade and is covered with fish scale slate shingles. The roof features an overhanging eave with exposed rafter ends. A shed dormer projects from the false mansard and also has overhanging eaves and exposed rafter ends. Fenestration consists of paired twelve-light wood windows (possibly awning). The northeastern bay of the first story holds a single-leaf paneled wood door with lights and a one-light rectangular transom topped by a soldier brick segmental arch. A one-story, full-width porch spans the façade and is set on a brick pier foundation that has been infilled with wood lattice. The roof of the porch has overhanging eaves and is supported by brick posts set on the brick piers. Metal balusters encircle the porch, which is accessed by poured concrete steps in the northeastern end bay. All window openings on the façade hold 1/1, double-hung, vinyl-sash windows and have concrete sills and soldier brick segmental arches.

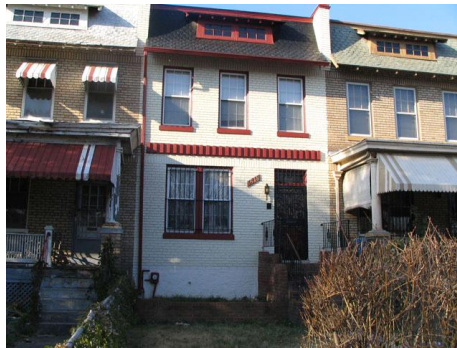
August 2008: This two-story, two-bay Colonial Revival-style rowhouse was constructed in 1923 by H.R. Howenstein and is one of seven similar rowhouses constructed from the same permit (#3387) along Potomac Avenue, S.E. The dwelling is constructed of brick and is set on a solid concrete block foundation; the façade (southeast) elevation is faced with five-course, American-bond brick. A string course, composed of soldier bricks, runs across the façade and is located above the first story and second story window openings. An architrave spans the façade above the first story string course and features imitation dentils. A sloping roof caps the building and is fronted along the façade by a false mansard roof. The false mansard is covered with fish scale shingles and has an overhanging eave with exposed rafter ends. A shed dormer pierces the false mansard and features overhanging eaves and exposed rafter ends. Paired six-light wood awning windows fenestrate the dormer. The northeastern bay of the first story holds a single-leaf door and a one-light rectangular wood transom. The southwestern bay holds paired 6/6, double-hung, wood-sash windows with a concrete sill. The original one-story, full-width porch has been removed from the façade. The second story window openings contain 6/6, double-hung, wood-sash windows and have concrete sills. The rear (northwest) elevation was not surveyed or photographed by the volunteer surveyor.

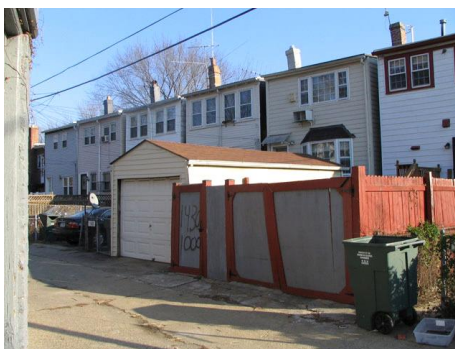
August 2008: This one-story, one-bay garage is located northwest of the dwelling and was constructed c. 1960. The garage is clad with aluminum siding and is set on a solid foundation. A front-gabled roof caps the dwelling and is

August 2008: This two-story, two-bay Colonial Revival-style rowhouse was constructed in 1923 by H.R. Howenstein and is one of seven similar rowhouses constructed from the same permit (#3387) along Potomac Avenue, S.E. The dwelling is constructed of brick and is set on a solid concrete foundation; the façade (southeast) elevation is faced with five-course, American-bond brick. A string course, composed of soldier bricks, runs across the façade and is located above the first and second story window openings. A sloping roof caps the building and is fronted along the façade by a false mansard roof. The false mansard is covered with fish scale slate shingles and has an overhanging eave with exposed rafter ends. A shed dormer pierces the false mansard and features overhanging eaves and exposed rafter ends. Paired six-light wood awning windows fenestrate the dormer. The northeastern bay of the first story holds a single-leaf door. The southwestern bay holds windows with a concrete sill. A one-story, full-width porch spans the façade and is set on a brick pier foundation. The roof of the porch features a molded cornice and overhanging eaves and is supported by Tuscan wood columns set on the brick piers. Metal balusters encircle the porch, which is accessed by poured concrete steps in the northeastern end bay. A metal awning projects from the façade of the porch. The second story window openings contain 6/1, double-hung, wood-sash windows.
