# Resource All Data Report

ID Number: 0778-0008

**Condominium Building, 615 3rd Street, N.E.** **Common**

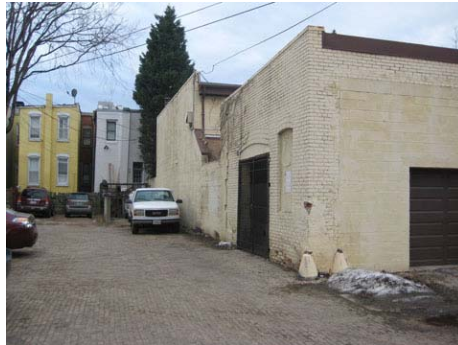
Path: **X:\SD Databases\F&G  
Street\Database\Pictures\Square 0778\  
File: 615\_3rd\_St\_NE\_garage&rear\_looking\_NW.jpg**  
Date:: Photog:  
Code:: R: Fr:

**January 2010: This one-story, five-bay garage is located east of the dwelling and was constructed c. 1925. The garage is constructed of five-course, American-bond brick and is set on a solid foundation. A sloping roof caps the garage. The façade (east elevation) is pierced by five roll-up paneled metal doors. The southernmost bay was originally much larger, but has**

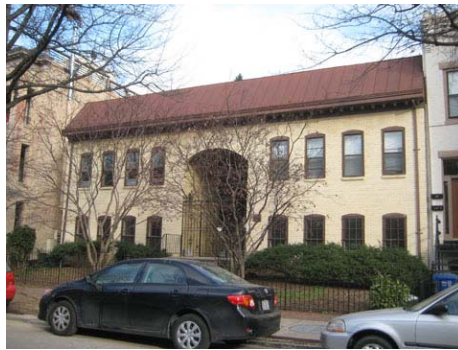
File: 615\_3rd\_Street\_NE\_facade\_looking\_NE.JPG

January 2010: Constructed c. 1984, this two-story, nine-bay condominium building is composed of concrete blocks and is set on a solid concrete block foundation; both are faced with stretcher-bond brick on the façade (west elevation). A sloping roof caps the building and is fronted along the façade by a false mansard roof. The false mansard is covered with standing-seam metal and features an overhanging eave with modillions. A metal gate protects the two-story segmental opening, which serves as the entry point to the four condominiums inside. All window openings on the façade hold 1/1, double-hung, wood-sash windows and feature soldier brick segmental arches and rowlock brick sills.

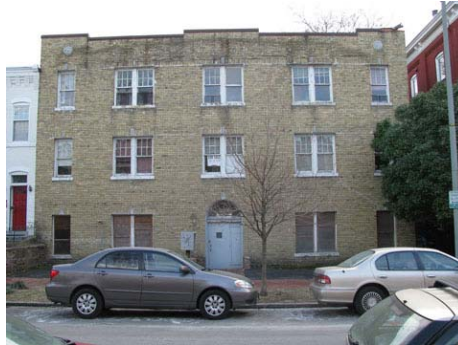
Path: **X:\SD Databases\F&G  
Street\Database\Pictures\Square 0778\**  
File: **315\_G\_Street\_NE\_facade\_looking\_S.JPG**  
Date:: Photog:  
Code:: R: Fr:

January 2010: Constructed in 1926 by Hyman Klavans, this apartment building was constructed in the Colonial Revival style. This three-story, five-bay building has a T-shaped form. Set on a solid concrete foundation, this brick structure has six-course, American-bond coursing. The brick is rough, not pressed. The flat roof features a brick parapet wall which appears to be a battlement. The parapet features rowlock brick panels and rosette moldings. The symmetrically balanced façade has single and paired openings of 6/1, double-hung, wood-sash windows. All of the window openings have concrete sills and soldier-brick flat arches with keystones. The third-story openings feature a lintel course of soldier bricks. The main entry, located below grade in the central bay, holds a single-leaf, non-original metal door with light. This door openings includes a multi-pane half-round transom and a brick surround. The south (rear) elevation of the main block has paired, 6/1, double-hung, wood-sash windows with concrete sills. A single-leaf metal door opening is located below grade in the eastern bay of the rear elevation. A three-story, three-bay original block is centrally located on the rear elevation of the main block. This block has 6/1 and 6/6 double-hung, vinyl-sash windows. A door opening (covered with plywood) is located on the second story of the rear elevation. This opening is accessed via concrete-block steps with metal railing.
