**Testimony of the Capitol Hill Restoration Society
before the DC Preservation Review Board on November 16, 2017
716-718 L St SE (HPA 17-658)**

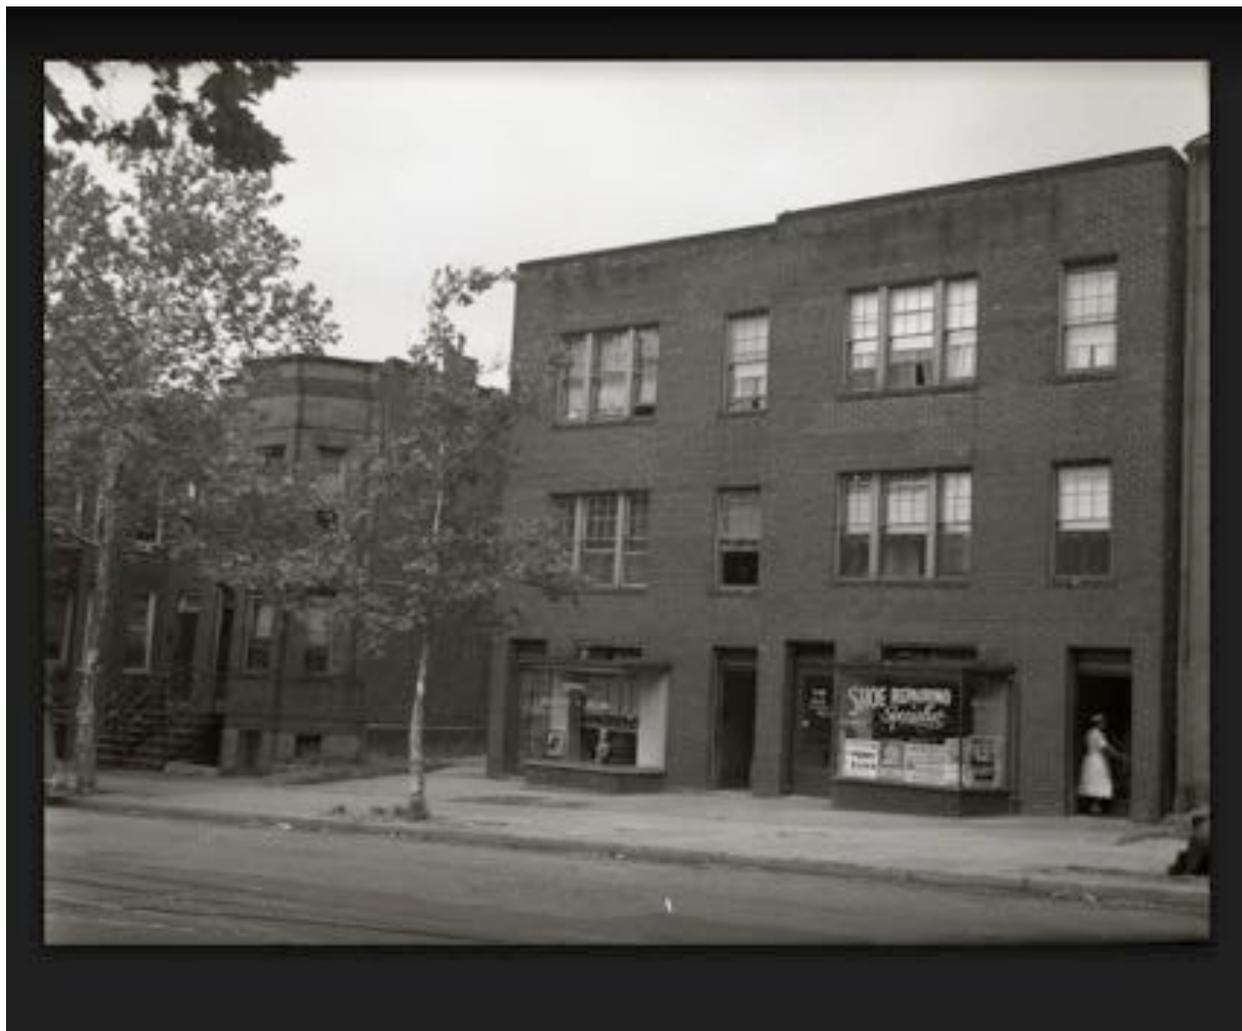
Figure 1. John P. Wymer photograph # 1503 of 700 block of L Street, SE (1949) Image courtesy Historical Society of Washington, DC.

A photograph from 1949 that Beth Purcell found likely shows the buildings' original appearance. We suggest the applicant return to the six-over-one and four-over-one windows as seen in the 1949 photograph. We agree with HPO's recommendations that the storefront roofs should be flat and these new storefront windows retain the transom above, as in the original, matching the transom over the other two entrances (Figures 1, 2).
