Resource All Data Report

ID Number: 1082-0042

Name(s)	Type of Name
Rowhouse, 200 17th Street, N.E.	Common

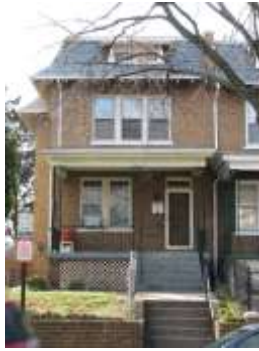
Path: C:\Users\CHRS\Documents\CHRS
Databases\Rosedale - 15 to 19th
St\Database\Pictures\Square
1082\200_block17thNE\
File: 200_17thStNE.jpg

March 2008: Constructed in 1928 by D.C. Gruver, this two-story, two-bay rowhouse is one of twelve similar dwellings constructed from the same permit (#5841). Designed by George T. Santmyers, the Colonial Revival-style rowhouse was influenced by the Craftsman Style. Set on a solid concrete foundation, this brick dwelling is faced with five-course, American-bond brick. Multiple brick stringcourses ornament the façade. A false mansard and pent roof of slate shingles roof caps the dwelling and has overhanging eaves with exposed rafter ends. A shed dormer is located on the mansard and holds eight-light wood windows. The dwelling is fenestrated with 6/6, double-hung, wood-sash windows with concrete sills. The primary entry is located on the façade (east elevation) and holds a single-leaf, paneled wood door with lights surmounted by a single-light transom. A one-story, two-bay porch projects from the façade and sits on a foundation of brick piers infilled with wood lattice. The flat roof of the porch is supported by metal filigree posts and the porch is encircled by metal balusters.

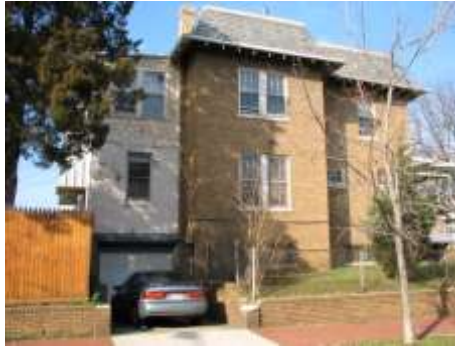
Path: C:\Users\CHRS\Documents\CHRS
Databases\Rosedale - 15 to 19th
St\Database\Pictures\Square
1082\200_block17thNE\
File: 200_17thStNE_side.jpg

The side (south) elevation received the same material treatment as the façade. A three-sided rectangular bay projects from this elevation, and the foundation is fenestrated with sliding metal windows with concrete sills. A brick chimney with a plain cap is visible from this elevation. A two-story, full-width enclosed porch is located on the rear (west) elevation. The first story has been parged and the second story is faced with aluminum siding. The foundation is pierced by a roll-up garage door on the south elevation. The porch is capped by a shed roof and fenestrated with 6/6 and 1/1, double-hung, wood-sash windows. A single-leaf door is sheltered by a vinyl awning on the west elevation.

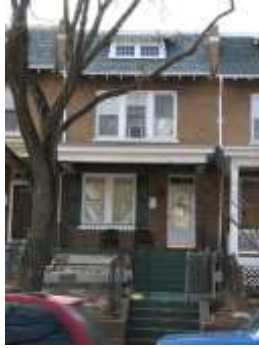
File: 202_17thStNE.jpg

March 2008: Constructed in 1928 by D.C. Gruver, this two-story, two-bay rowhouse is one of twelve similar dwellings constructed from the same permit (#5841). Designed by George T. Santmyers, the Colonial Revival-style rowhouse was influenced by the Craftsman Style. Set on a solid concrete foundation, this brick dwelling is faced with five-course, American-bond brick. Multiple brick stringcourses ornament the façade. A sloping roof caps the dwelling and is complemented on the façade (east elevation) by a false mansard and pent roof of slate shingles with overhanging eaves and exposed rafter ends. A shed dormer is located on the mansard and holds eight-light wood windows. The dwelling is fenestrated with 1/1, double-hung, vinyl-sash windows with concrete sills. The primary entry is located on the façade and holds a single-leaf, paneled metal door with an oval light surmounted by a single-light transom. A one-story, one-bay porch projects from the façade and sits on a foundation of brick piers infilled with brick. The flat roof of the porch is supported by metal filigree posts and the porch is encircled by metal balusters.

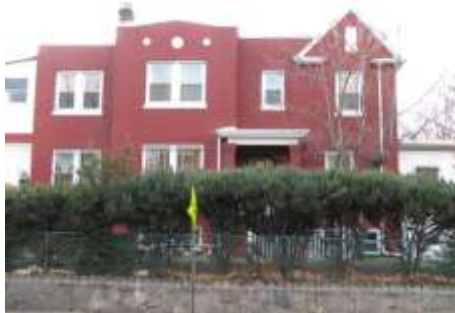
Path: C:\Users\CHRS\Documents\CHRS
Databases\Rosedale - 15 to 19th
St\Database\Pictures\Square
1082\1600_blockCSt\
File: 1661_CStNE_fronton17th.jpg
Date:: Photog:
Code:: R: Fr:

March 2008: Constructed in 1932 by Fulton R. Gruver, this two-story, two-bay Colonial Revival-style single-family rowhouse is one of six similar buildings constructed from the same permit (#157541). Set on a solid brick foundation, this brick building is faced with six-course, American-bond brick. A sloping roof caps the building and is fronted by a false mansard roof of slate shingles. Two blind dormers mark the false mansard roof and each has a front-gabled roof. An interior brick chimney pierces the roof and has a plain cap. The second story of the façade is pierced by 1/1, double-hung, vinyl-sash windows, each with a molded concrete sill. A one-story, full-width enclosed porch spans the façade and is set on a brick pier foundation. A flat roof, featuring overhanging eaves, caps the porch and is supported by brick posts. Vinyl siding encloses the porch and is pierced by a three-sided, canted oriel window. The oriel is fenestrated with eight-light casement windows.

A three-sided, square bay rises the full height of the east (side) elevation and is original. The bay has the same material treatment as the main block. Visible fenestration on the east elevation and bay consists of single and paired 1/1, double-hung, vinyl-sash windows. A one-story, one-bay porch extends from the east elevation and is set on a brick pier foundation. The flat roof is supported by brick posts.

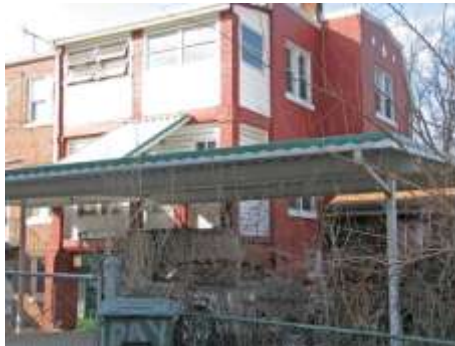
Path: C:\Users\CHRS\Documents\CHRS
Databases\Rosedale - 15 to 19th
St\Database\Pictures\Square
1082\1600_blockCSt\
File: 1661_CStNE_rear.jpg
Date:: Photog:
Code:: R: Fr:

A two-story, full-width enclosed porch, set on a brick pier foundation, spans the rear elevation of the dwelling and is original. Brick posts support the sloping roof. Each level of the porch is enclosed with vinyl siding and visible fenestration consists of paired metal awning windows.
