1325 D Street, SE.

Original use: school

The buildings constructed in 1895 and 1921 are extant; the buildings constructed in 1930 and c. 1960 were demolished in 2016.

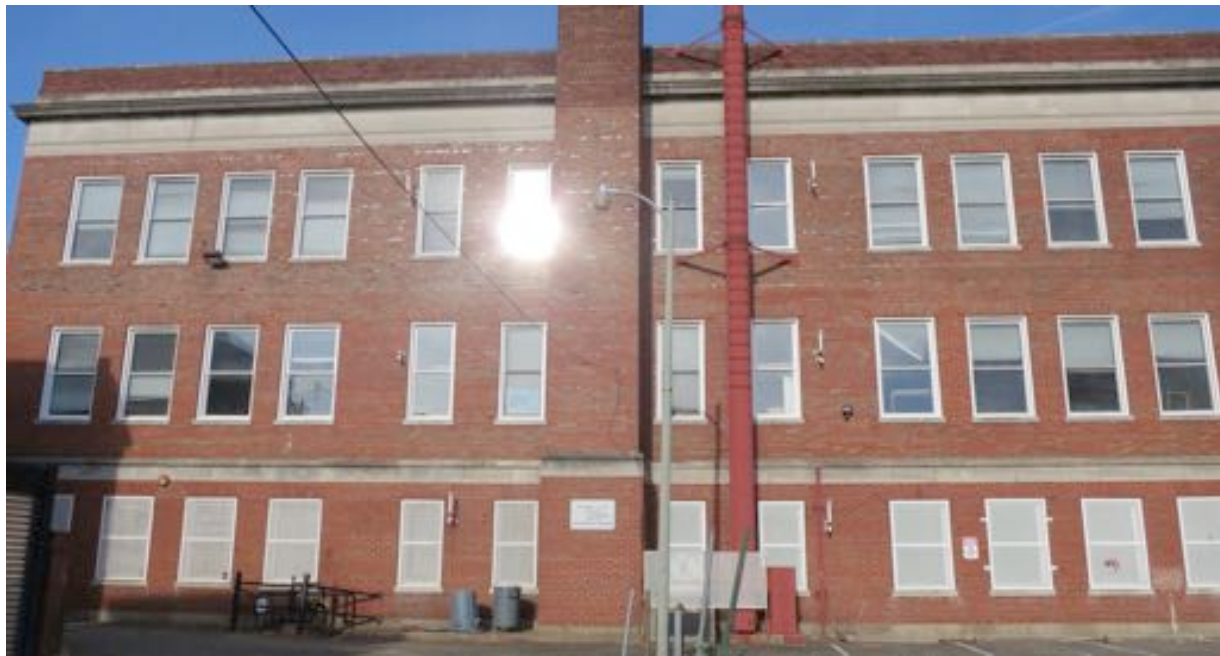
Buchanan School 1930 building looking west

1930 building (demolished): The 1930 addition was attached to the 1921 addition on the north elevation. According to the 1960 Sanborn Map, the addition had a twelve-inch brick walls and a concrete floor and roof.

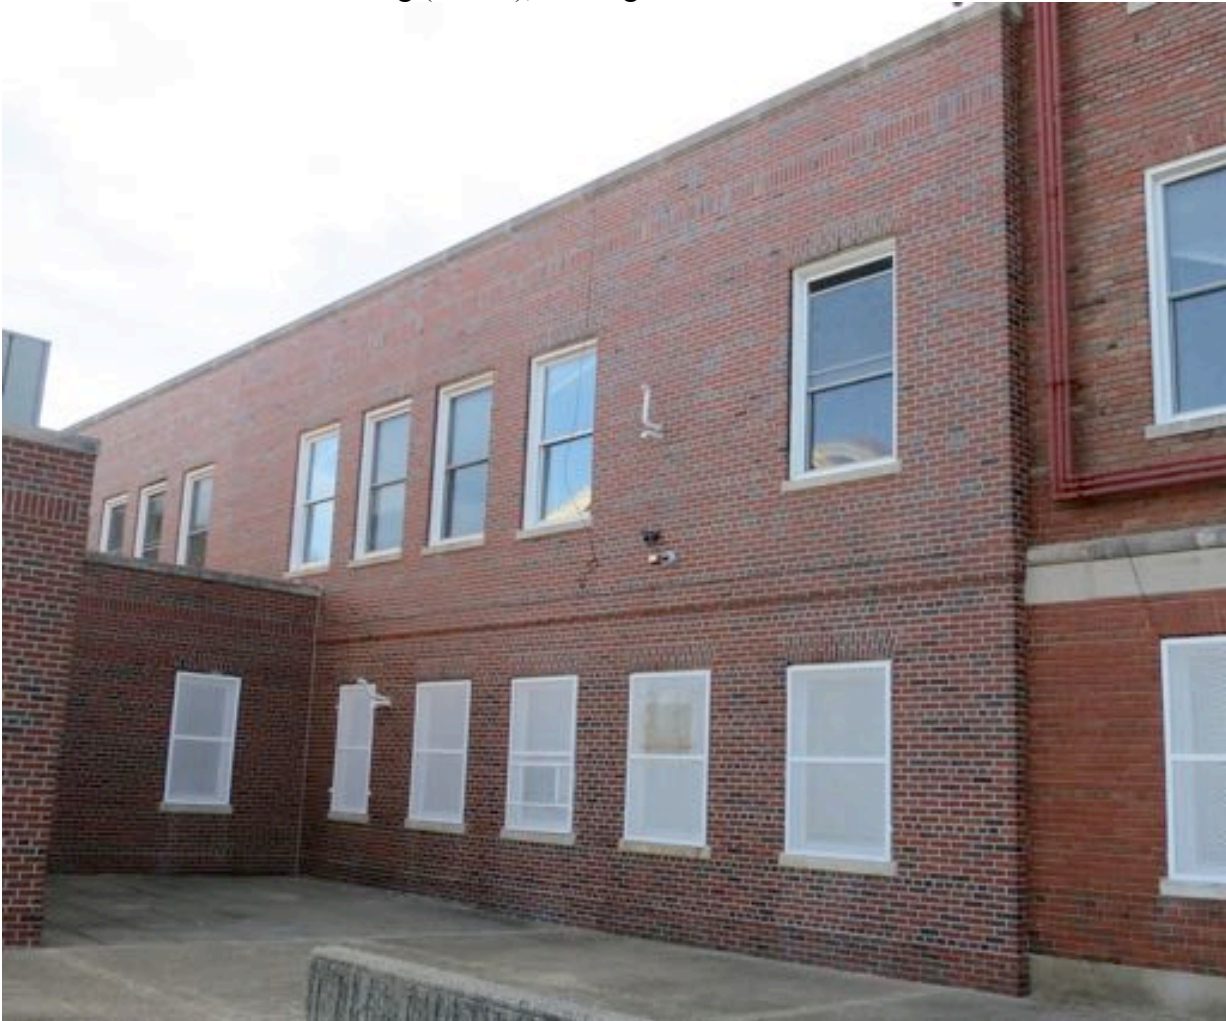
Buchanan School 1930 building (on left), looking east

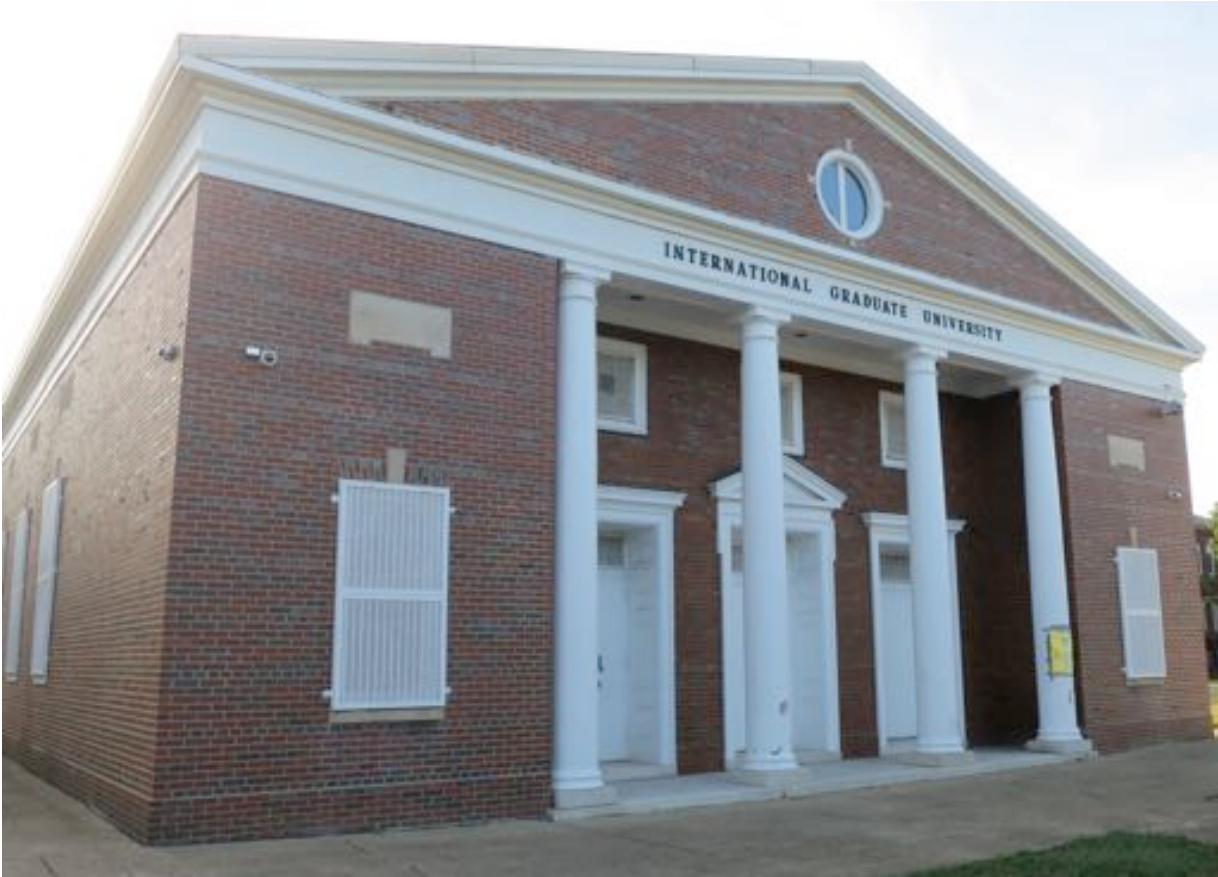
Buchanan School c. 1960 auditorium, front elevation:

c. 1960 building (demolished): The final addition was located west of the 1930 addition and was connected to the addition on the east by a hyphen. The one-and-a-half-story, wood-frame addition had been faced with six-course, American-bond brick. According to the 1960 Sanborn Insurance Map, the addition was constructed as an auditorium and gymnasium. It was capped by a gable roof and finished with overhanging eaves, an ogee molded cornice with plain frieze and

ogee-molded architrave. The western gable end had a closed pediment with a two-light ocular window in the tympanum. The opening had a header surround with keystones. The façade (west elevation) was three bays wide. The outermost bays were fenestrated with single window openings with flat brick arches and keystones. A concrete spandrel was located above each opening. The center bay was symmetrically fenestrated with three double-leaf paneled wood doors with a nine-light, wood-frame window above. These recessed openings were a Colonial Revival-style.

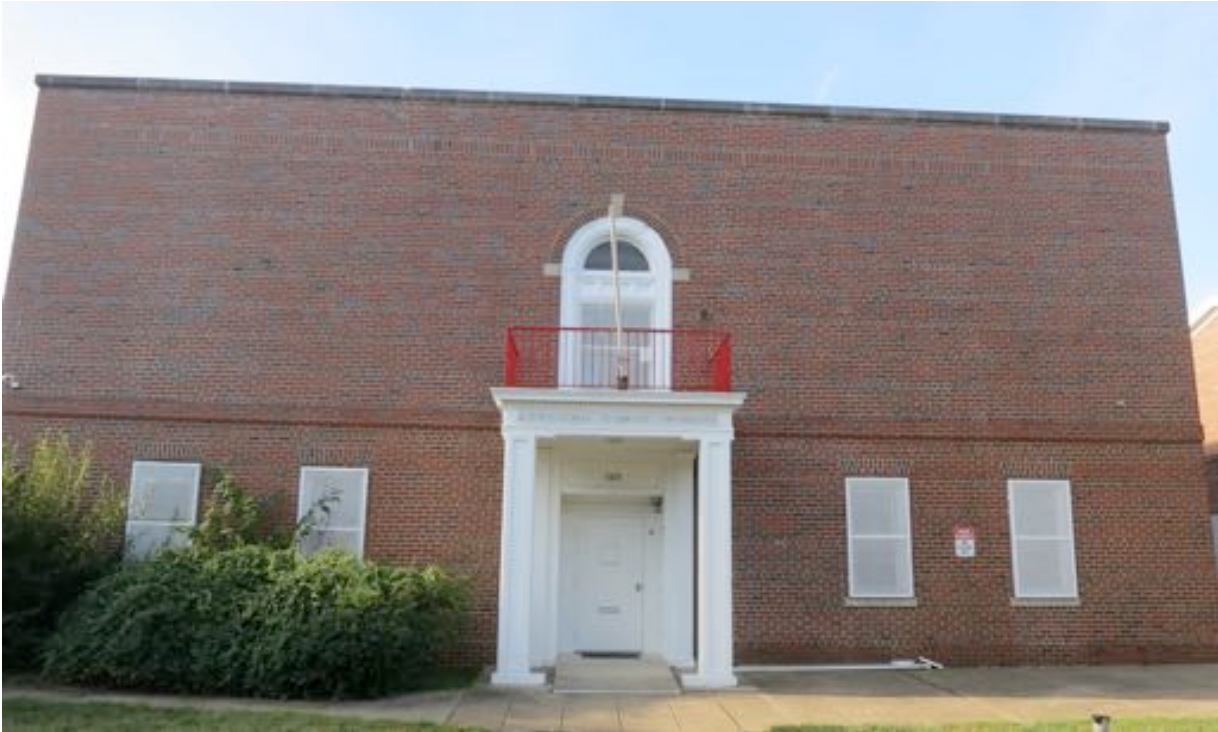
Buchanan School c. 1960 auditorium, side view facing D Street, SE, looking west:
